BMW 5 TOURING: 1KNJ118

Limited Technical Inspection

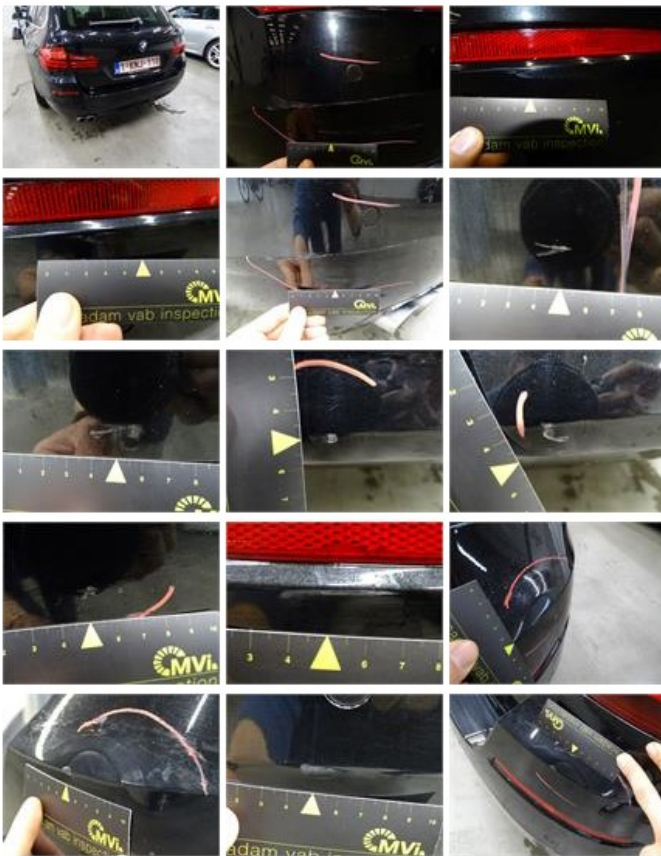
Bumper R, Dent(s) and scratch(es), LI - Repair and paint (complete) 254,16

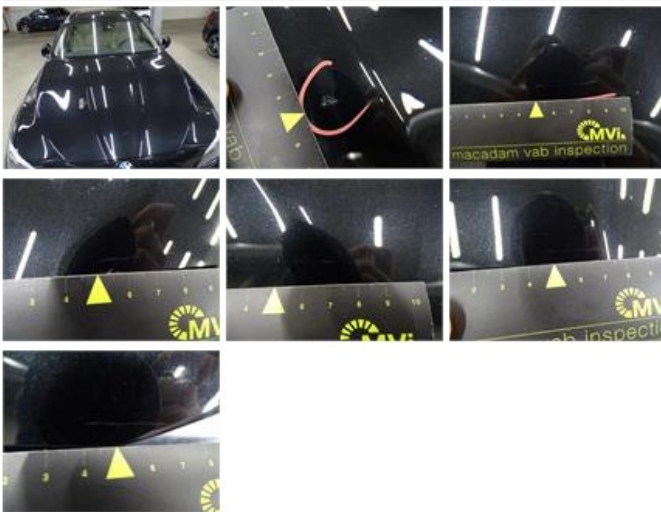
Bonnet, Scratch(es), LI - Repair and paint (complete) 348,09

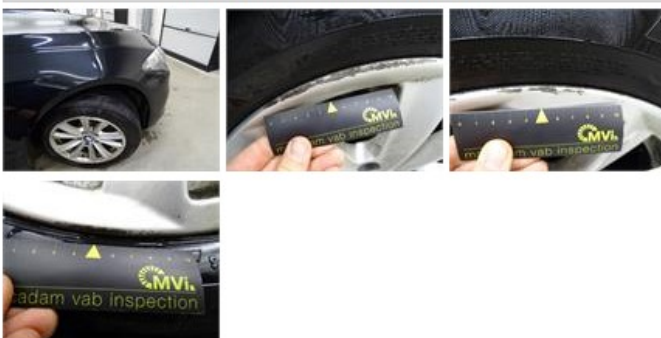
Alloy rim F R, Scratch(es), LI - Repair and paint (complete) 95,00

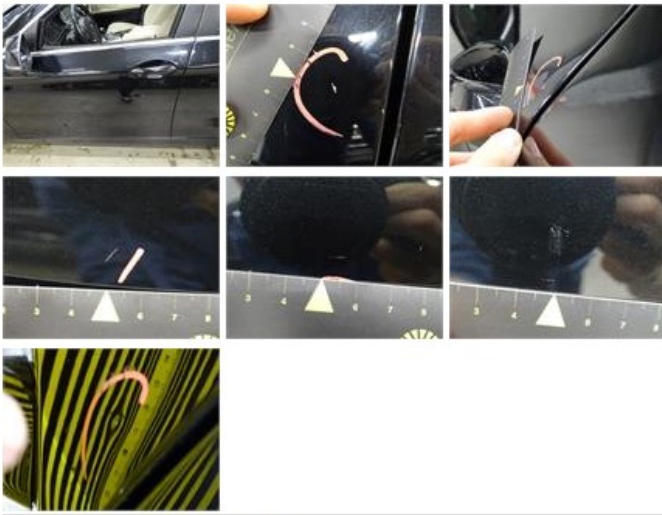
Door F L, Dent(s) and scratch(es), LI - Repair and paint (complete) 382,02
