BMW 5 TOURING: 1KXB843

Limited Technical Inspection

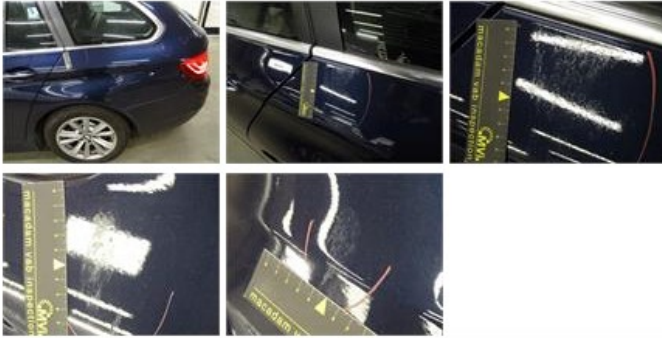
Wing R L, Chemical polution, LI - Repair and paint (complete) 369,84

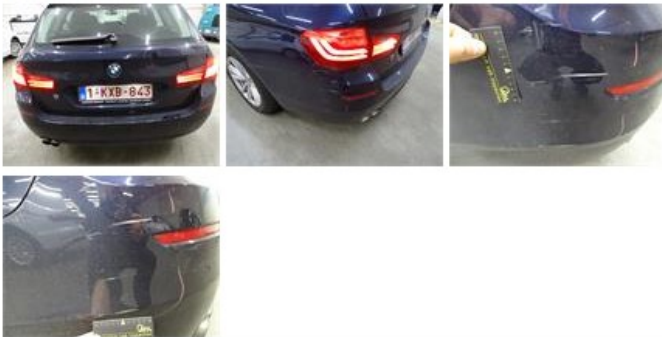
Bumper R, Dent(s) and scratch(es), LI - Repair and paint (complete) 254,16

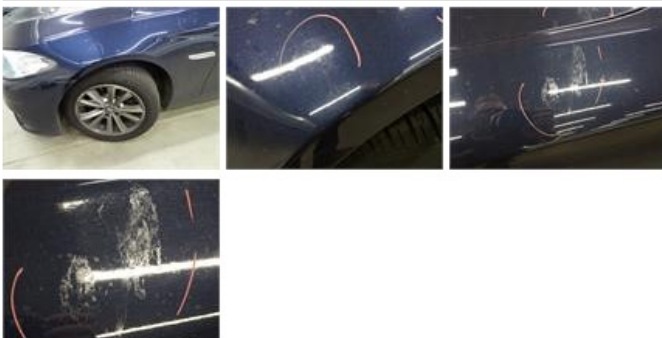
Wing F L, Chemical polution, LI - Repair and paint (complete) 264,21

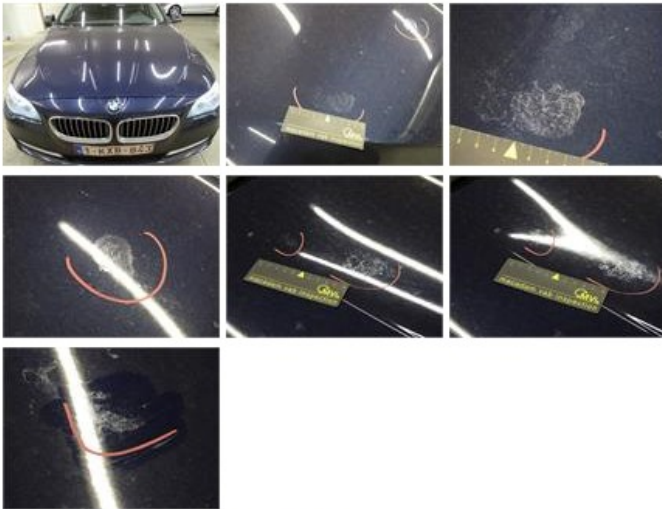
Bonnet, Chemical polution, LI - Repair and paint (complete)

348,09

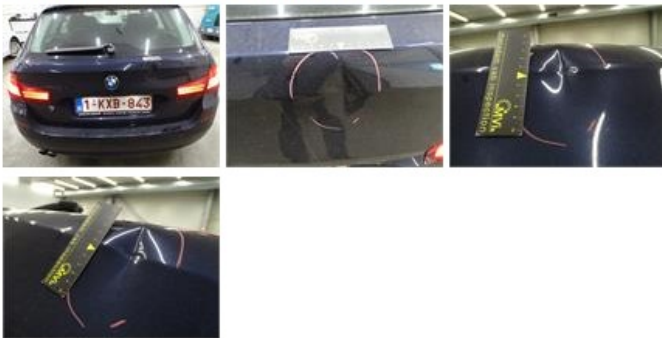
Tailgate, Dent(s), LI - Repair and paint (complete)

362,02

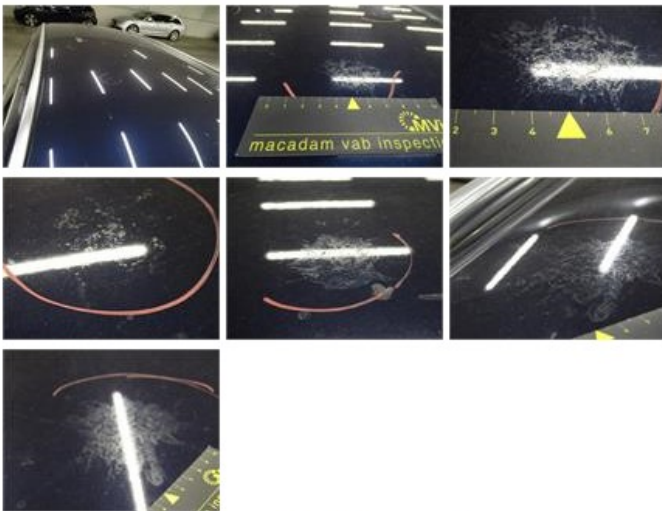
Roof, Chemical polution, LI - Repair and paint (complete)

577,80

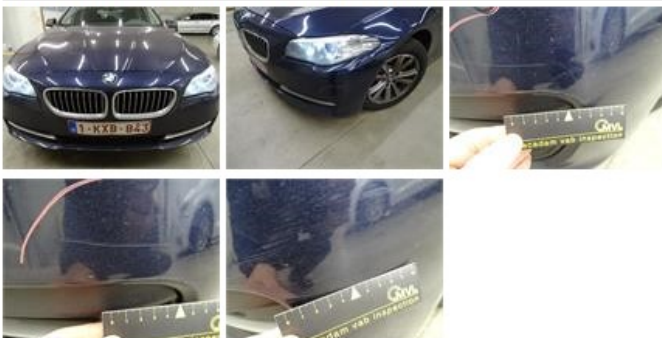
Bumper F, Scratch(es), LI - Repair and paint (complete)

254,16
