<b>BMW 3: 1GHM326</b>			
Vinnumber:	<b>WBA3K11050F830642</b>	Versionname:	<b>3 TOURING 318d 136PK</b>
First Registrationdate:	<b>10/02/2014</b>	Fiscalpower:	
Expertise Mileage:	<b>165857</b>	Power Kw:	<b>100</b>
Bodytype:	<b>Break</b>	Body color:	<b>Grey</b>
Gearbox:	<b>MAN 6 VIT</b>	Paint type:	<b>Metalic</b>
Transmission:	<b>Back</b>	Rims summer:	<b>Aluminium</b>
Fueltype:	<b>Diesel</b>	Oil level:	<b>OK</b>
Battery functioning:	<b>Yes</b>	Parking lot:	<b>1227</b>
Number of doors:	<b>5</b>		
Number of seats:	<b>5</b>		
Number head rests:	<b>5</b>		
Rims summer:	<b>Aluminium</b>		
Category:	<b>Passenger Car</b>		
Oil level:	<b>OK</b>		
Registration Certificate Car (BE):	<b>Yes</b>

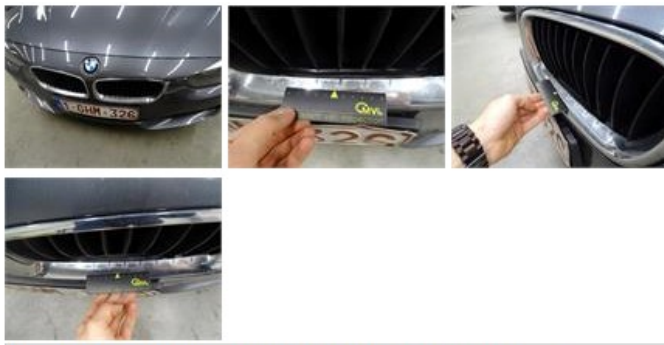
<b>Total cost ex VAT</b>	<b>1911,69</b>
<b>Bumper grille F L, Deformed / Strained, E - Replace</b>	<b>32,40</b>

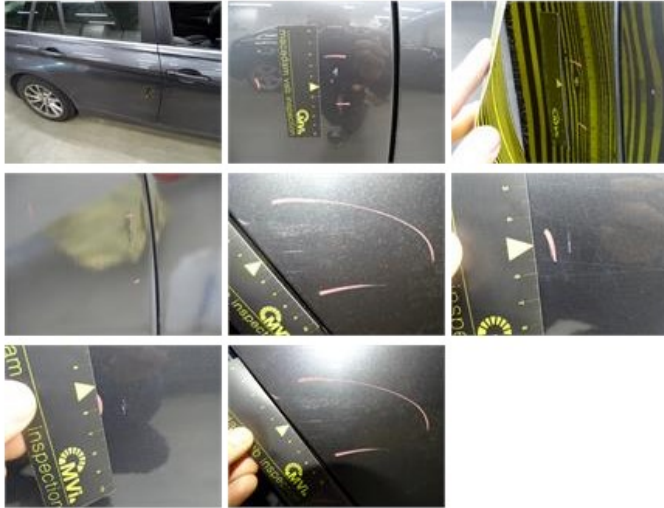
Door R R, Dent(s) and scratch(es), LI - Repair and paint (complete)

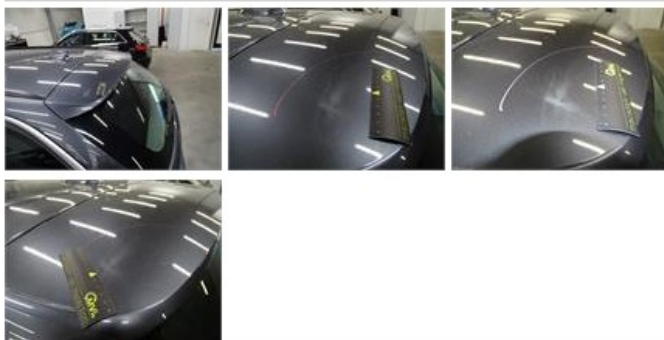
Rear spoiler, Scratch(es), LI - Repair and paint (complete)

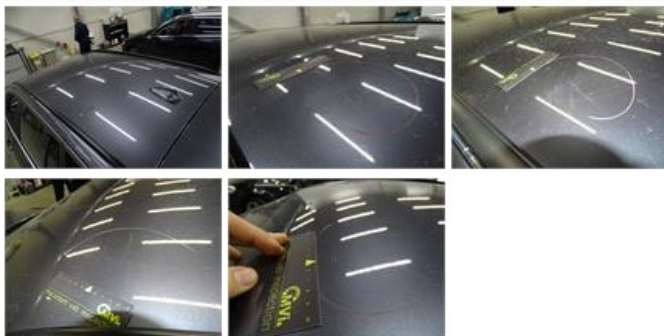
Roof, Scratch(es), LI - Repair and paint (complete)

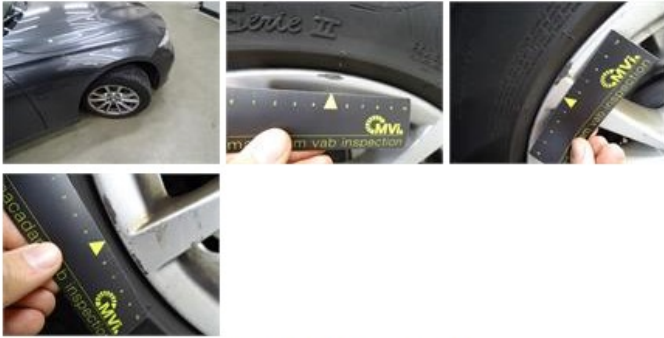
Alloy rim F R, Scratch(es), LI - Repair and paint (complete) 95,00

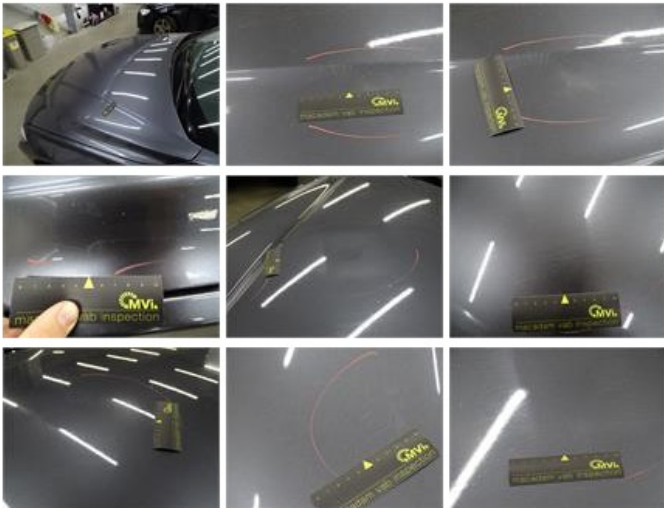
Bonnet, Scratch(es), LI - Repair and paint (complete) 290,08

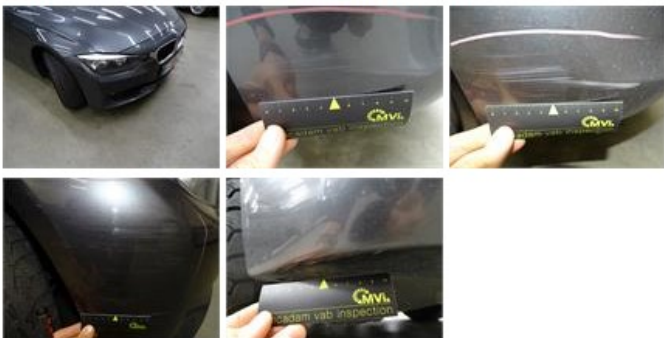
Bumper F, Scratch(es), LI - Repair and paint (complete) 211,80
