BMW 3 TOURING: 1JKR986

Limited Technical Inspection

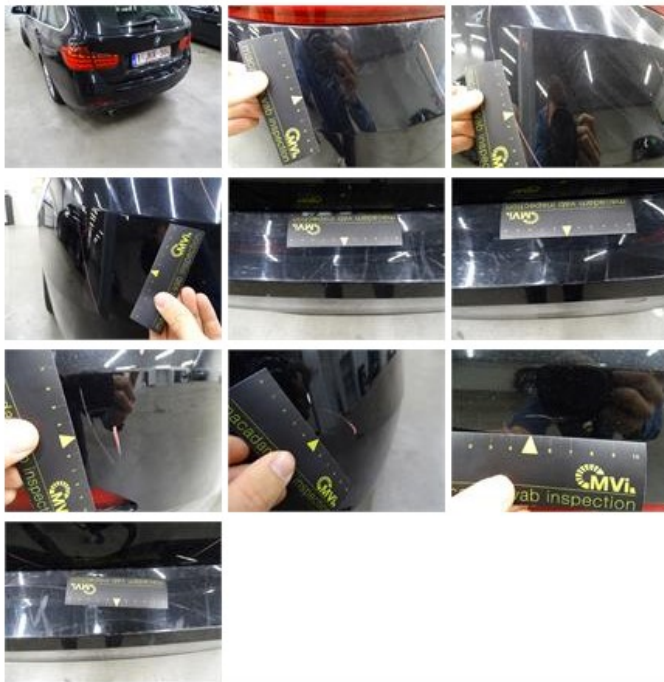
Bumper R, Scratch(es), LI - Repair and paint (complete) 211,80

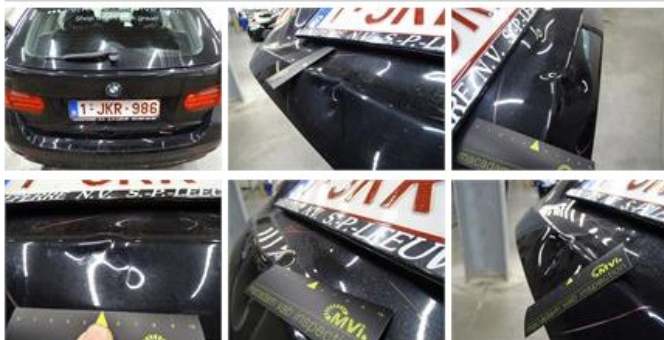
Tailgate, Dent(s) and scratch(es), LI - Repair and paint (complete) 301,68

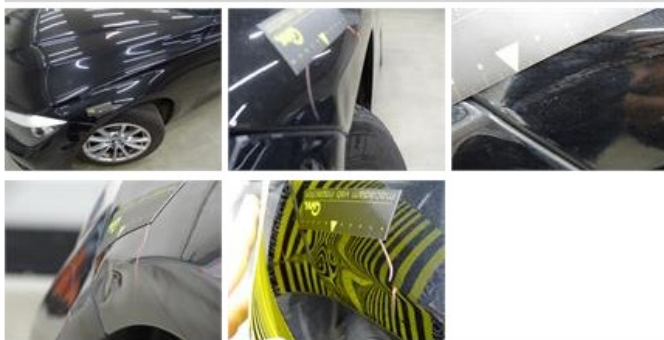
Wing F L, Dent(s) and scratch(es), LI - Repair and paint (complete) 220,18

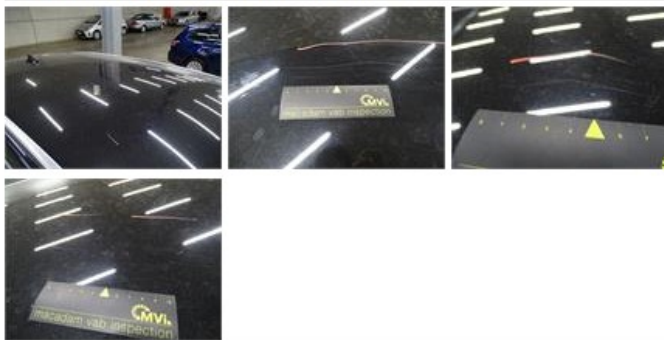
Roof, Scratch(es), LI - Repair and paint (complete) 481,50

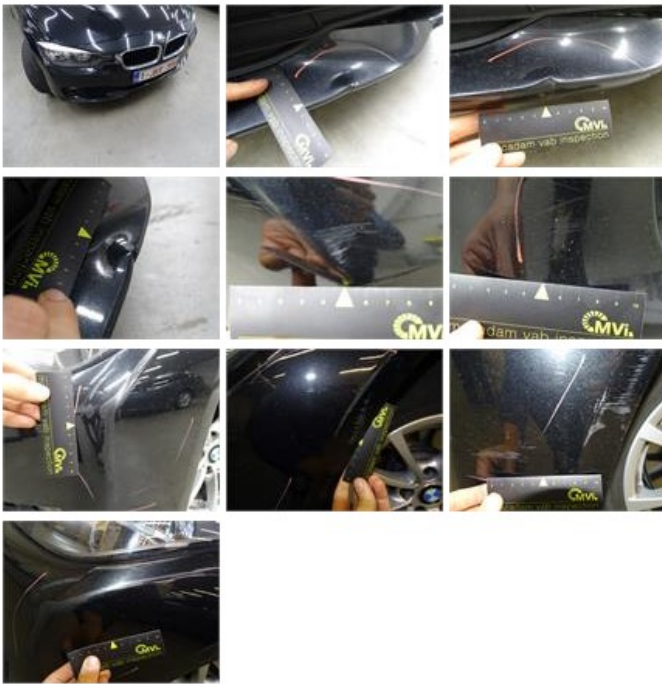
Bumper F, Dent(s) and scratch(es), LI - Repair and paint (complete) 211,80

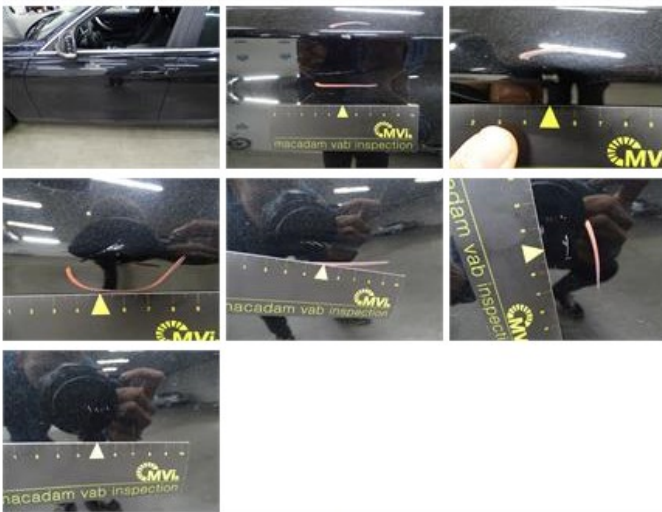
Door F L, Scratch(es), LI - Repair and paint (complete) 318,35

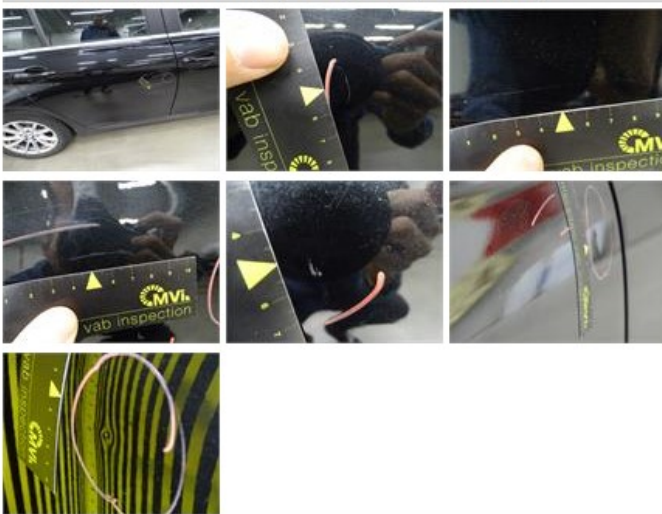
Door R R, Dent(s) and scratch(es), LI - Repair and paint (complete) 318,35
