RENAULT Scenic: 1KHL226

Limited Technical Inspection

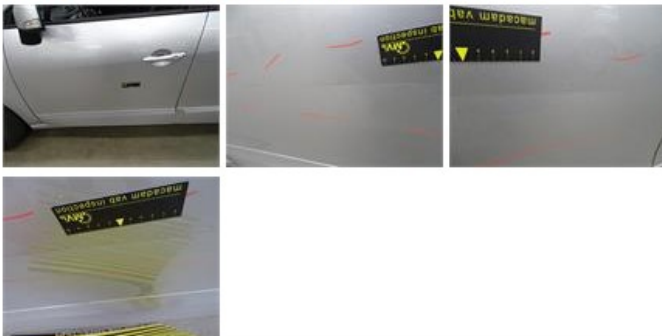
Door F L, Dent(s) and scratch(es), LI - Repair and paint (complete) 318,35

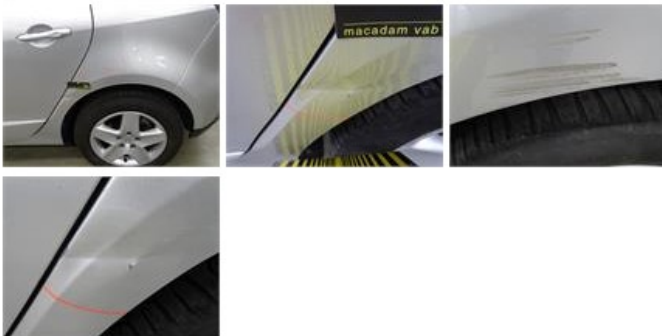
Wing R L, Dent(s) and scratch(es), LI - Repair and paint (complete) 308,20
