VOLKSWAGEN GOLF VII: 1JHL071

Limited Technical Inspection

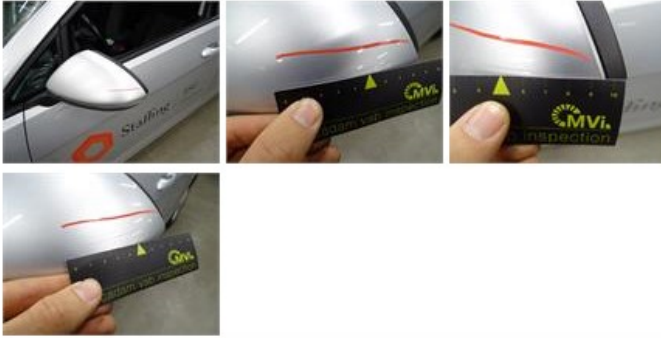
Rearview mirror housing L, Scratch(es), LI - Repair and paint (complete) 115,56

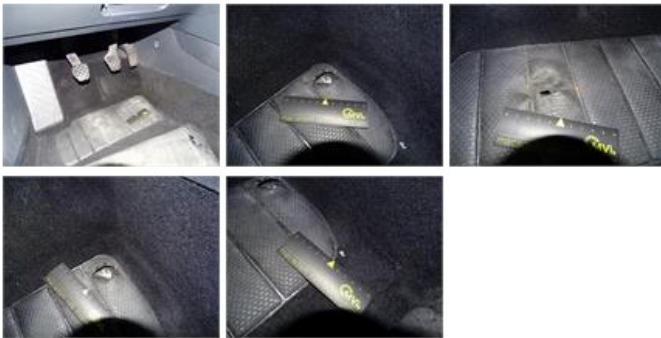
Floor covering F L, Hole, E - Replace 252,00

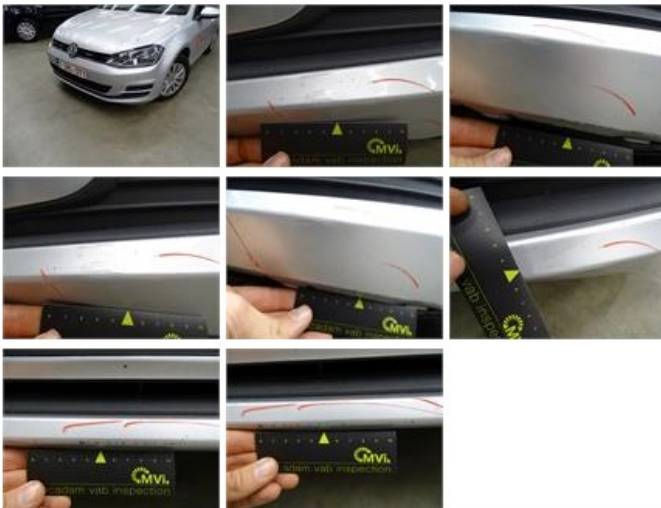
Bumper F, Scratch(es), LI - Repair and paint (complete) 211,80

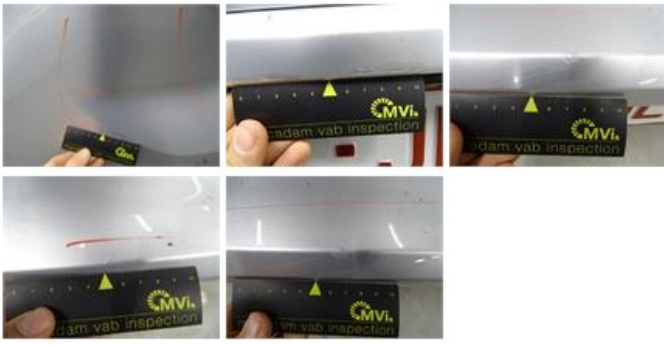
Bumper R, Scratch(es), LI - Repair and paint (complete) 211,80
