VOLKSWAGEN Golf: 1DLV476

Limited Technical Inspection

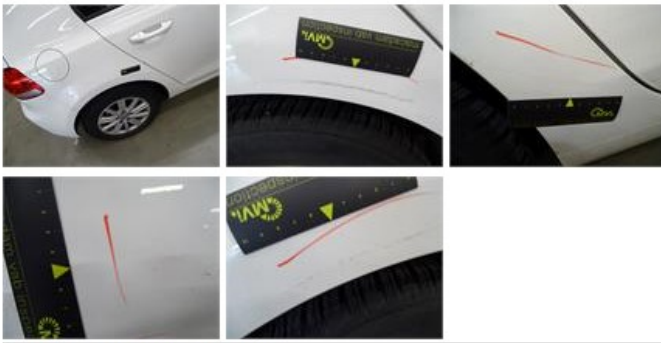
Wing R R, Scratch(es), LI - Repair and paint (complete) 308,20

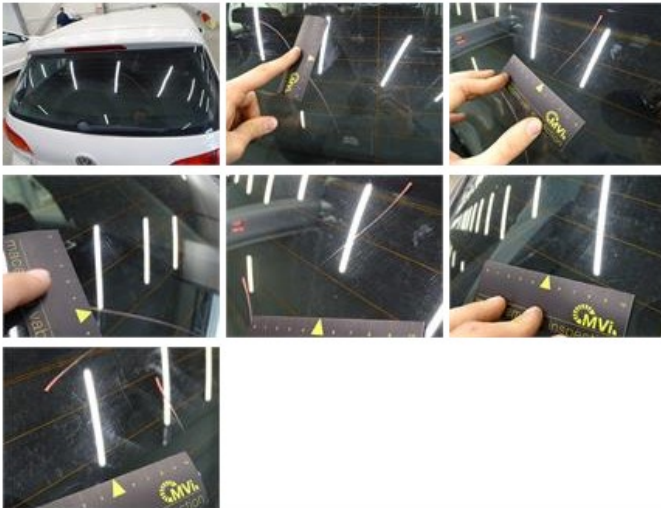
Rear window, Scratch(es), E - Replace 0,00

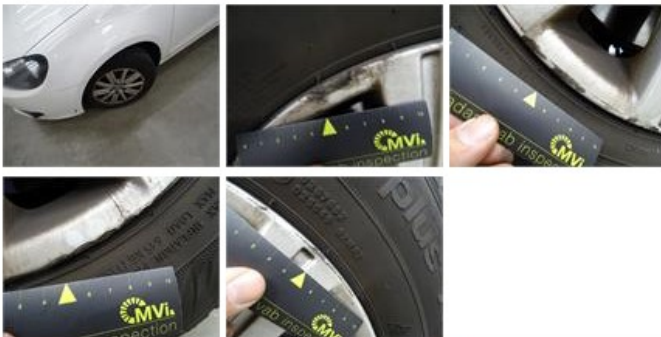
Alloy rim F L, Scratch(es), LI - Repair and paint (complete) 95,00

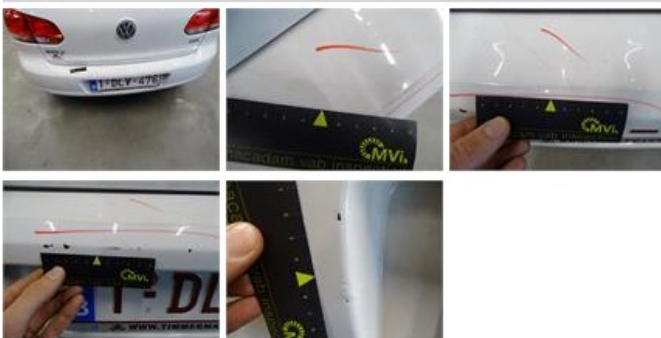
Bumper R, Scratch(es), LI - Repair and paint (complete) 211,80
