VOLVO V40: 1KFC211

Limited Technical Inspection

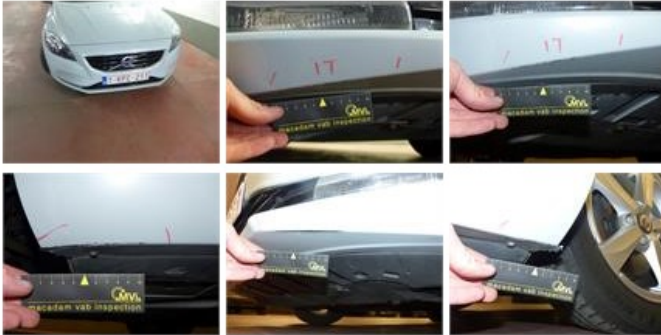
Wing R L, Repaired, Acceptable	0,00
<i>No pictures to display</i>	
Door R L, Repaired, Acceptable	0,00
<i>No pictures to display</i>	
Bumper F, Scratch(es), It - Spot repair	115,56
