**VOLVO V60: 1KET254**

**Limited Technical Inspection**

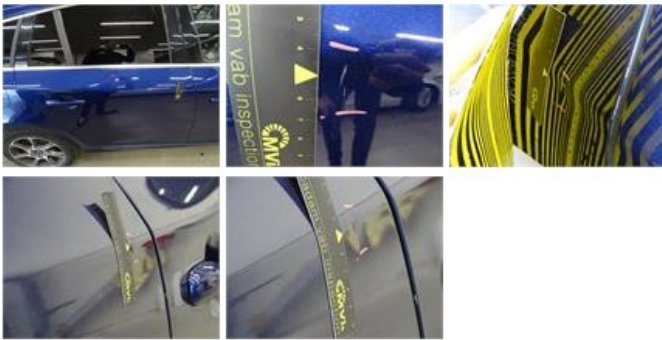
Door R R, Dent(s) and scratch(es), LI - Repair and paint (complete)

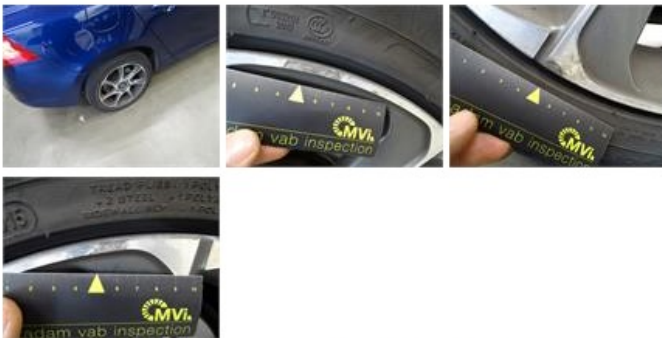
Alloy rim R R polished, Scratch(es), LI - Repair and paint (complete)

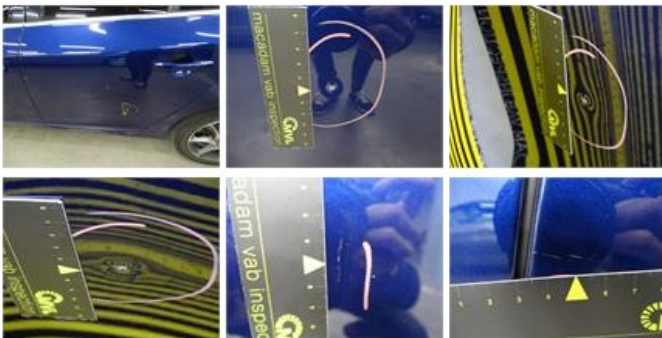
Door R L, Dent(s) and scratch(es), LI - Repair and paint (complete)

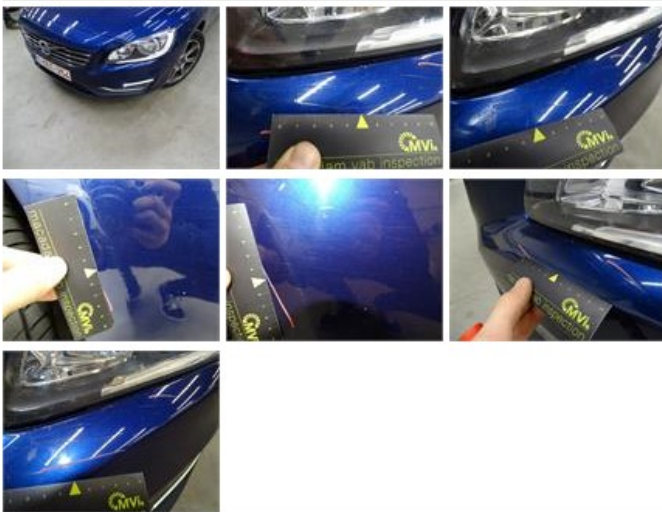
Bumper F, Scratch(es), LI - Repair and paint (complete)

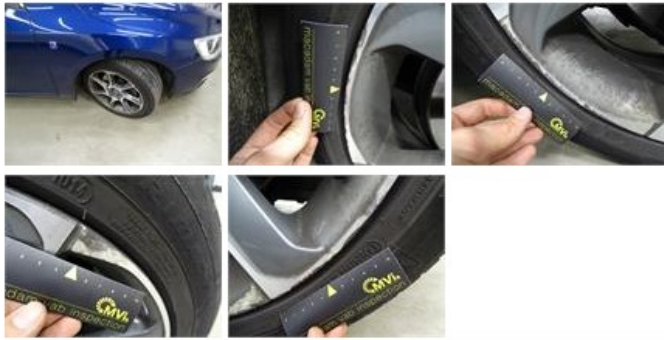
Alloy rim F R polished, Scratch(es), LI - Repair and paint (complete)

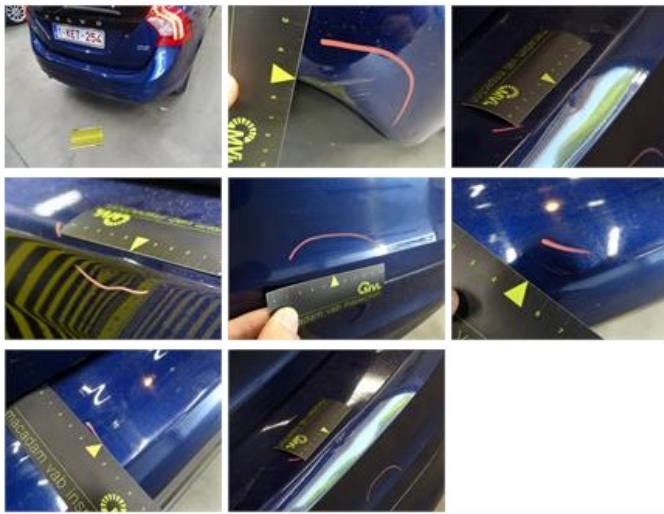
Bumper R, Dent(s) and scratch(es), LI - Repair and paint (complete)

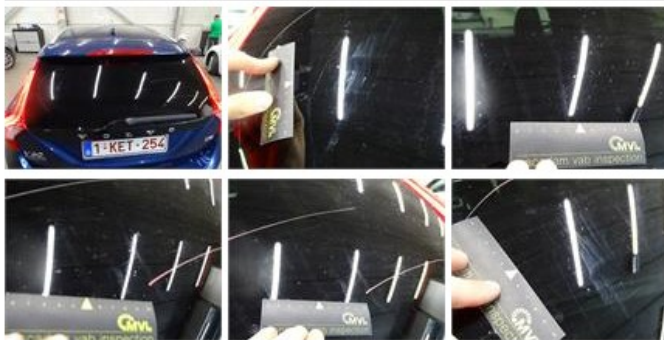
Rear window, Scratch(es), E - Replace

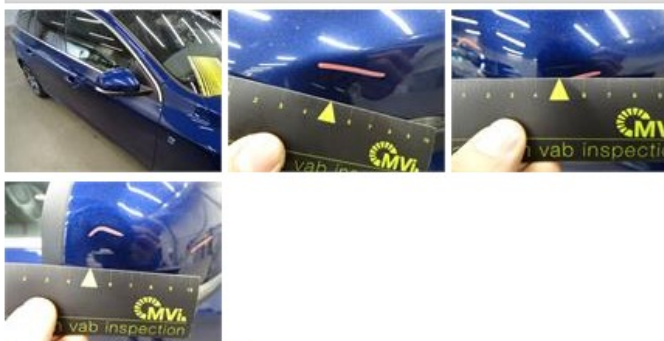
Rearview mirror housing R, Scratch(es), LI - Repair and paint (complete)

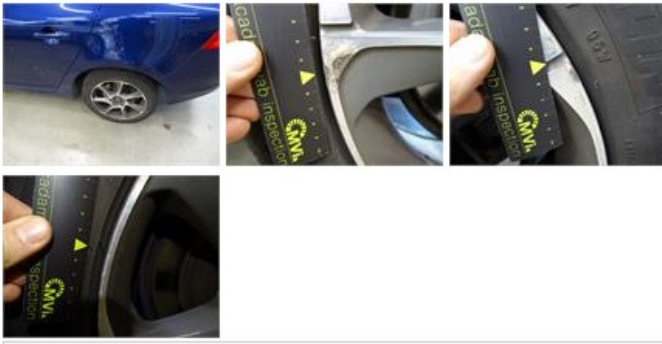
Alloy rim R L polished, Scratch(es), LI - Repair and paint (complete)
