VOLVO V60: 1GTQ175

Limited Technical Inspection

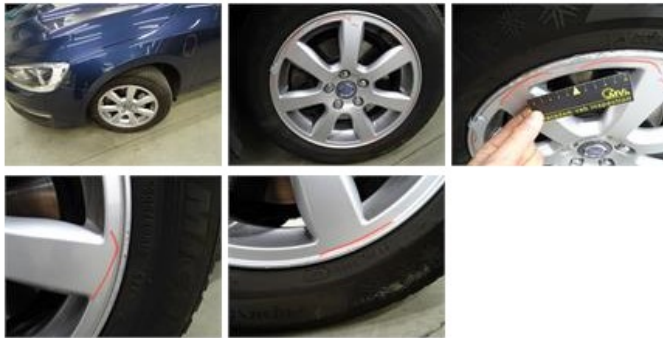
Alloy rim F L, Scratch(es), LI - Repair and paint (complete)

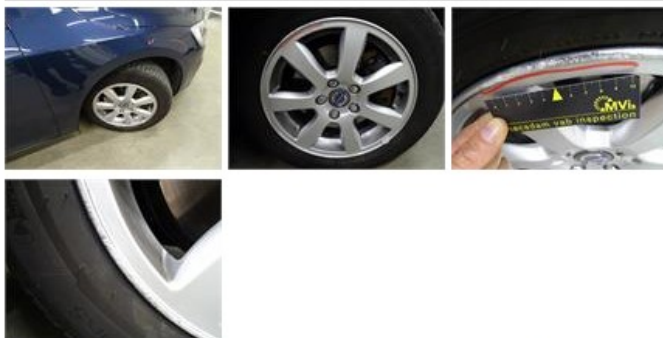
Alloy rim F R, Scratch(es), LI - Repair and paint (complete)

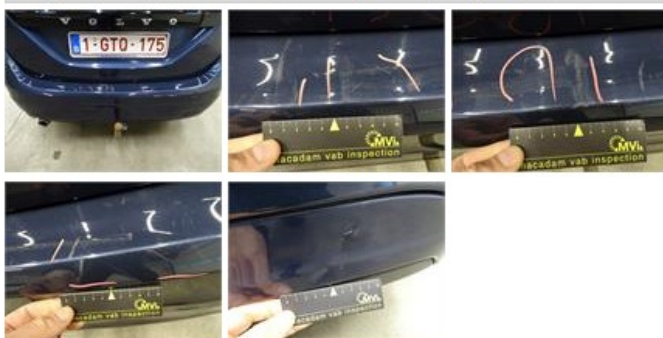
Bumper R, Dent(s) and scratch(es), LI - Repair and paint (complete)
