VOLKSWAGEN Polo: 1EWC165

Limited Technical Inspection

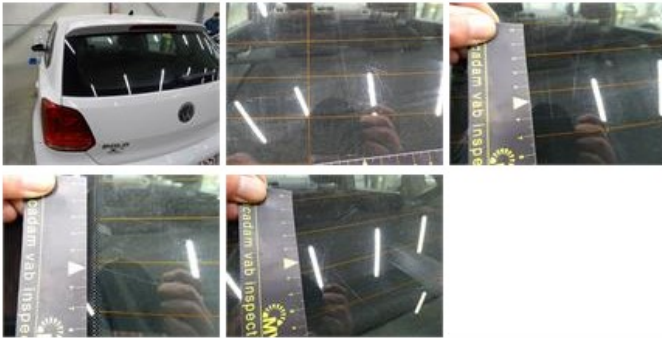
Rear window, Scratch(es), E - Replace 320,00

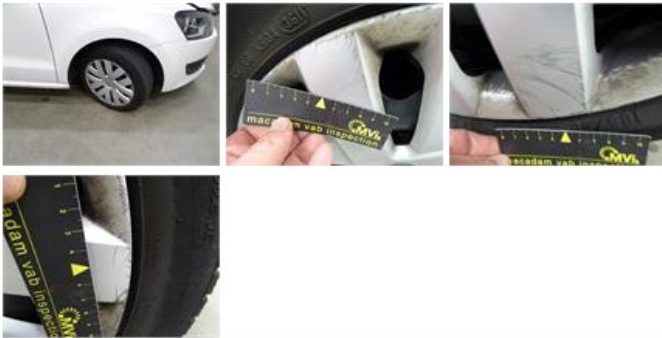
Wheel cover F R, Scratch(es), E - Replace 24,00

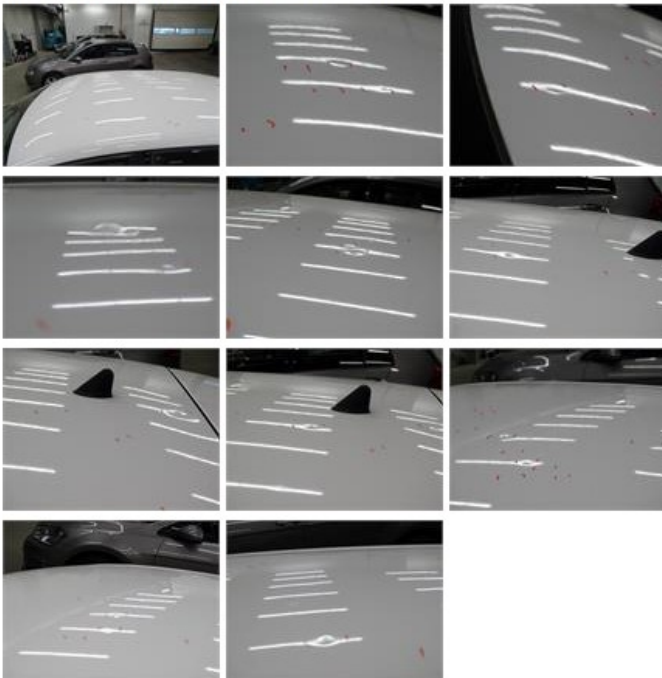
Roof, Hail damage, LI - Repair and paint (complete) 0,00
