VOLVO V40: 1URG443

Limited Technical Inspection

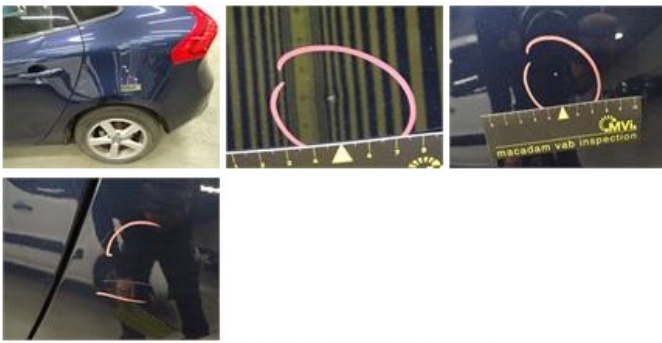
Repair kit	Yes	Compressor	Yes
Total cost ex VAT			1936,21
Wing R L, Dent(s) and scratch(es), LI - Repair and paint (complete)			308,20

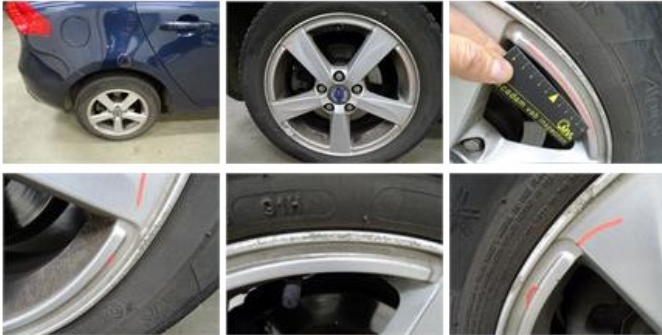
Alloy rim R R, Scratch(es), LI - Repair and paint (complete) 95,00

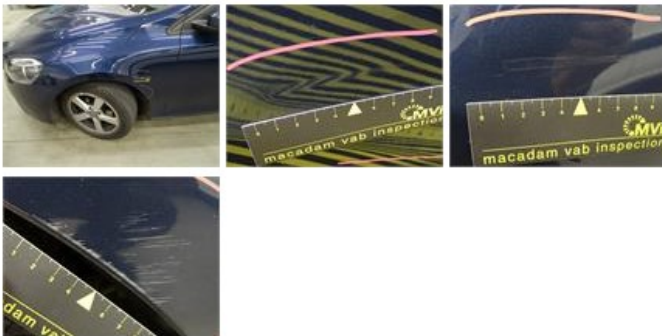
Wing F L, Dent(s) and scratch(es), LI - Repair and paint (complete) 220,18

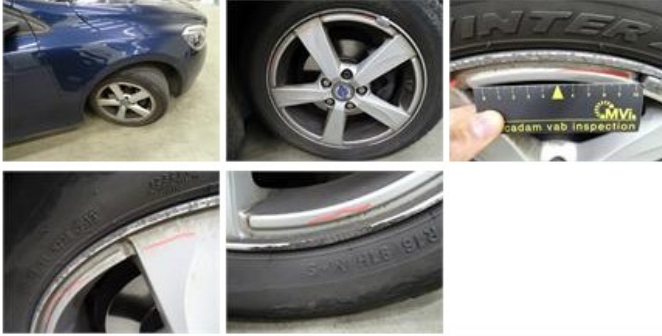
Alloy rim F R, Scratch(es), LI - Repair and paint (complete) 95,00

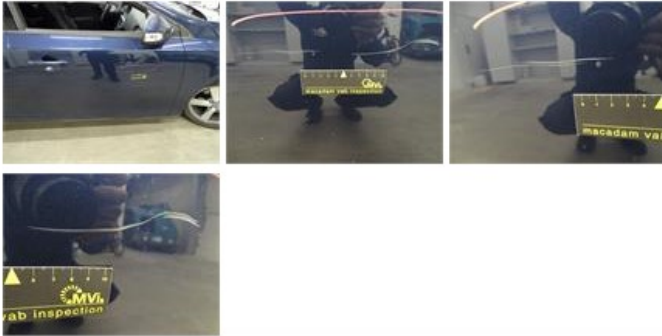
Door F R, Scratch(es), LI - Repair and paint (complete) 318,35

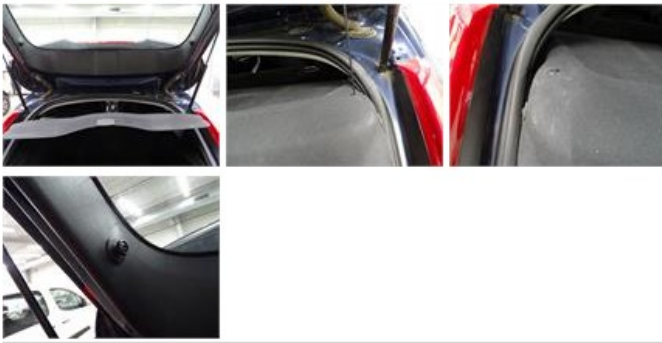
Baggage rack, Deformed / Strained, Repair/replace (lump sum) 20,00

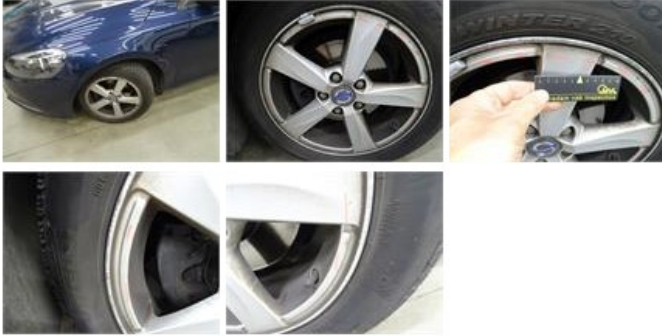
Alloy rim F L, Scratch(es), LI - Repair and paint (complete) 95,00

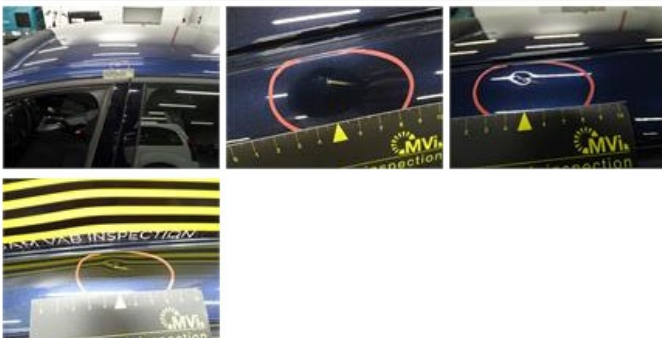
Roof pillar L, Dent(s) and scratch(es), LI - Repair and paint (complete) 220,18
