VOLVO XC60: 1FAN369

Limited Technical Inspection

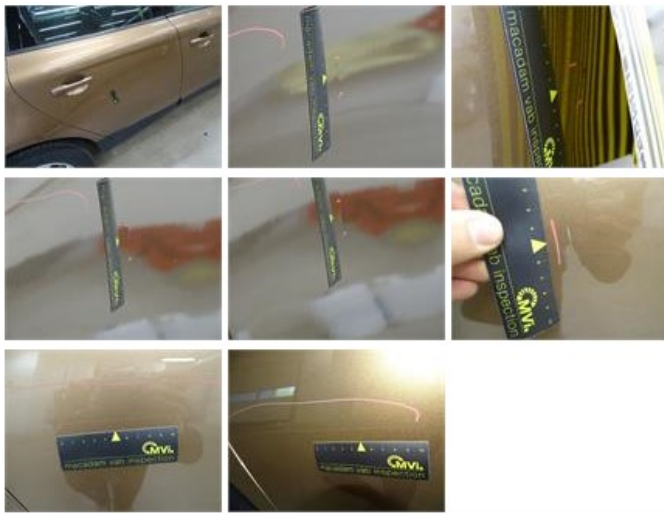
Total cost ex VAT	820,82
Wing F R, Scratch(es), 67 - Polish	0,00
<i>No pictures to display</i>	
Door R R, Dent(s) and scratch(es), LI - Repair and paint (complete)	382,02

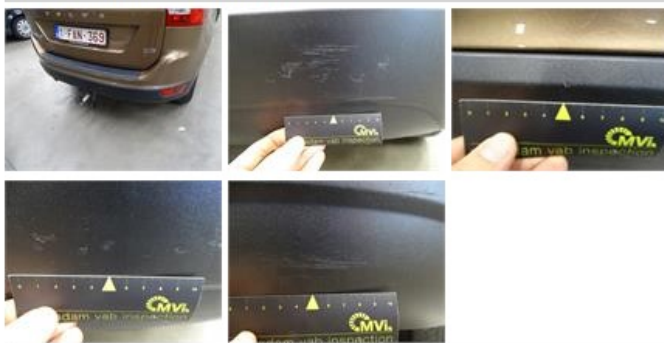
Bumper R, Scratch(es), Smart repair 110,64

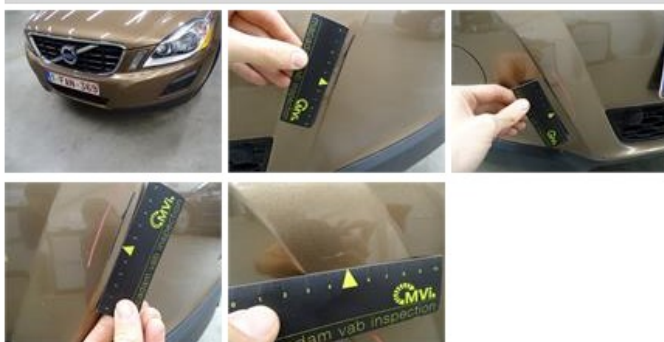
Bumper F, Scratch(es), LI - Repair and paint (complete) 254,16
