VOLKSWAGEN Golf: 1HYP431

Vinnumber:	WVWZZZAUZEW396997	Versionname:	GOLF BER Trendline 105PK
First Registrationdate:	30/10/2014	Fiscalpower:	
Expertise Mileage:	117019	Power Kw:	77
Bodytype:		Body color:	Grey
Gearbox:	MAN 5 VIT	Paint type:	Metalic
Transmission:	Front	Rims summer:	Aluminium
Fueltype:	Diesel	Oil level:	OK
Battery functioning:	Yes	Parking lot:	1124
Number of doors:	5		
Number of seats:	5		
Number head rests:	4		
Rims summer:	Aluminium		
Category:	Passenger Car		
Oil level:	OK		
Registration Certificate Car (BE):	Yes

Limited Technical Inspection

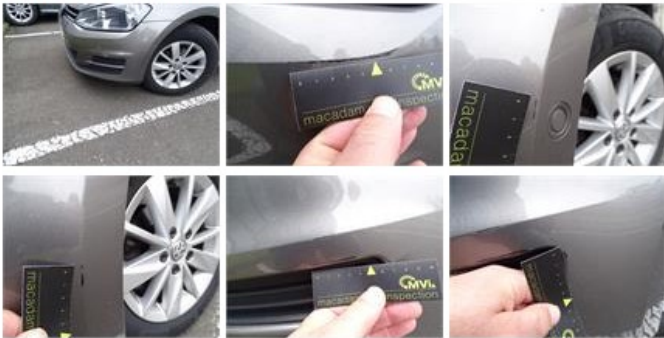
Door panel F L, Scratch(es), Acceptable	0,00
<i>No pictures to display</i>	
Bumper F, Scratch(es), It - Spot repair	115,56
