**AUDI A1 SPORTBACK: 1PYB490**

**Limited Technical Inspection**

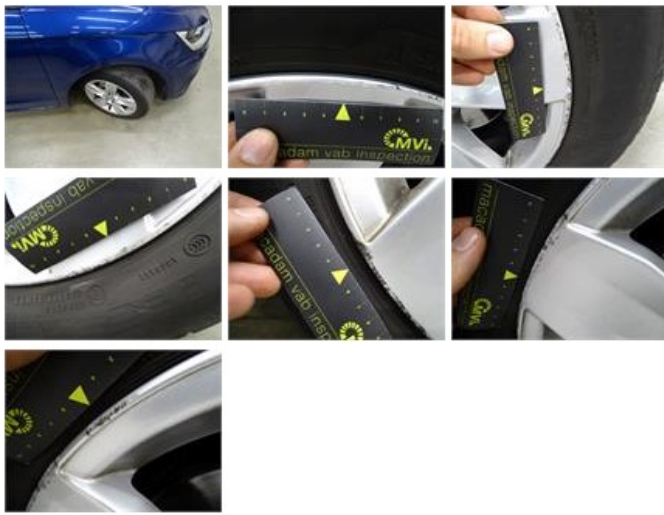
<b>Total cost ex VAT</b>	<b>1192,28</b>
<b>Alloy rim F R, Scratch(es), LI - Repair and paint (complete)</b>	<b>95,00</b>

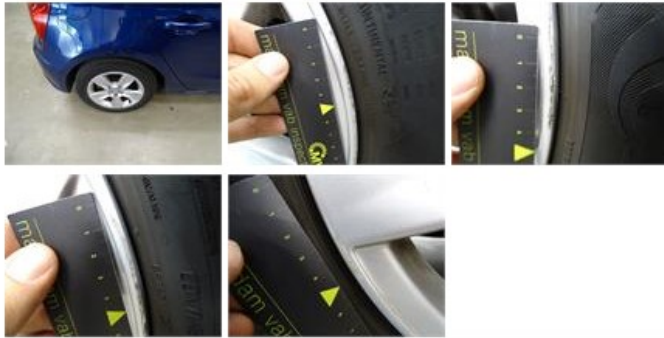
Alloy rim R R, Scratch(es), LI - Repair and paint (complete) 95,00

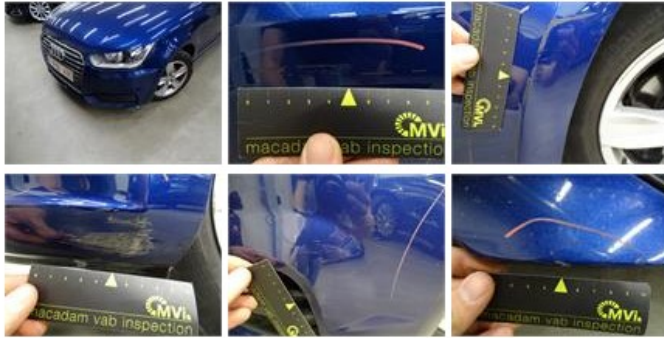
Bumper F, Scratch(es), LI - Repair and paint (complete) 169,44

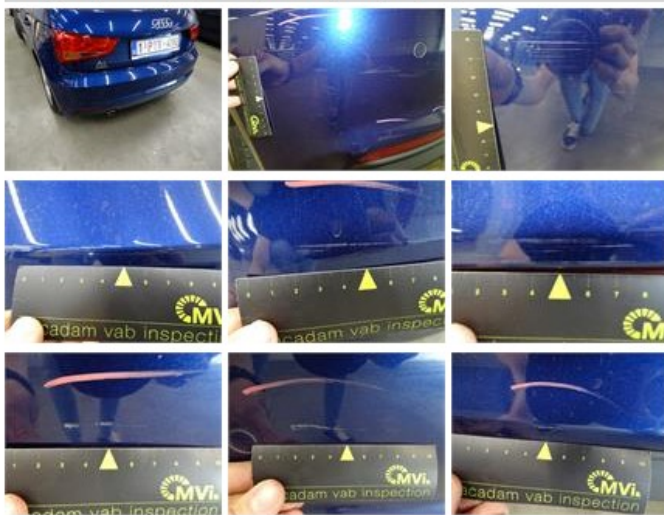
Bumper R, Scratch(es), LI - Repair and paint (complete) 169,44

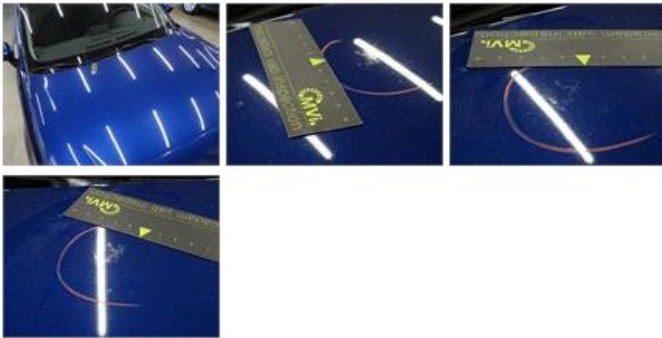
Bonnet, Chemical polution, LI - Repair and paint (complete) 232,06
