**FORD S-MAX: 1NBT831**

Vinnumber:	<b>WF0JXXWPCJFP05657</b>	Versionname:	<b>2.0 TDCI 88KW S/S BUSINESS ED</b>
First Registrationdate:	<b>14/01/2016</b>	Fiscalpower:	
Expertise Mileage:	<b>67962</b>	Power Kw:	<b>88</b>
Bodytype:	<b>MPV</b>	Body color:	<b>Silver</b>
Gearbox:	<b>MAN 6 VIT</b>	Paint type:	<b>Metallic</b>
Transmission:		Rims summer:	<b>Steel</b>
Fueltype:	<b>Diesel</b>	Oil level:	<b>OK</b>
Battery functioning:	<b>Yes</b>	Parking lot:	<b>2507</b>
Number of doors:	<b>5</b>		
Number of seats:	<b>7</b>		
Number head rests:	<b>7</b>		
Rims summer:	<b>Steel</b>		
Category:	<b>Passenger Car</b>		
Oil level:	<b>OK</b>		
Registration Certificate Car (BE):	<b>Yes</b>

**Limited Technical Inspection**

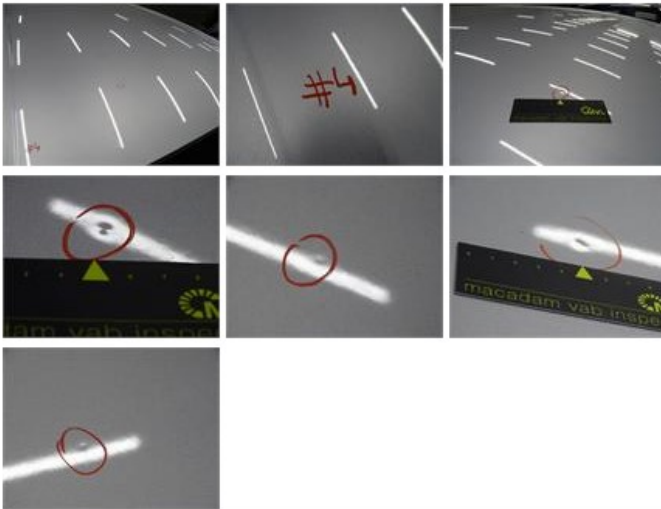
Roof, Hail damage, PDR - Hail 0,00

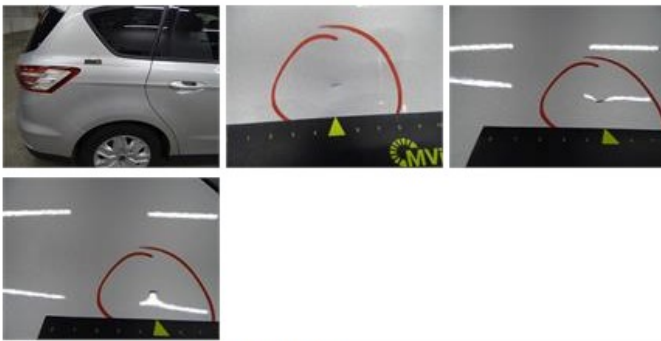
Wing R R, Dent(s) and scratch(es), LI - Repair and paint (complete) 369,84
