**LU Audi a3 Sportback: GD4289**

| Vinnumber: | <b>WAUZZZ8VXF145094</b> | Versionname: | <b>2.0 TDI 110KW CLEAN DIESEL AMBIENTE SB</b> |

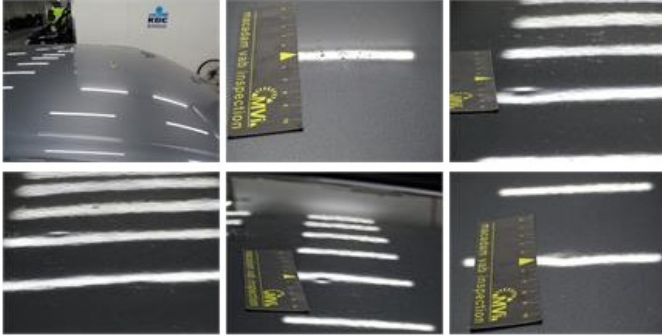
| Roof, Chemical polution, LI - Repair and paint (complete) | 577,50 |
