BMW 2 ACTIVE TOURER: 1KBU154

Limited Technical Inspection

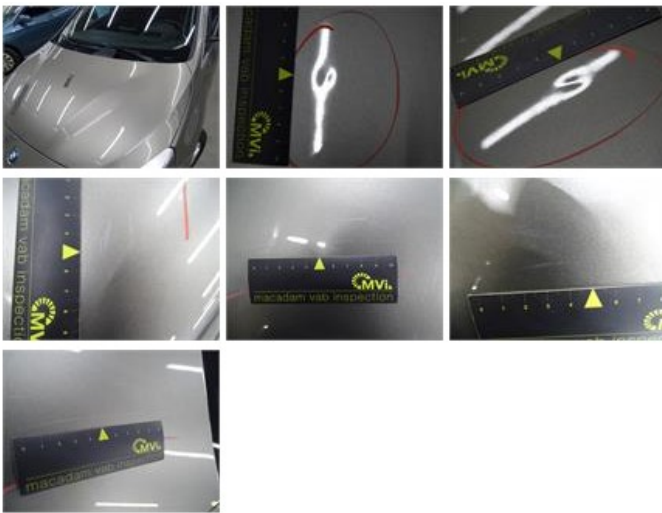
Total cost ex VAT	915,23
Bonnet, Dent(s) and scratch(es), LI - Repair and paint (complete)	290,08

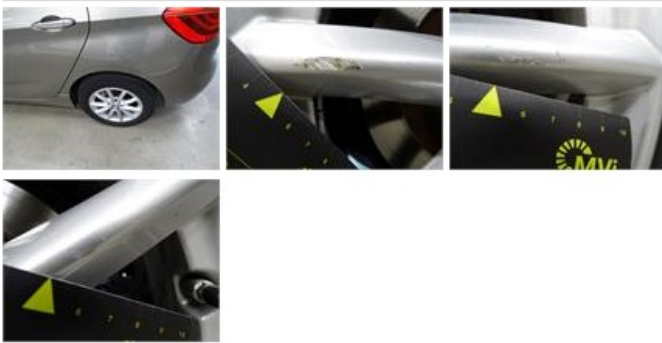
Alloy rim R L, Scratch(es), LI - Repair and paint (complete) 95,00

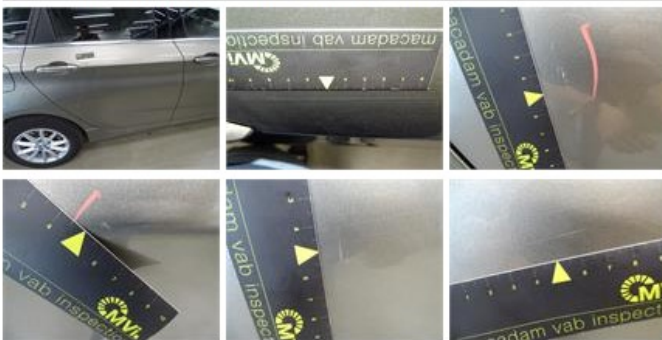
Door R R, Scratch(es), LI - Repair and paint (complete) 318,35

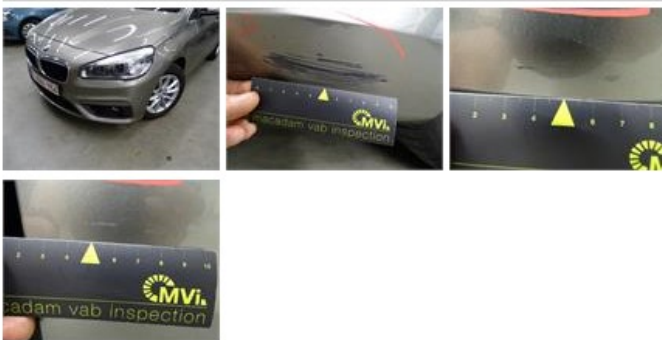
Bumper F, Scratch(es), LI - Repair and paint (complete) 211,80
