BMW 2: 1HAU114

Limited Technical Inspection

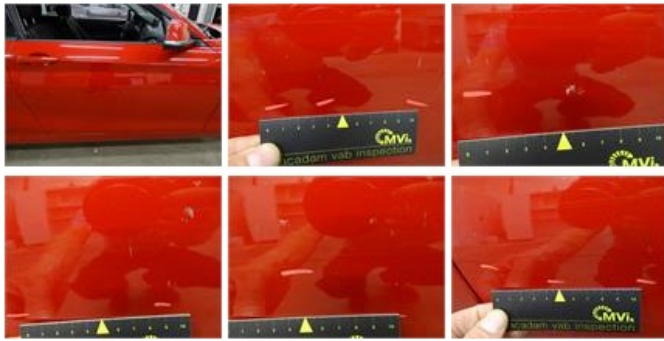
Door F R, Scratch(es), LI - Repair and paint (complete) 318,35

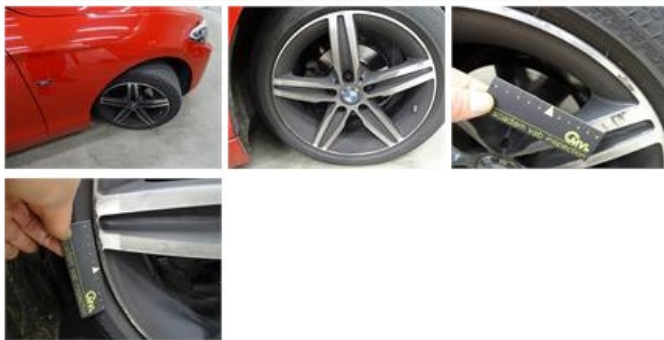
Alloy rim F R polished, Scratch(es), LI - Repair and paint (complete) 95,00

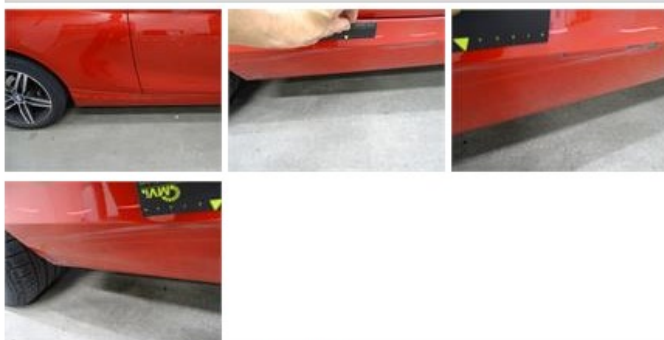
Sill outer R, Scratch(es), LI - Repair and paint (complete) 310,50

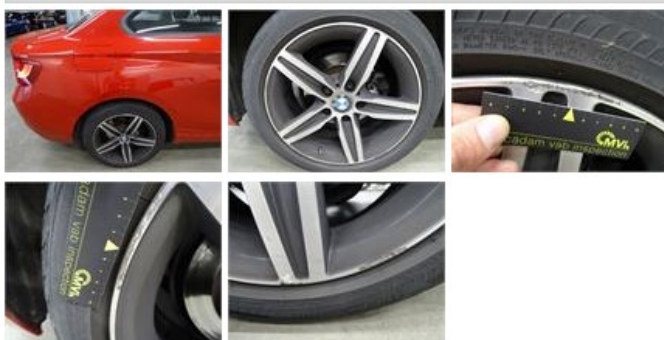
Alloy rim R R polished, Scratch(es), LI - Repair and paint (complete) 95,00

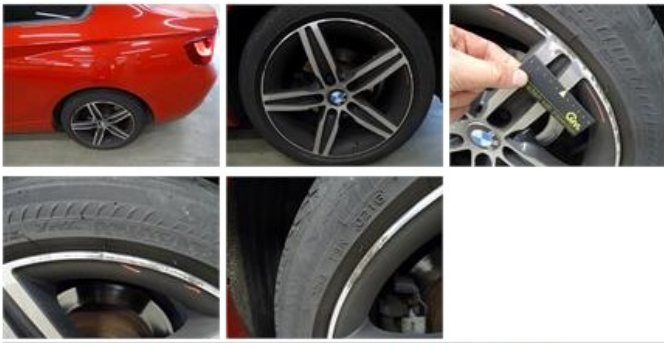
Alloy rim R L polished, Scratch(es), LI - Repair and paint (complete) 95,00

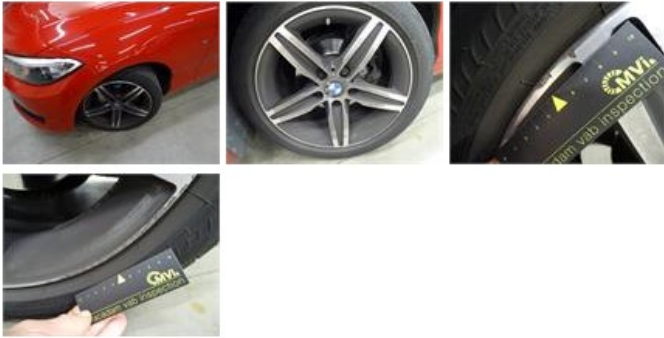
Alloy rim F L polished, Scratch(es), LI - Repair and paint (complete) 95,00
