BMW 1 HATCH: 1LES148

Limited Technical Inspection

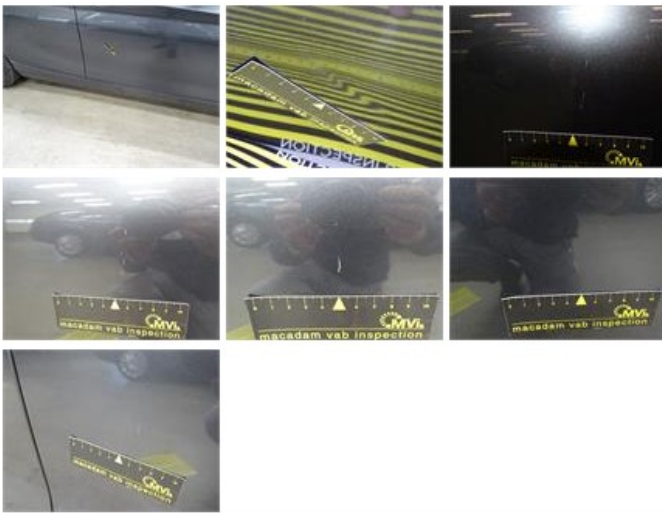
<i>No pictures to display</i>	
Door F R, Dent(s) and scratch(es), LI - Repair and paint (complete)	318,35
