**BMW 3: 1GNG394**

**Limited Technical Inspection**

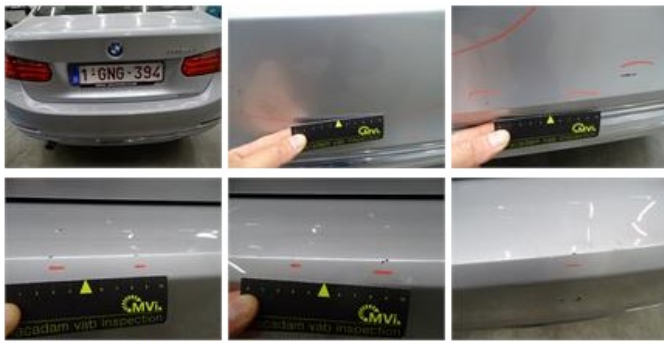
<b>Runflat</b>	<b>Yes</b>
Total cost ex VAT		<b>840,65</b>
Bumper R, Scratch(es), LI - Repair and paint (complete)		<b>211,80</b>

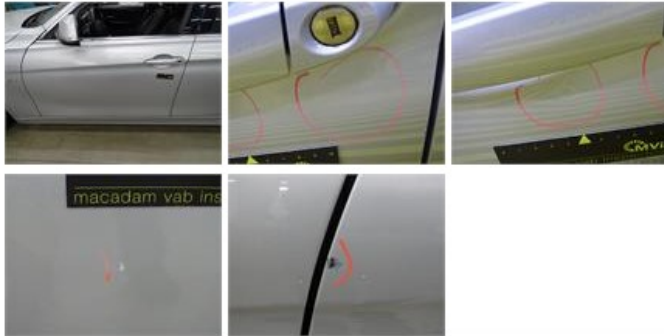
Door F L, Dent(s) and scratch(es), LI - Repair and paint (complete) 318,35
