PEUGEOT 308 SW: 1KLA550

Limited Technical Inspection

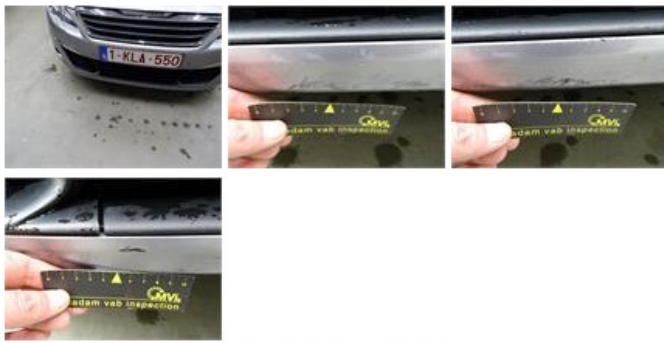
Total cost ex VAT	895,60
Bumper F, Scratch(es), LI - Repair and paint (complete)	211,80
