PEUGEOT 5008: 1GTD046

| Vinnumber: | VF30E9HD8E5069606 | Versionname: | 5008 e-HDi Active STT BMP 115PK Aut. |

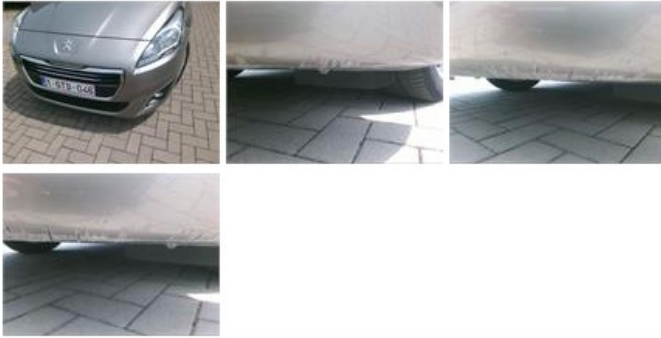
Bumper F, Scratch(es), LI - Repair and paint (complete) 211,80

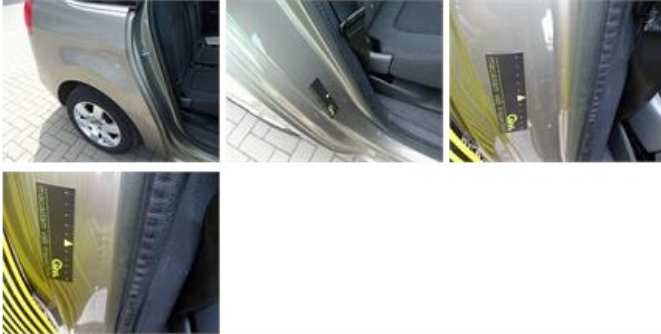
Rocker panel inner R R, Dent(s), LI - Repair and paint (complete) 115,56

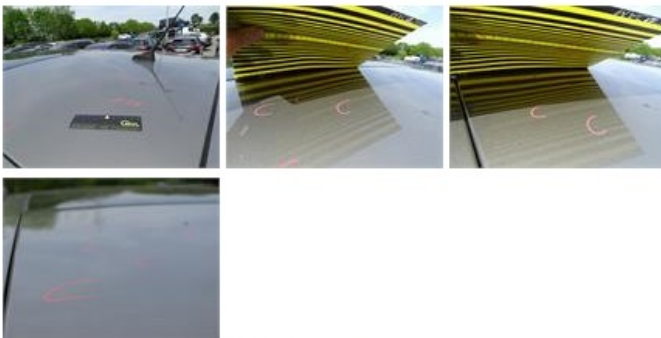
Roof, Hail damage, PDR - Hail 625,00
