PEUGEOT 308: 1JFP500

Limited Technical Inspection

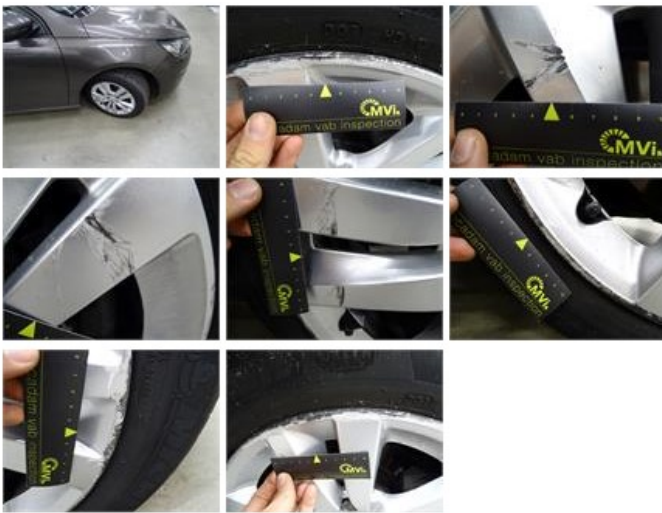
Total cost ex VAT	622,12
Alloy rim F R, Scratch(es), LI - Repair and paint (complete)	95,00

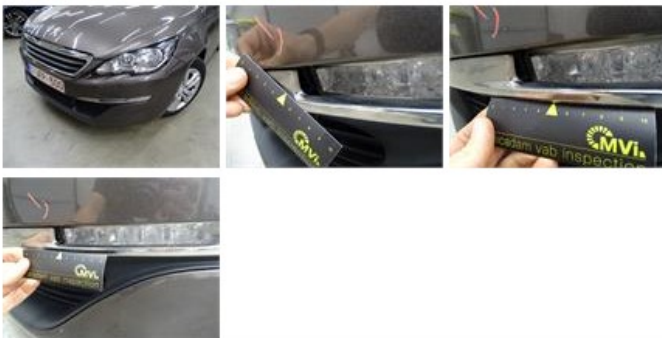
Foglight L, Deformed / Strained, E - Replace 138,00

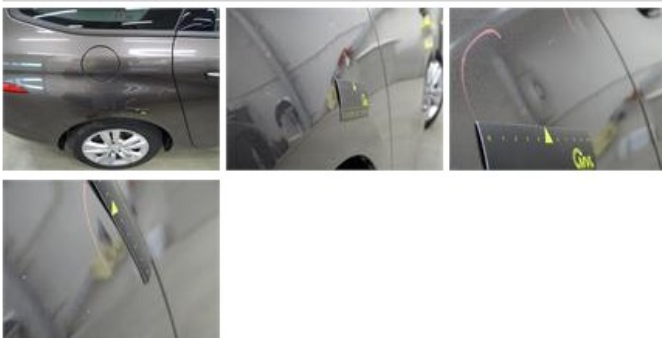
Wing R R, Dent(s), PDR - Paintless dent repair 63,00

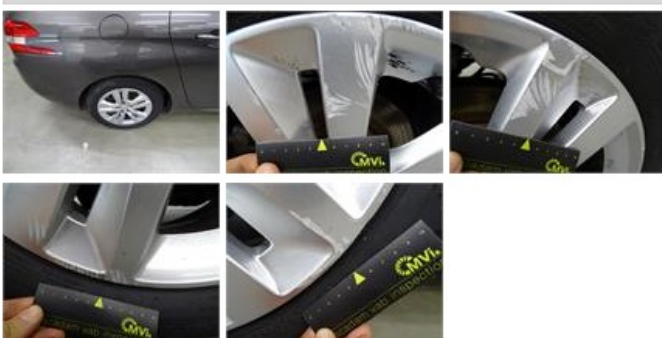
Alloy rim R R, Scratch(es), LI - Repair and paint (complete) 95,00

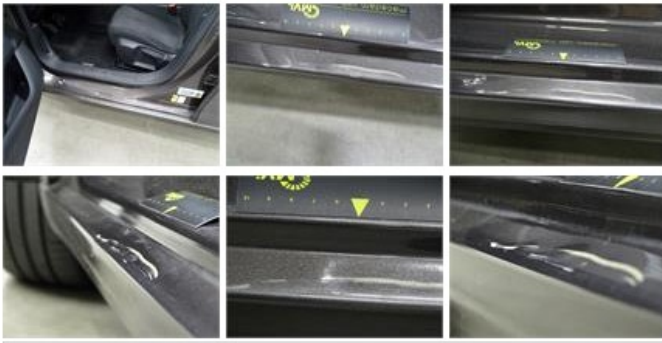
Door frame F L, Dent(s), It - Spot repair 115,56

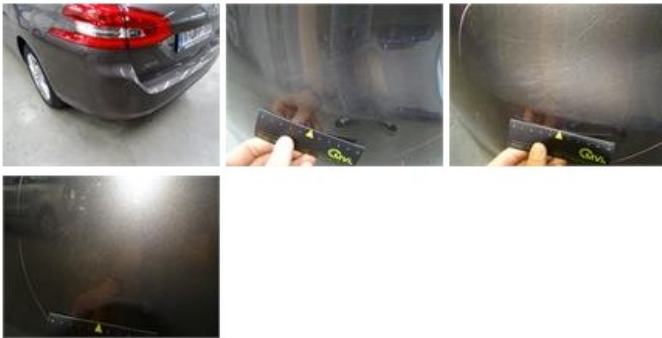
Alloy rim R L, Scratch(es), Acceptable	0,00
<i>No pictures to display</i>	
Trunk lid covering R, Scratch(es), Acceptable	0,00
<i>No pictures to display</i>	
Bonnet, Chemical polution, Acceptable	0,00
<i>No pictures to display</i>	
Bumper corner R L, Scratch(es), It - Spot repair	115,56
