**VOLVO V60: 1FAN346**

**Limited Technical Inspection**

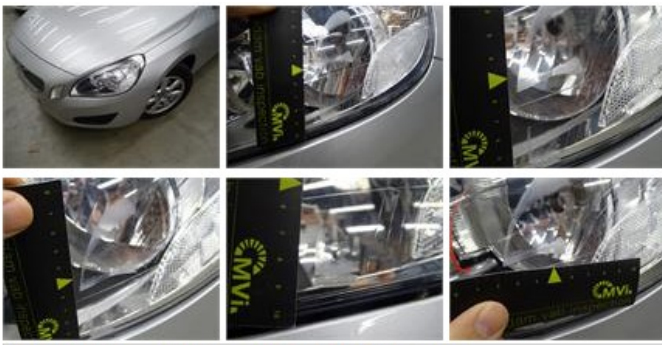
Total cost ex VAT	1899,38
Headlight L, Crack, E - Replace	396,00

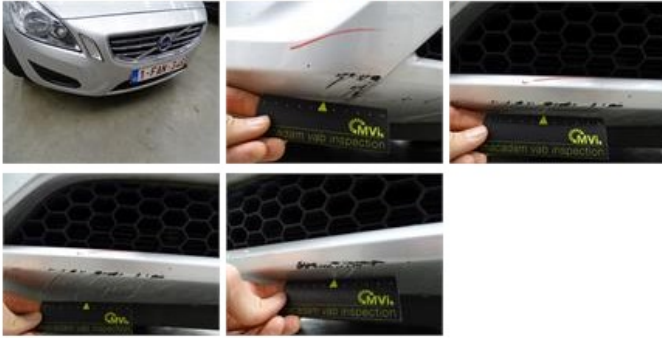
Bumper F, Scratch(es), LI - Repair and paint (complete) 211,80

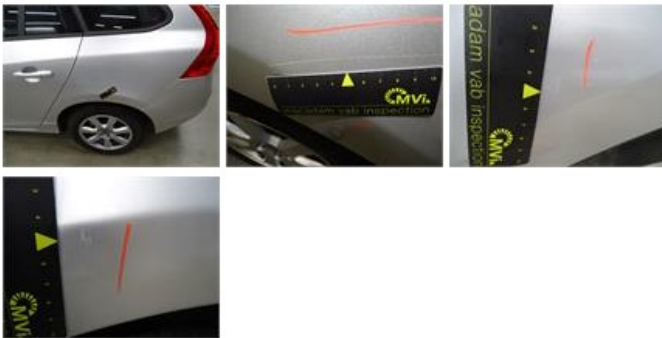
Wing R L, Scratch(es), LI - Repair and paint (complete) 308,20

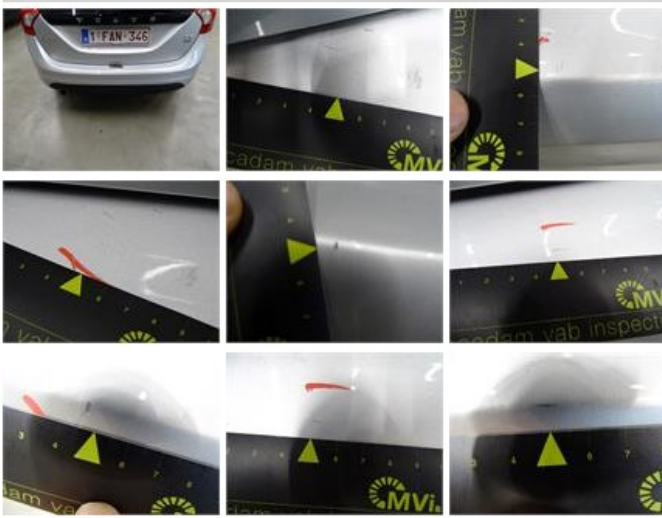
Bumper R, Scratch(es), LI - Repair and paint (complete) 211,80

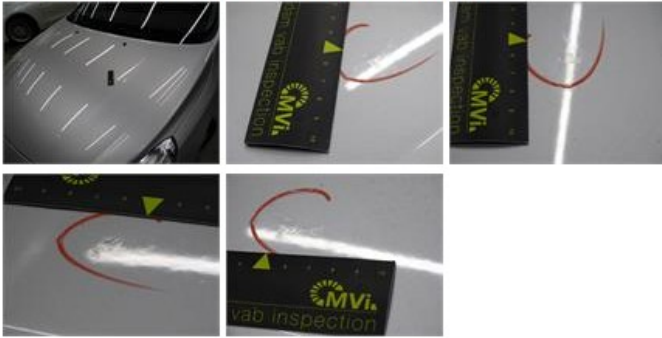
Bonnet, Chemical polution, LI - Repair and paint (complete)	290,08
---	--------
