VOLKSWAGEN Touran: 1GWA287

Limited Technical Inspection

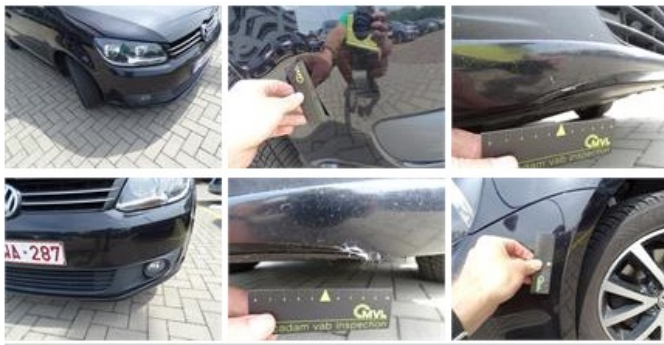
Total cost ex VAT	845,60
Alloy rim R R polished, Scratch(es), Acceptable	0,00
<i>No pictures to display</i>	
Bumper F, Scratch(es), LI - Repair and paint (complete)	211,80

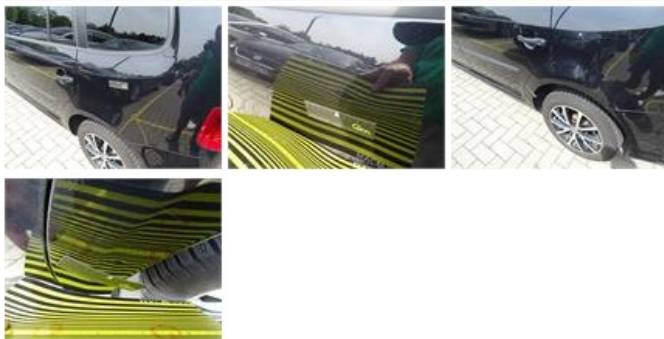
Wing R L, Dent(s), PDR - Paintless dent repair	82,80
--	-------
