**VOLVO XC60: 1KXB831**

| Vinnumber: | <b>YV1DZA8C1G2812059</b> | Versionname: | <b>2.0 D4 2WD SUMMUM</b> |

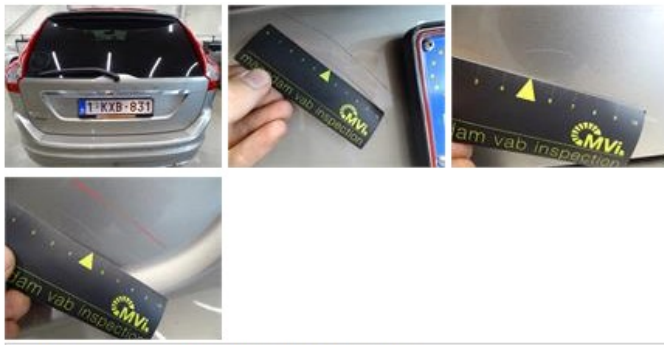
| Tailgate, Scratch(es), LI - Repair and paint (complete) | | 362,02 |

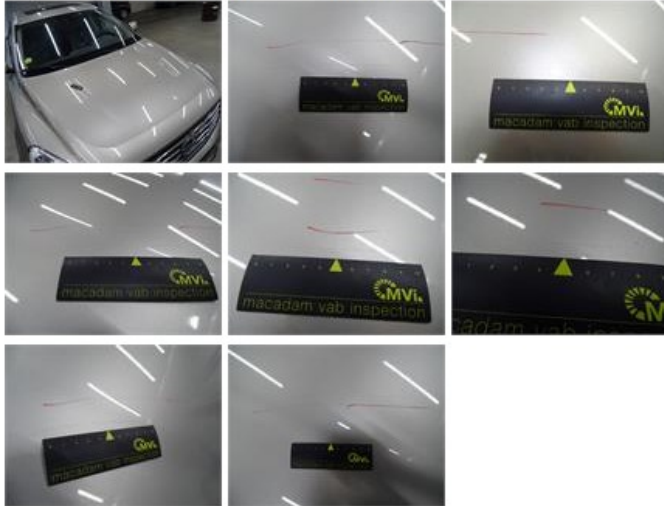
Bonnet, Scratch(es), LI - Repair and paint (complete)

348,09

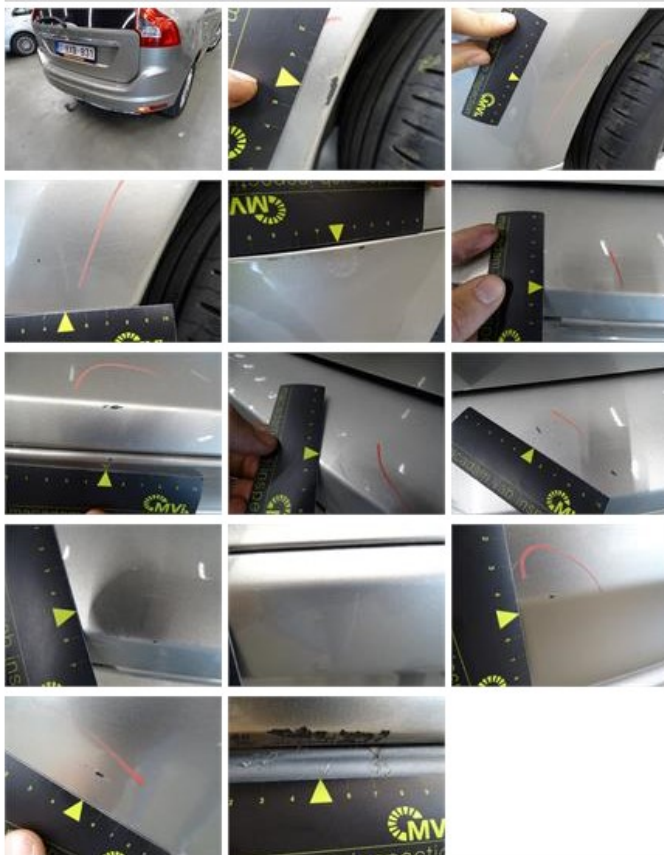
Bumper R, Scratch(es), LI - Repair and paint (complete)

254,16

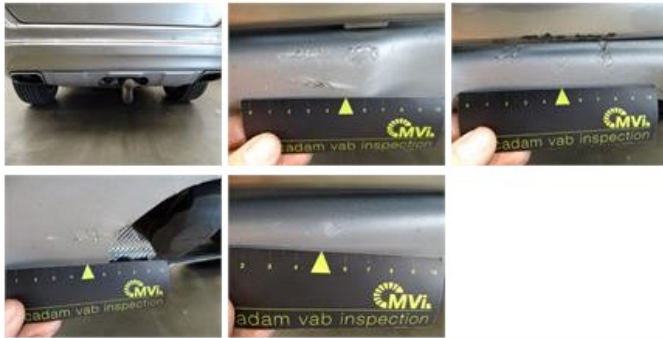
Bumper R, Scratch(es), Smart repair

110,64

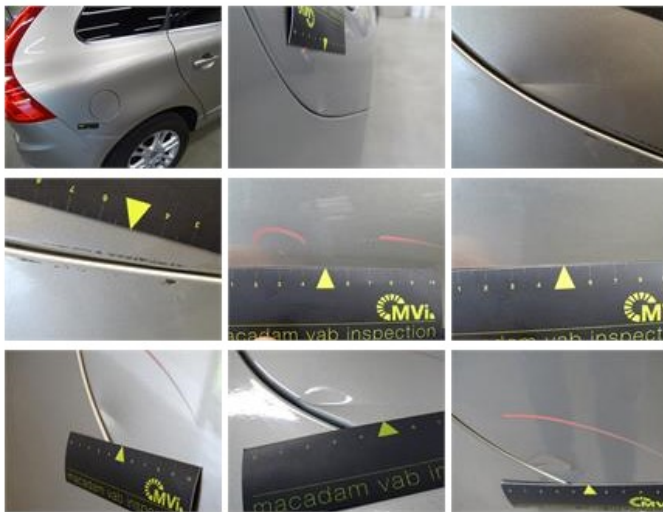
Wing R R, Dent(s) and scratch(es), LI - Repair and paint (complete)

369,84
