**LAND ROVER Range: 1JPC089**

**Limited Technical Inspection**

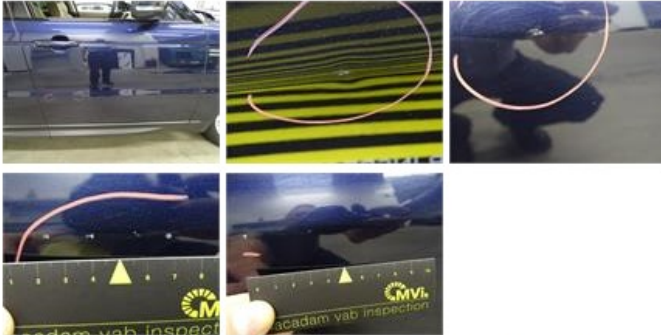
Door F R, Dent(s) and scratch(es), LI - Repair and paint (complete) 382,02

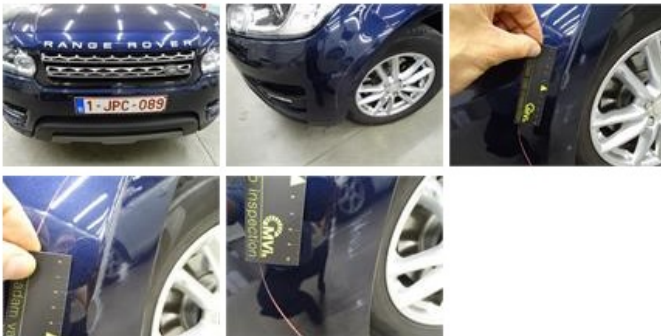
Bumper F, Scratch(es), LI - Repair and paint (complete) 254,16
