VOLKSWAGEN TOURAN: 1KHJ965

Limited Technical Inspection

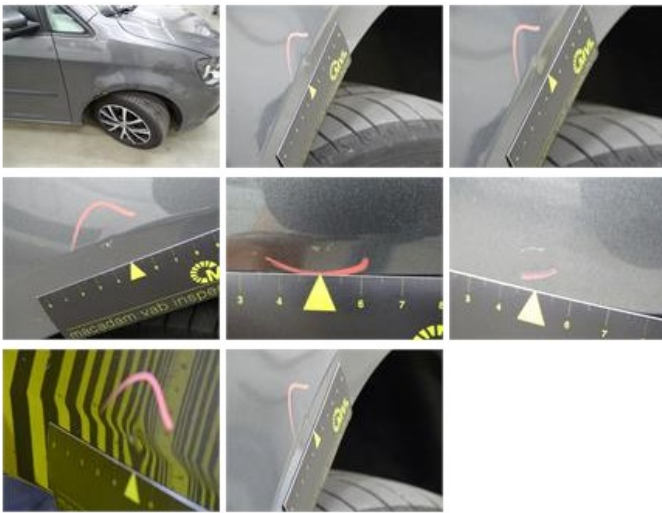
Total cost ex VAT	1554,30
Wing F R, Dent(s) and scratch(es), LI - Repair and paint (complete)	220,18

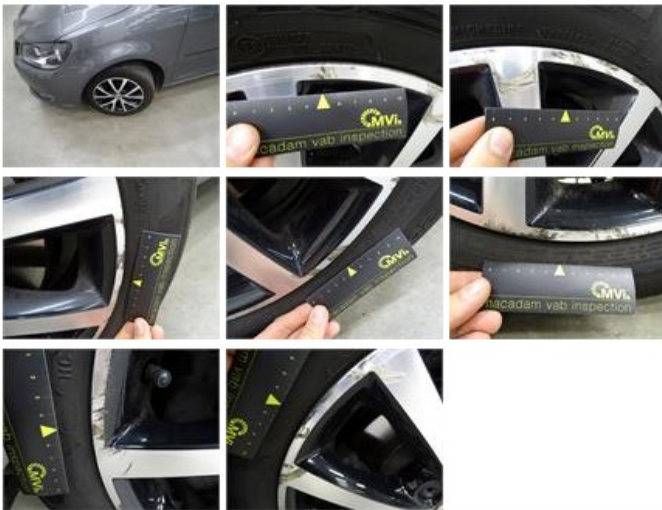
Alloy rim F L polished, Scratch(es), LI - Repair and paint (complete) 95,00

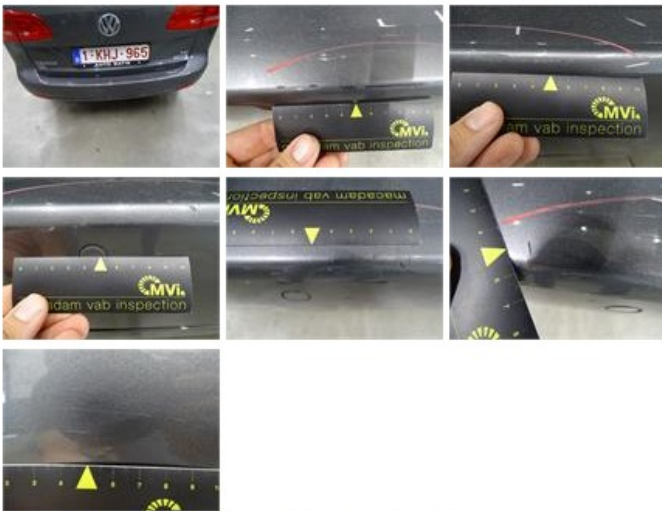
Bumper R, Scratch(es), LI - Repair and paint (complete) 211,80

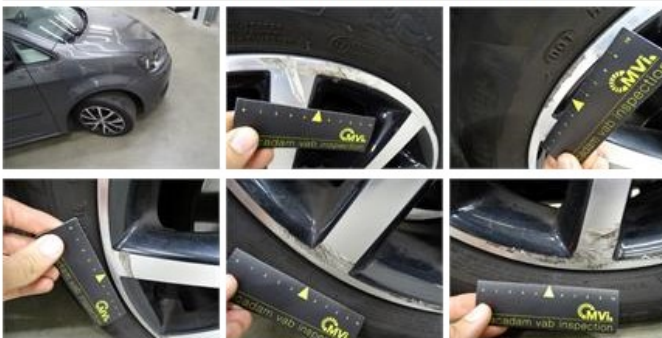
Alloy rim F R R polished, Scratch(es), LI - Repair and paint (complete) 95,00

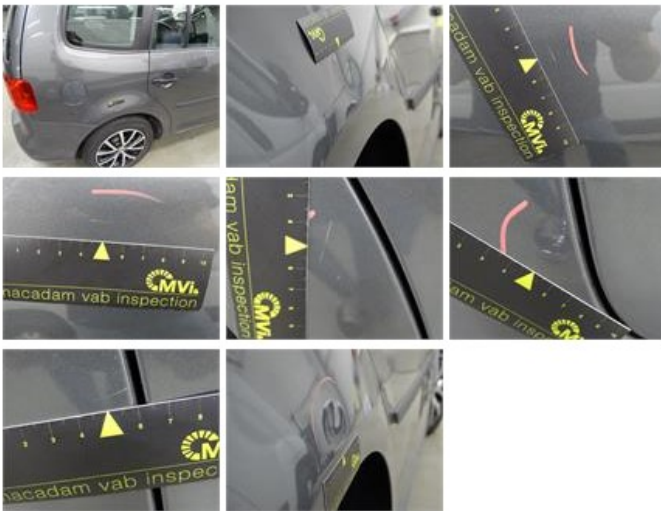
Wing R R, Dent(s) and scratch(es), LI - Repair and paint (complete)

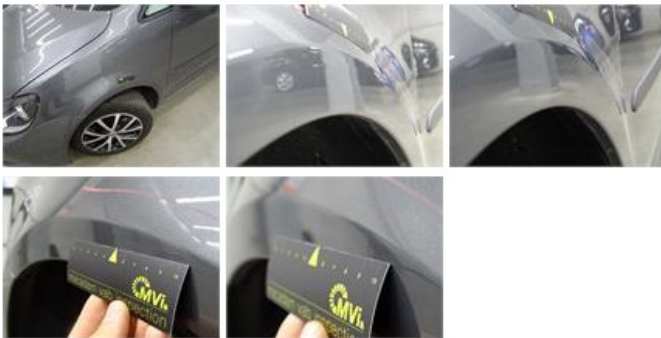
Wing F L, Bad repair, Acceptable

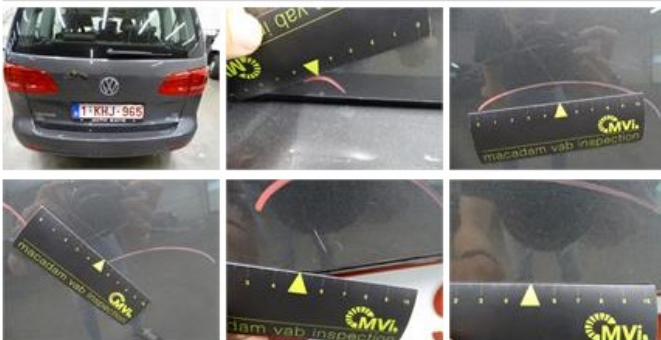
Tailgate, Scratch(es), LI - Repair and paint (complete)

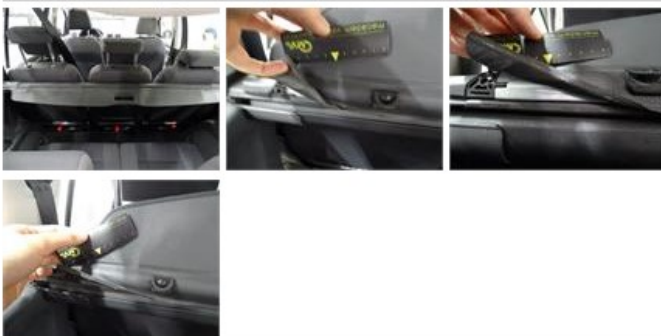
Luggage space cover, Worn, Smart repair

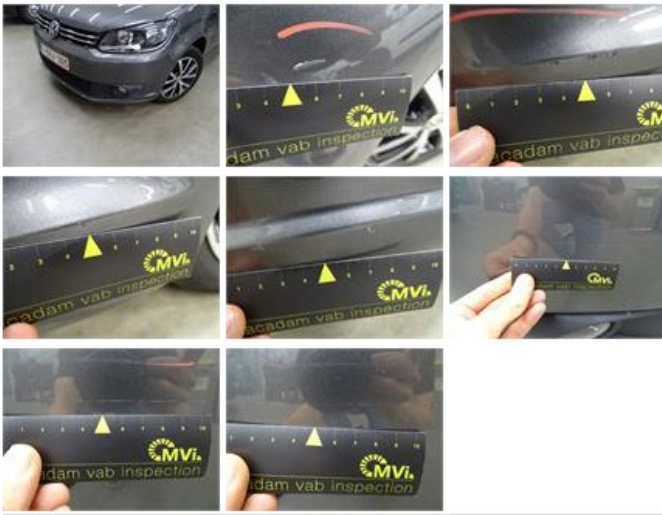
Bumper F, Scratch(es), LI - Repair and paint (complete)
