BMW 518: 1HNV628

Limited Technical Inspection

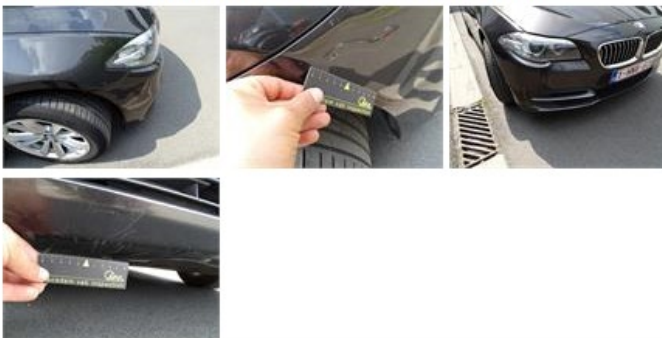
Bumper F, Dent(s) and scratch(es), LI - Repair and paint (complete) 350,16
