BMW 1 HATCH: 1KG710

Limited Technical Inspection

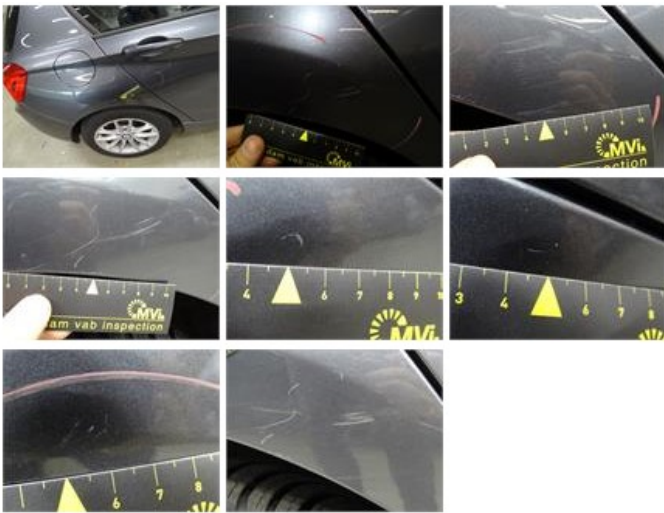
Total cost ex VAT	1511,98
Wing R R, Scratch(es), LI - Repair and paint (complete)	308,20

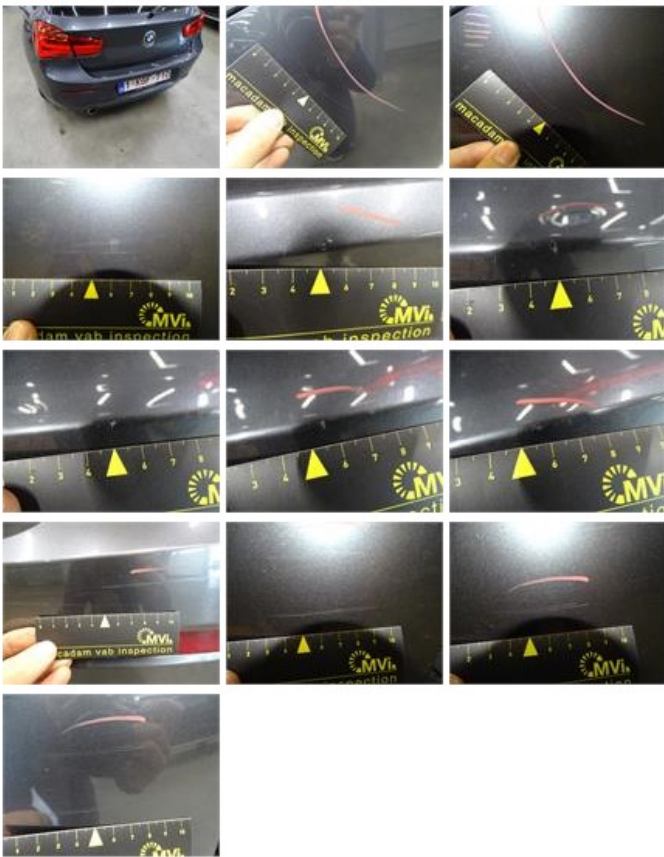
Bumper R, Scratch(es), LI - Repair and paint (complete) 211,80

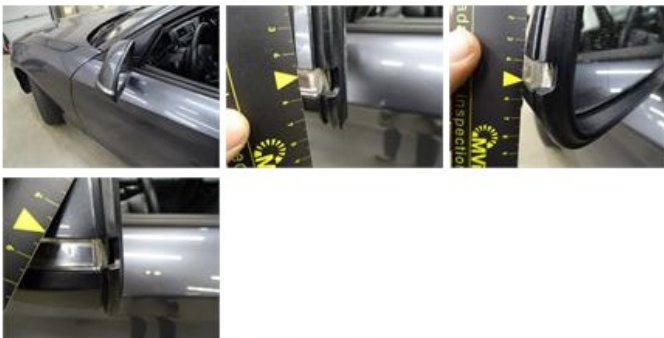
Mirror side blinker L, Broken, E - Replace 30,00

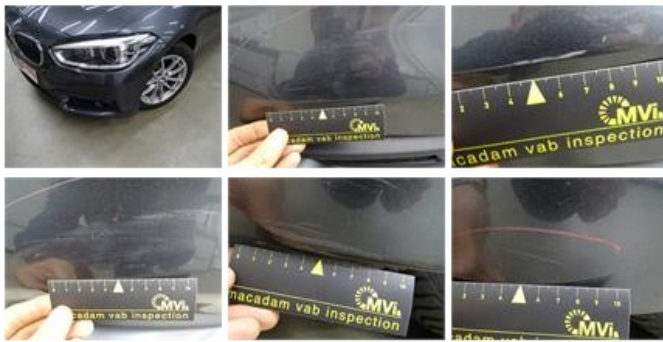
Bumper F, Scratch(es), LI - Repair and paint (complete)

211,80

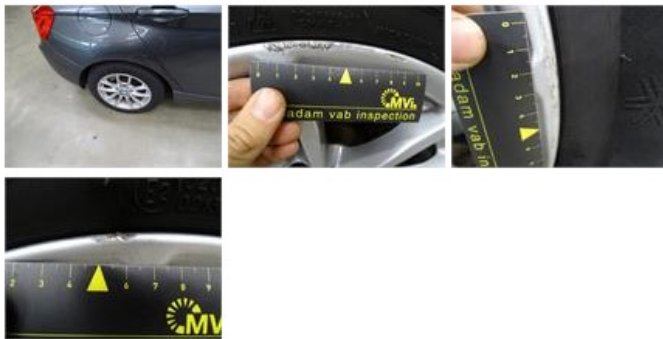
Alloy rim R R, Scratch(es), LI - Repair and paint (complete)

95,00

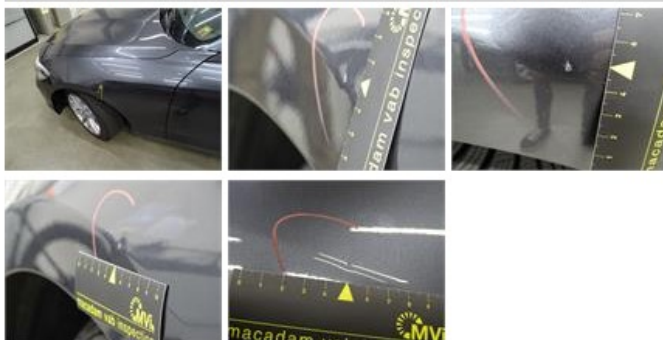
Wing F L, Dent(s) and scratch(es), LI - Repair and paint (complete)

220,18

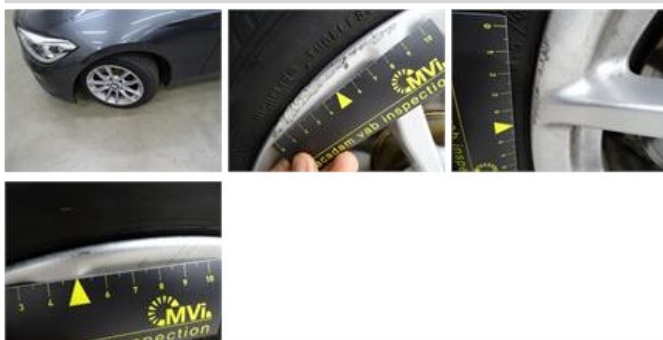
Alloy rim F L, Scratch(es), LI - Repair and paint (complete)

95,00
