**BMW 5 TOURING: 1KBR347**

**Limited Technical Inspection**

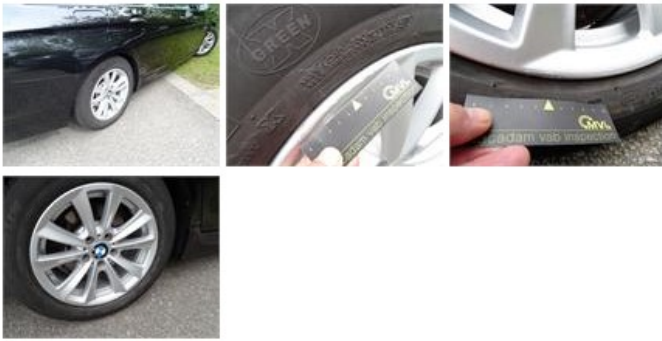
Alloy rim R R, Scratch(es), LI - Repair and paint (complete)	<b>95,00</b>
--	--------------
