MERCEDES A: 1GIY733

Limited Technical Inspection

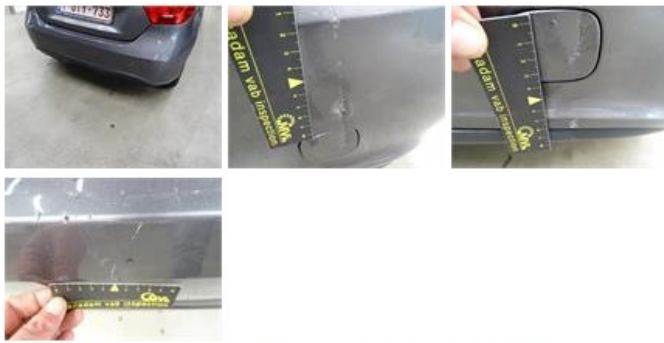
Total cost ex VAT	1187,06
Bumper R, Dent(s), LI - Repair and paint (complete)	211,80

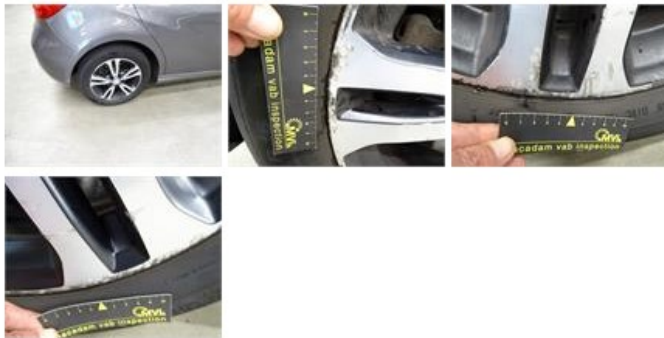
Alloy rim R R polished, Scratch(es), LI - Repair and paint (complete) 95,00

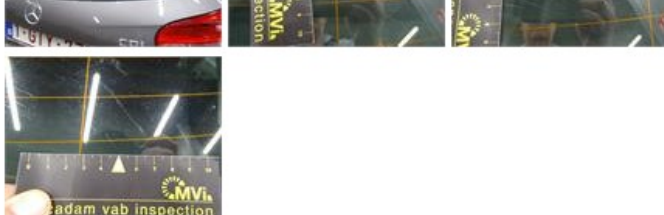
Rear window, Scratch(es), E - Replace 370,00

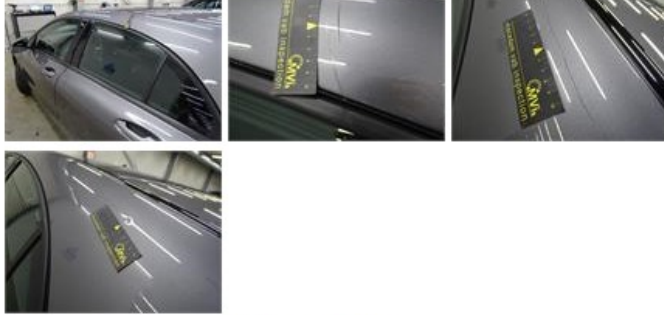
Roof pillar L, Scratch(es), LI - Repair and paint (complete) 220,18
