CITROEN DS5: 1GUH318

Limited Technical Inspection

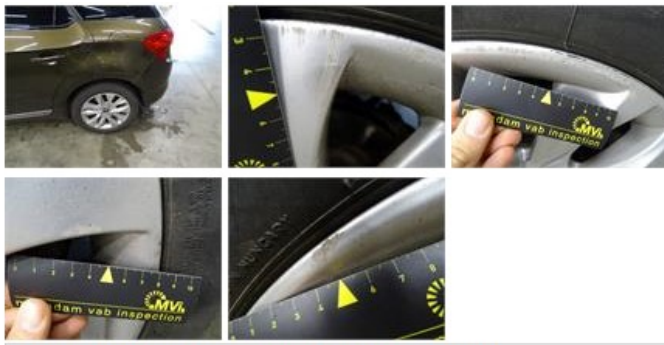
Total cost ex VAT	1336,40
Alloy rim R L, Scratch(es), LI - Repair and paint (complete)	95,00

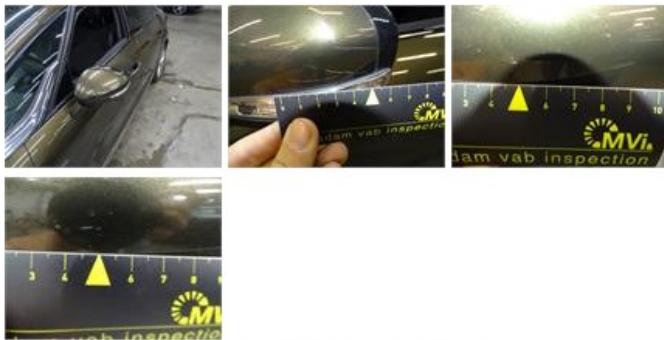
Rearview mirror housing L, Scratch(es), LI - Repair and paint (complete)

115,56

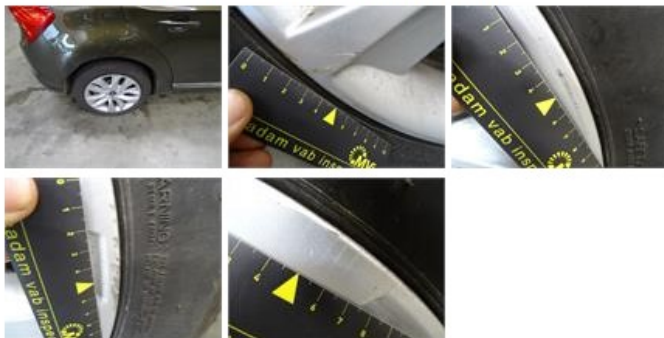
Alloy rim R R, Scratch(es), LI - Repair and paint (complete)

95,00

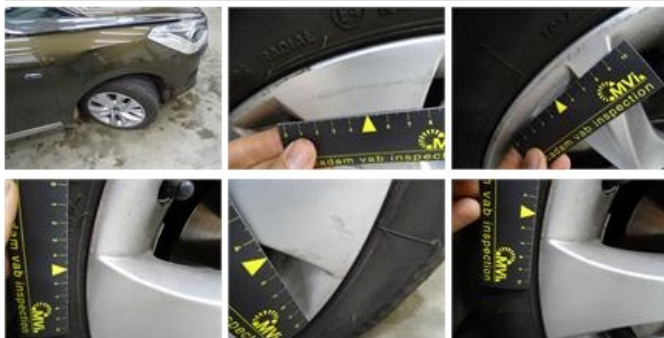
Alloy rim F R, Scratch(es), LI - Repair and paint (complete)

95,00

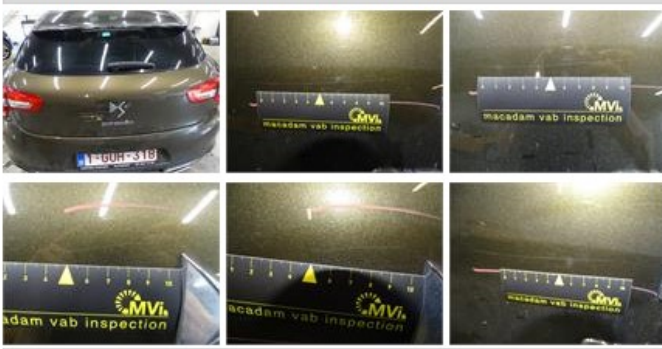
Tailgate, Scratch(es), LI - Repair and paint (complete)

301,68

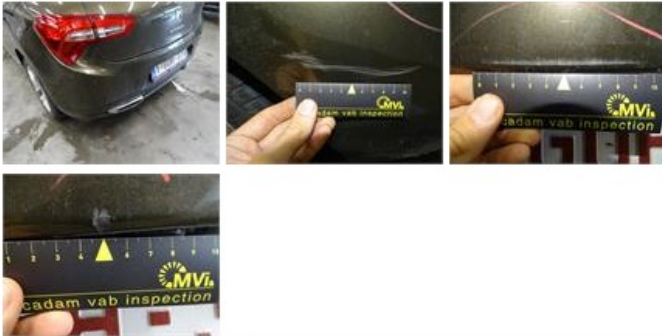
Bumper R, Scratch(es), LI - Repair and paint (complete)

211,80

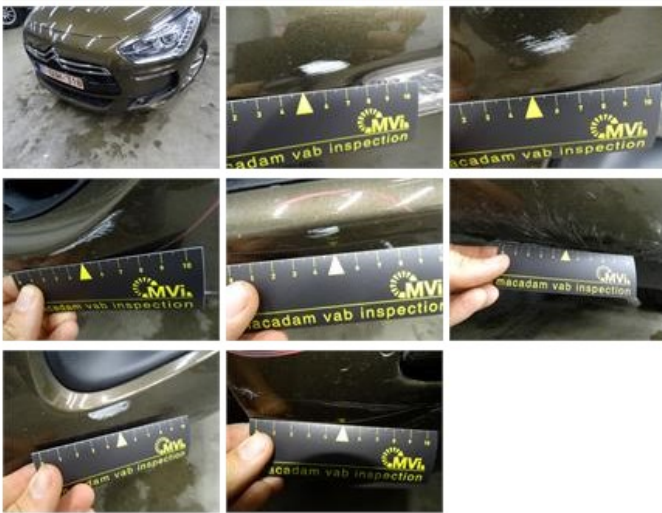
Bumper F, Scratch(es), LI - Repair and paint (complete)

211,80
