BMW 3: 1GKM777			
Vinnumber:	<b>WBA3K91010F933720</b>	Versionname:	<b>3 TOURING 316d 116PK</b>
First Registrationdate:	<b>4/03/2014</b>	Fiscalpower:	
Expertise Mileage:	<b>169475</b>	Power Kw:	<b>85</b>
Bodytype:	<b>Break</b>	Body color:	<b>Blue</b>
Gearbox:	<b>MAN 6 VIT</b>	Paint type:	<b>Metalic</b>
Transmission:	<b>Back</b>	Rims summer:	<b>Aluminium</b>
Fueltype:	<b>Diesel</b>	Oil level:	<b>OK</b>
Battery functioning:	<b>Yes</b>	Parking lot:	<b>1712</b>
Number of doors:	<b>5</b>		
Number of seats:	<b>5</b>		
Number head rests:	<b>5</b>		
Rims summer:	<b>Aluminium</b>		
Category:	<b>Passenger Car</b>		
Oil level:	<b>OK</b>		
Registration Certificate Car (BE):	<b>Yes</b>

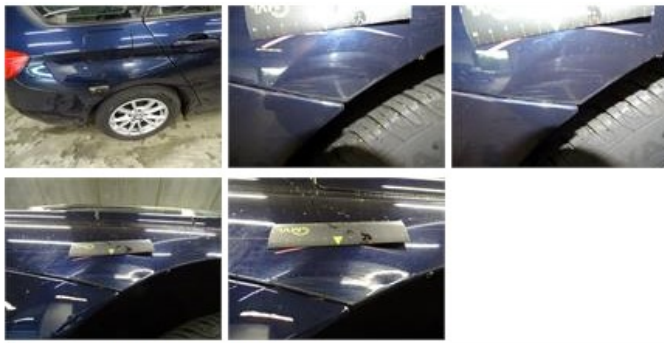
Total cost ex VAT		<b>1621,53</b>
Wing R R, Dent(s) and scratch(es), LI - Repair and paint (complete)		<b>308,20</b>

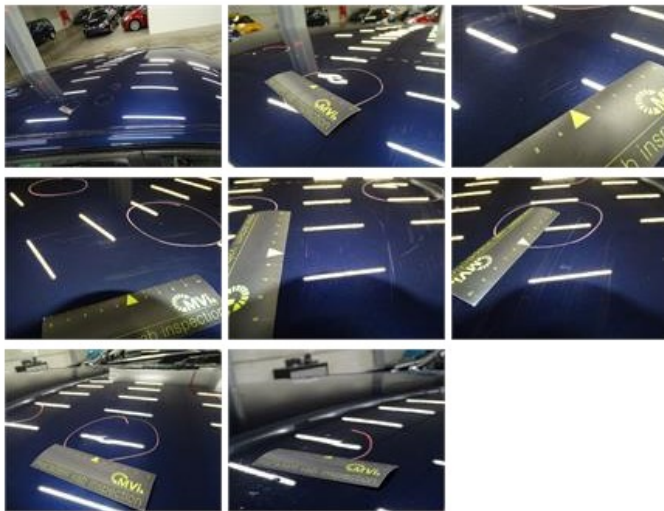
Door F R, Scratch(es), Acceptable	0,00
<i>No pictures to display</i>	
Alloy rim R R, Scratch(es), Acceptable	0,00
<i>No pictures to display</i>	
Bonnet, Scratch(es), Acceptable	0,00
<i>No pictures to display</i>	
Door R L, Scratch(es), Acceptable	0,00
<i>No pictures to display</i>	
Roof, Dent(s) and scratch(es), LI - Repair and paint (complete)	481,50

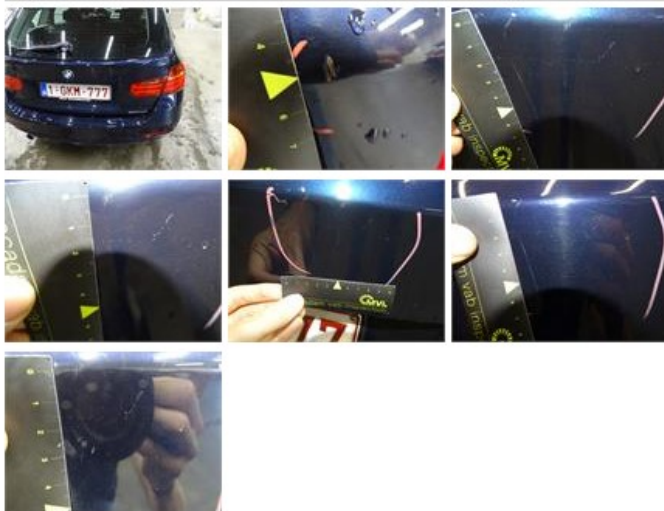
Wing F R, Scratch(es), Acceptable	0,00
<i>No pictures to display</i>	
Tailgate, Scratch(es), LI - Repair and paint (complete)	301,68

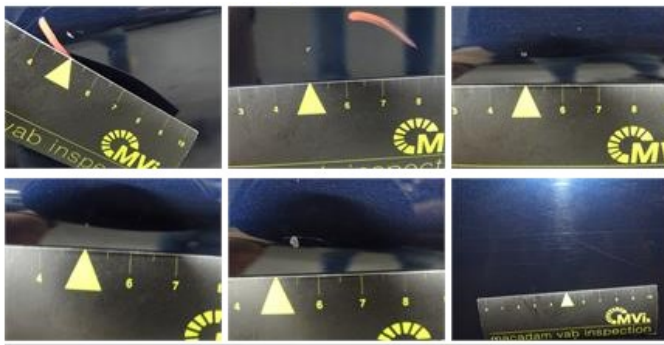
Alloy rim R L, Scratch(es), Acceptable	0,00
<i>No pictures to display</i>	
Door R R, Scratch(es), LI - Repair and paint (complete)	318,35

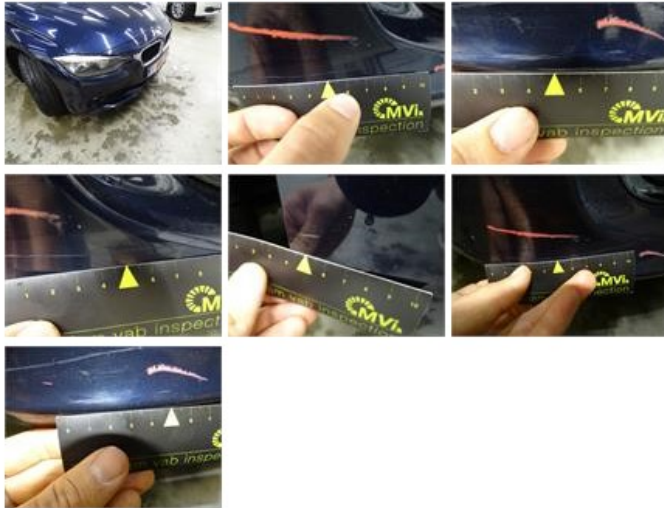
Bumper F, Scratch(es), LI - Repair and paint (complete) 211,80
