BMW 518 TOURING: 1JEY637

Limited Technical Inspection

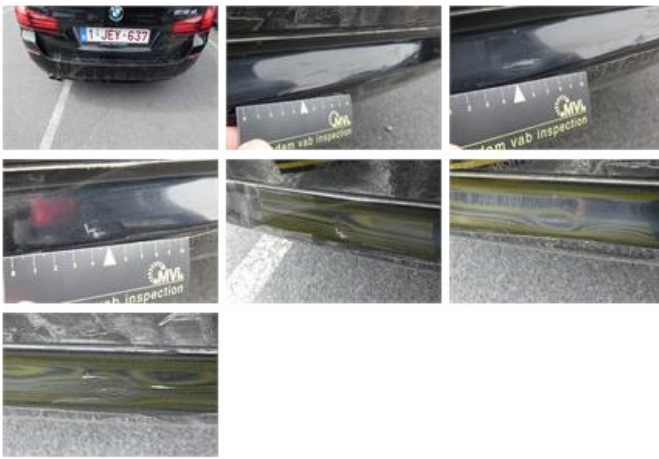
Bumper R, Dent(s) and scratch(es), LI - Repair and paint (complete)	350,16
---	--------

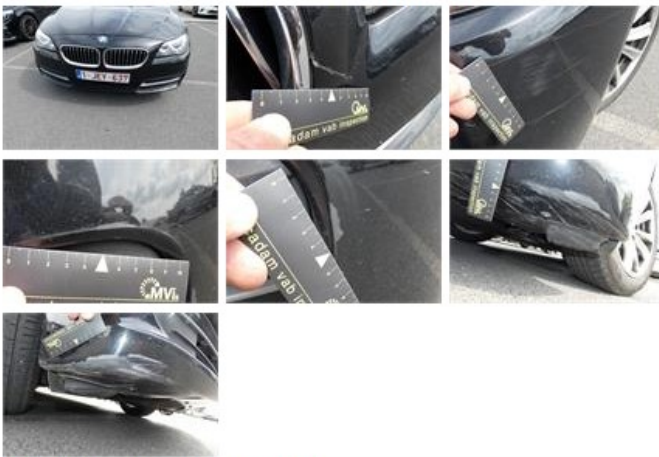
Bumper F, Scratch(es), LI - Repair and paint (complete)	254,16
--	---------------
