LEXUS IS: 1GUL998

Limited Technical Inspection

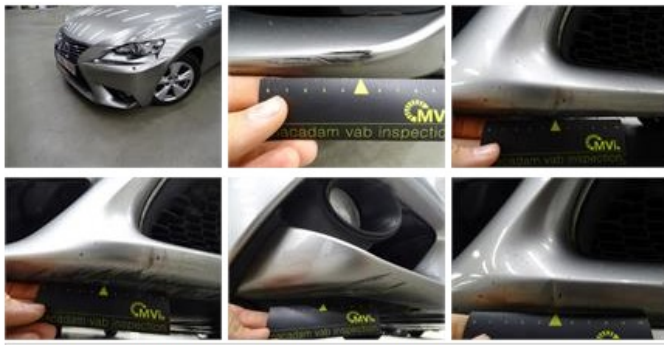
Total cost ex VAT		2674,48
Bumper F, Dent(s) and scratch(es), LI - Repair and paint (complete)		211,80

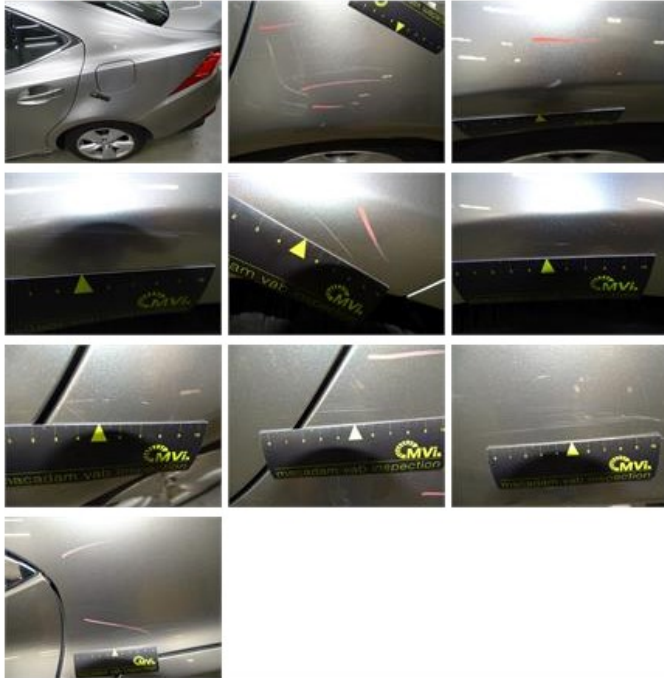
Wing R L, Scratch(es), LI - Repair and paint (complete)

308,20

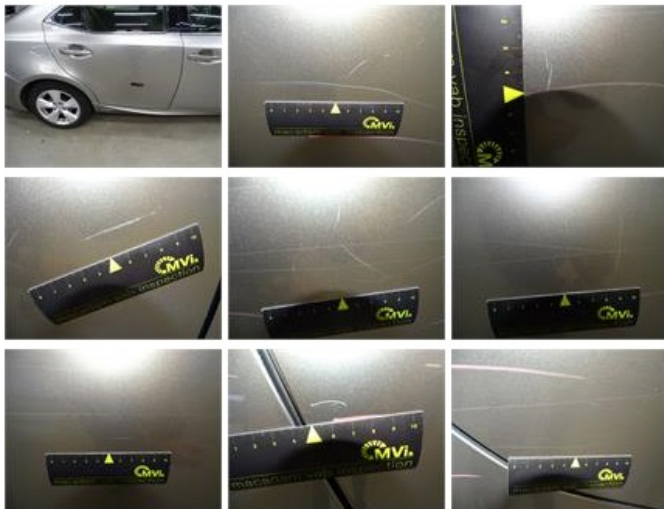
Door R R, Scratch(es), LI - Repair and paint (complete)

318,35

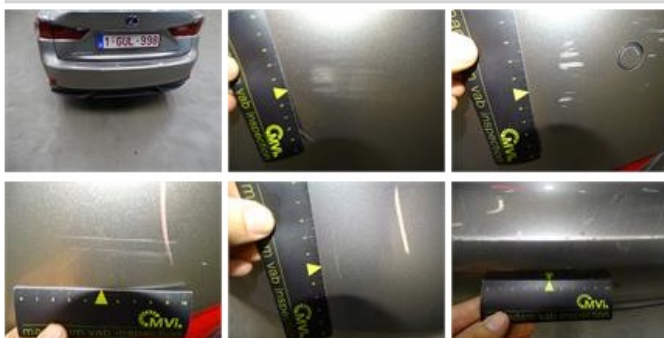
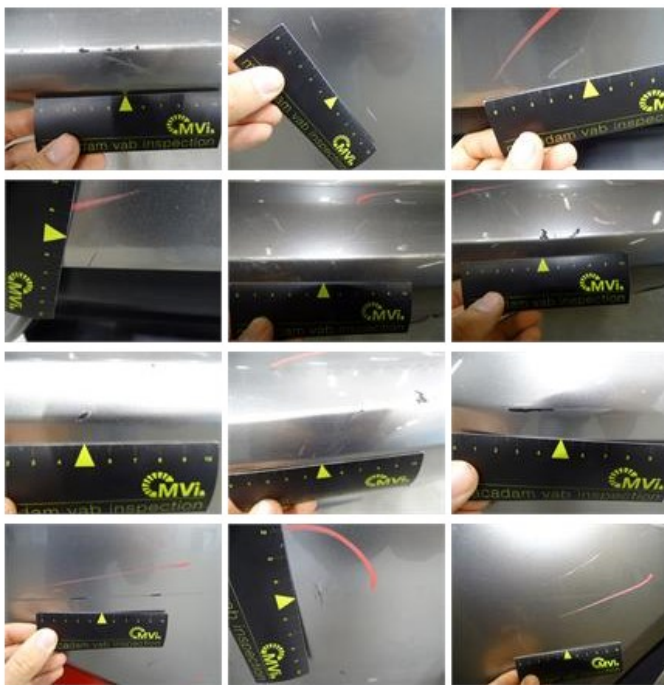
Bumper R, Scratch(es), LI - Repair and paint (complete)

211,80

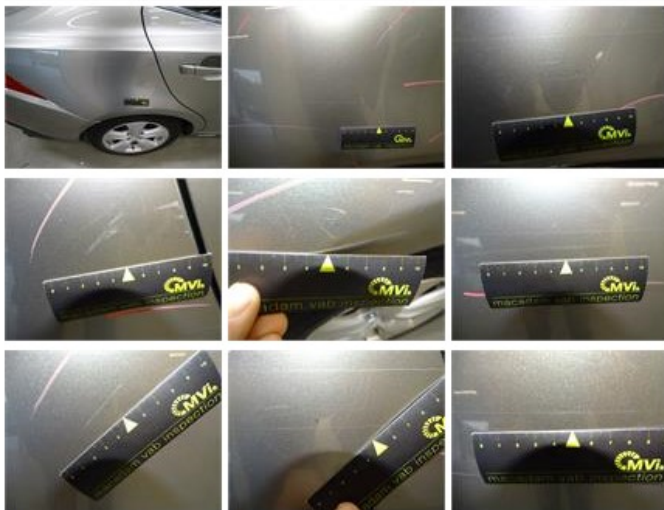
Wing R R, Scratch(es), LI - Repair and paint (complete)

308,20

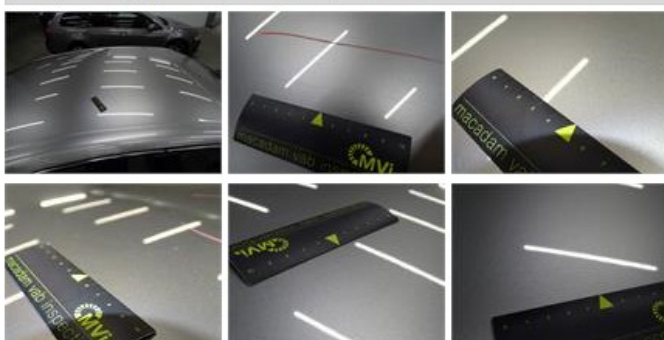
Roof, Scratch(es), LI - Repair and paint (complete)

481,50

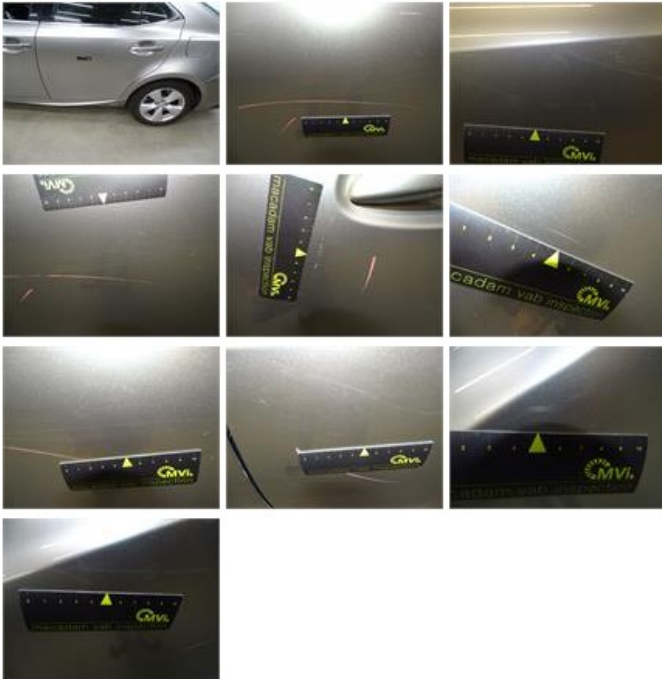
Door R L, Scratch(es), LI - Repair and paint (complete) 318,35

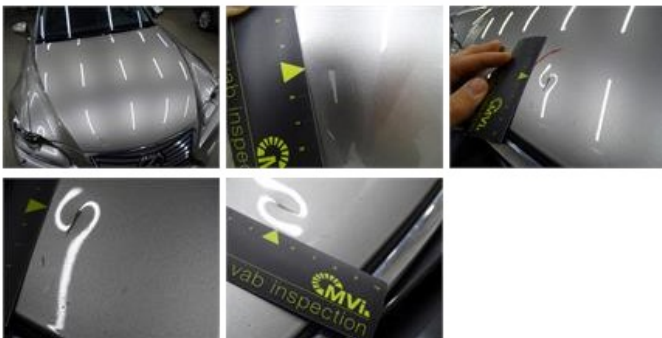
Bonnet, Dent(s) and scratch(es), LI - Repair and paint (complete) 290,08

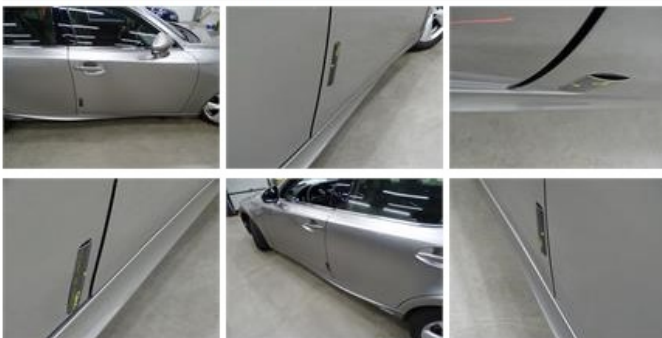
Door F R, Bad repair, Acceptable 0,00
