SKODA SUPERB COMBI: 1LBA261

Limited Technical Inspection

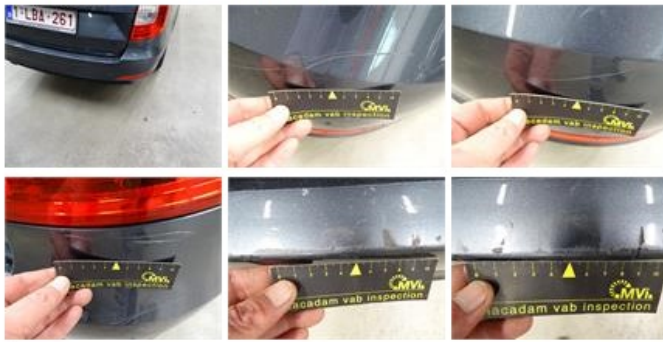
Bumper R, Scratch(es), LI - Repair and paint (complete) 254,16

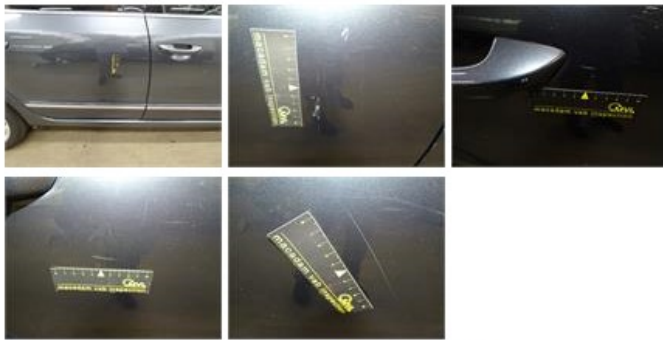
Door R R, Scratch(es), LI - Repair and paint (complete) 382,02

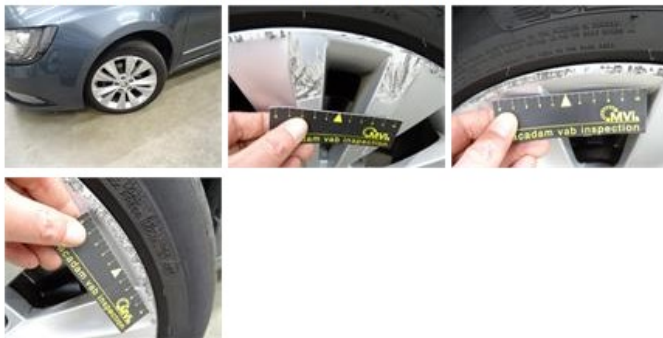
Alloy rim F L, Scratch(es), LI - Repair and paint (complete) 95,00

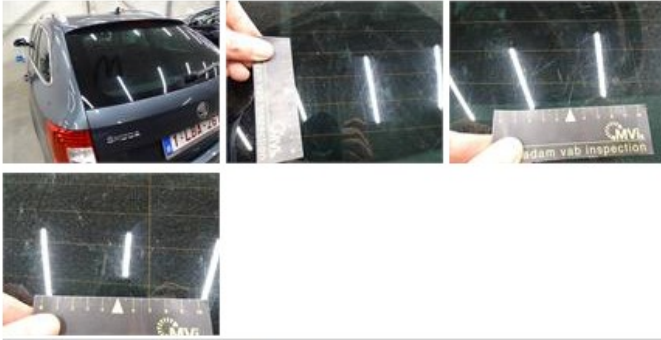
Rear window, Scratch(es), E - Replace
