RENAULT Megane: 1GIK798

Limited Technical Inspection

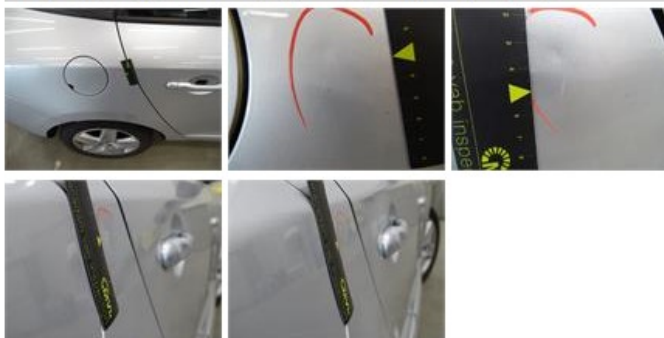
Wing R R, Dent(s) and scratch(es), LI - Repair and paint (complete)

308,20

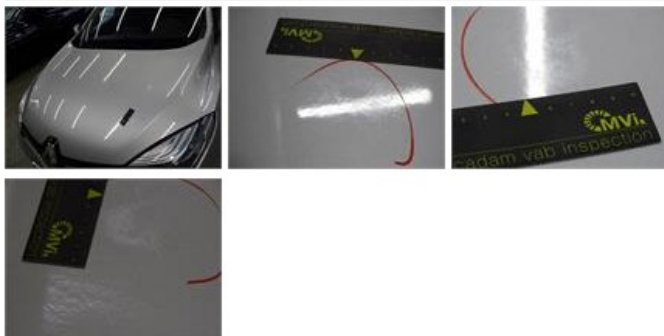
Bonnet, Chemical pollution, LI - Repair and paint (complete)

290,08

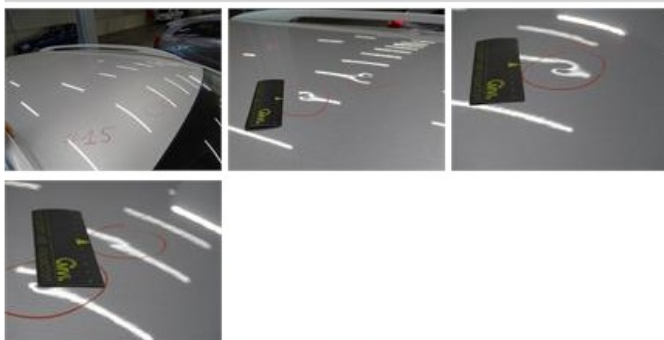
Roof, Hail damage, PDR - Hail

375,00

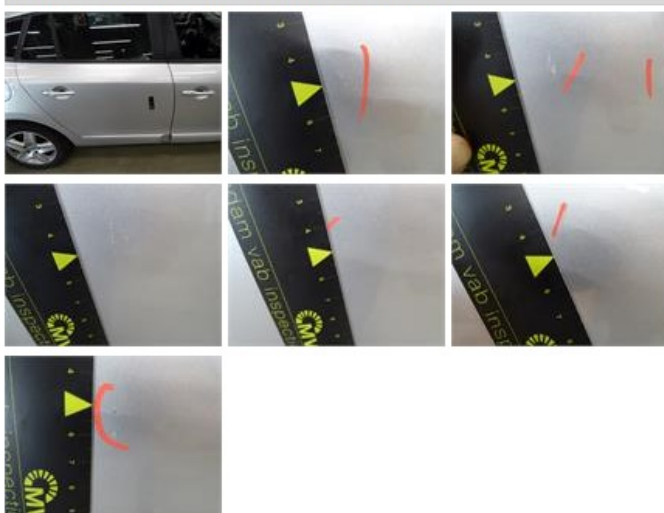
Door R R, Scratch(es), LI - Repair and paint (complete)

318,35

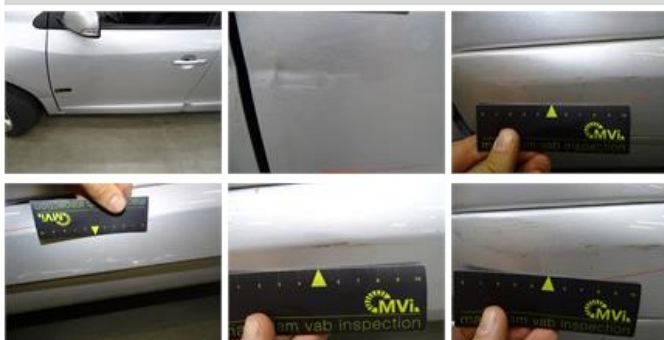
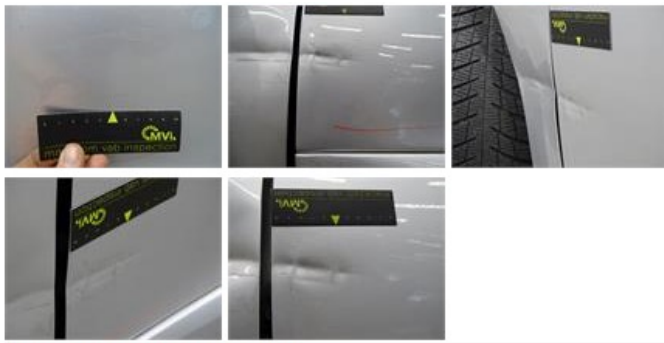
Door F L, Dent(s) and scratch(es), LI - Repair and paint (complete)

318,35

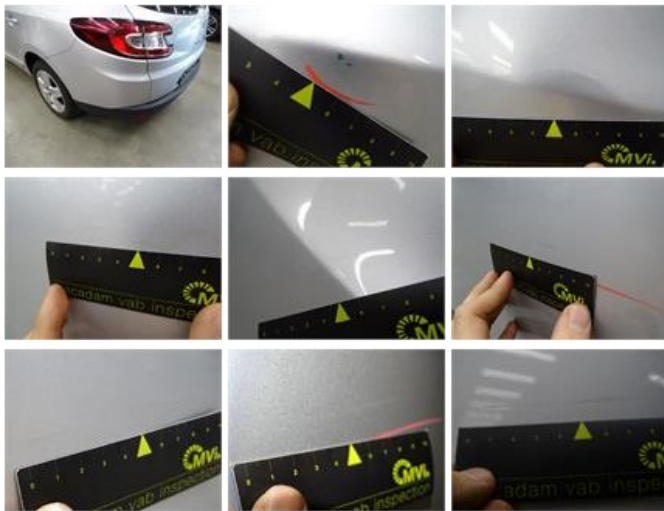
Bumper corner R L, Scratch(es), It - Spot repair

115,56

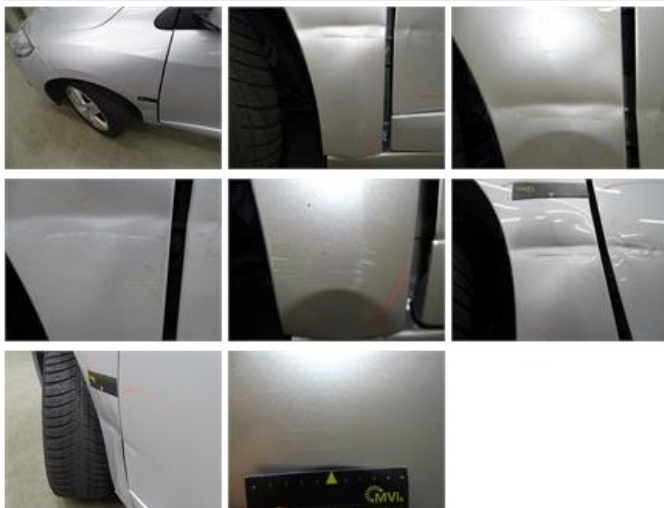
Wing F L, Dent(s) and scratch(es), LI - Repair and paint (complete)

268,18

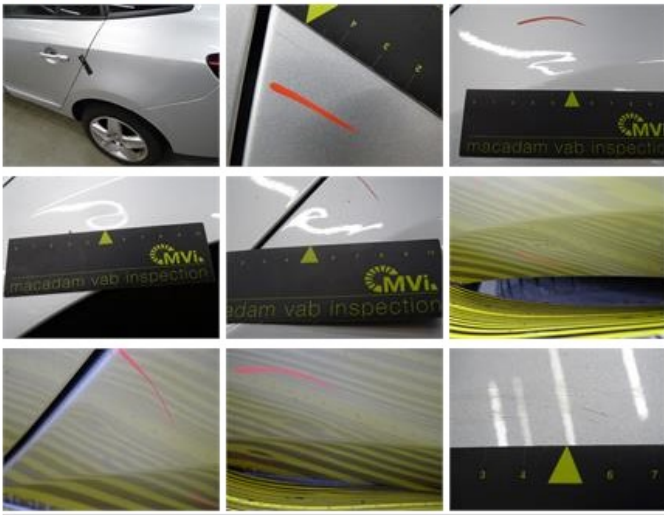
Wing R L, Dent(s) and scratch(es), LI - Repair and paint (complete)

308,20
