PEUGEOT 308 SW: 1KGU833

Limited Technical Inspection

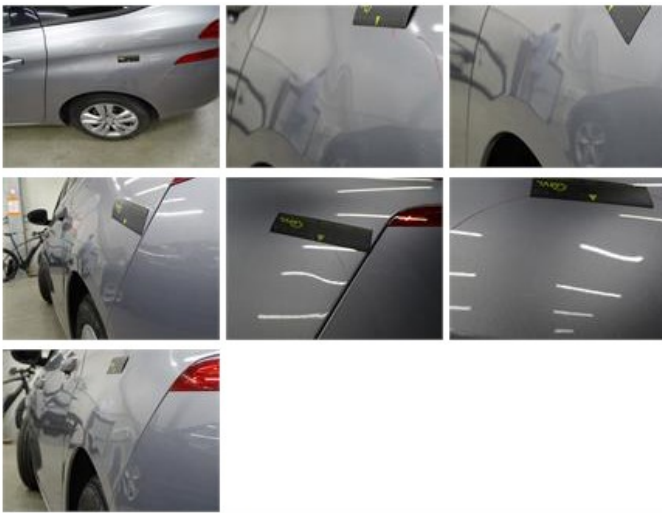
Total cost ex VAT	3353,45
Wing F R, Scratch(es), Acceptable	0,00
<i>No pictures to display</i>	
Wing R L, Dent(s), PDR - Paintless dent repair	82,80

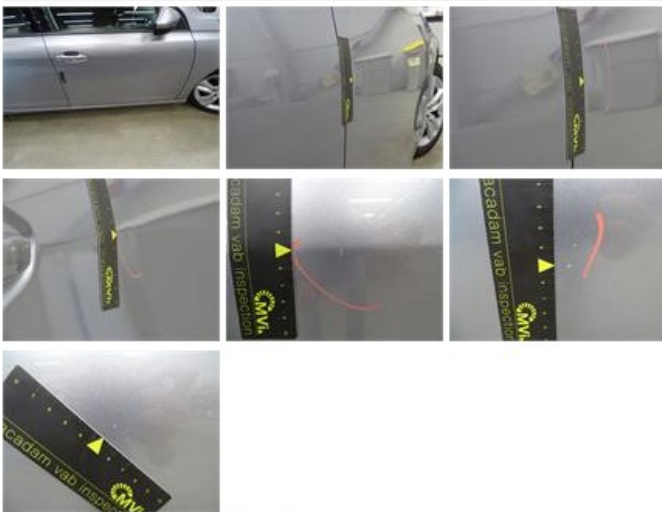
Door F R, Dent(s) and scratch(es), LI - Repair and paint (complete) 318,35

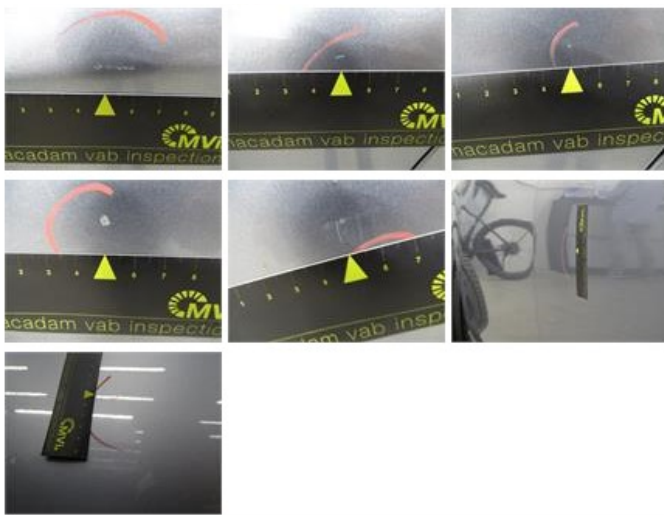
Door R L, Dent(s) and scratch(es), LI - Repair and paint (complete) 318,35

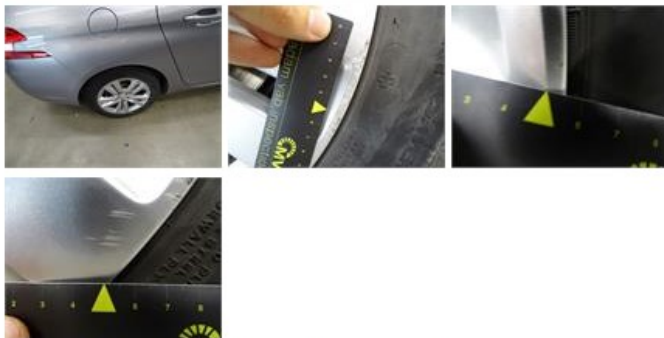
Alloy rim R R, Scratch(es), LI - Repair and paint (complete)

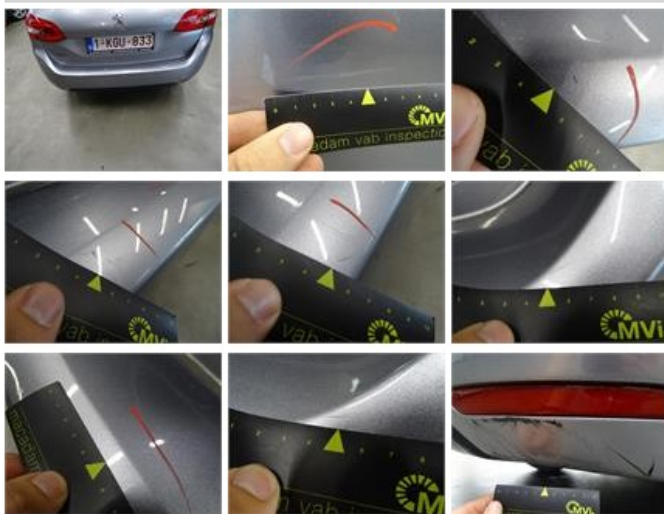
Bumper R, Scratch(es), LI - Repair and paint (complete)

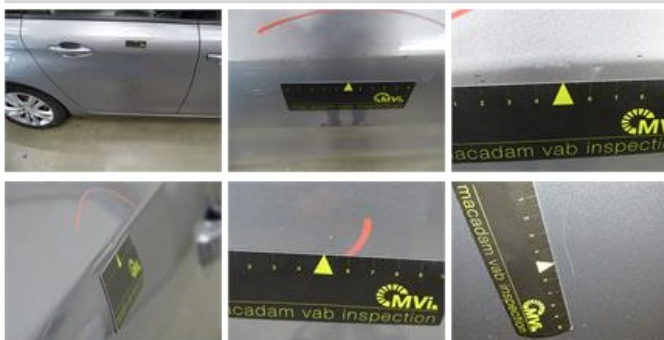
Door R R, Dent(s) and scratch(es), LI - Repair and paint (complete)

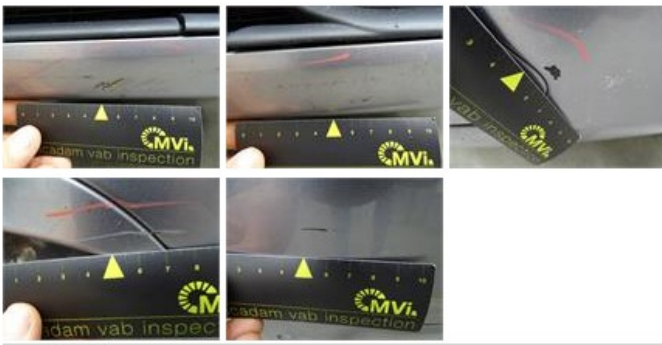
Bumper F, Scratch(es), LI - Repair and paint (complete)

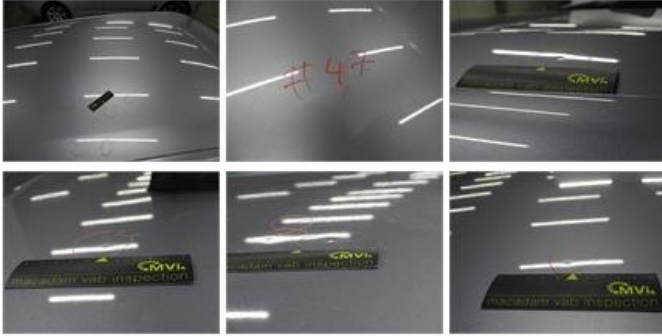
Roof, Hail damage, PDR - Hail
