**BMW 1: FG5463**

**Limited Technical Inspection**

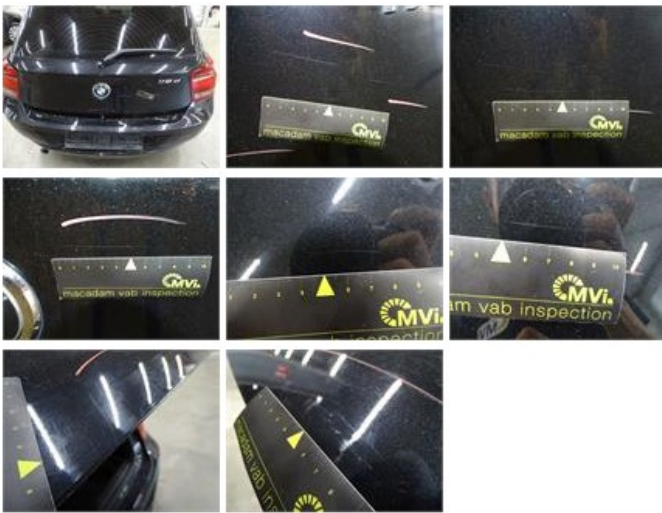
Total cost ex VAT	<b>1958,49</b>
Door F L, Repaired, Acceptable	<b>0,00</b>
<i>No pictures to display</i>	
Tailgate, Scratch(es), LI - Repair and paint (complete)	<b>301,68</b>

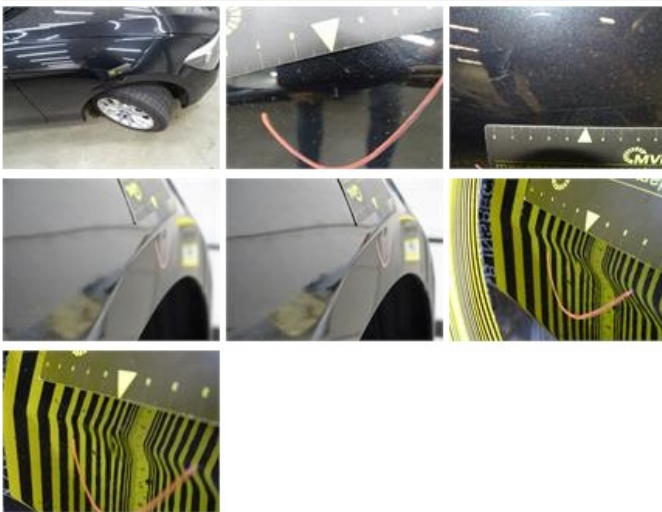
Wing F R, Dent(s) and scratch(es), LI - Repair and paint (complete) 220,18

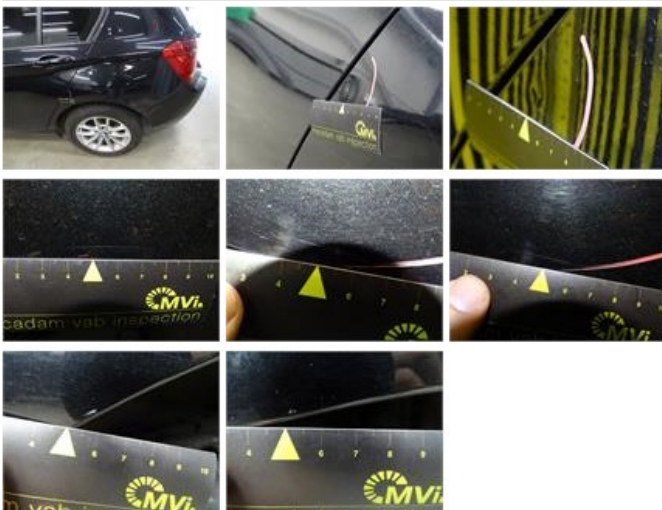
Wing R L, Dent(s) and scratch(es), LI - Repair and paint (complete) 308,20

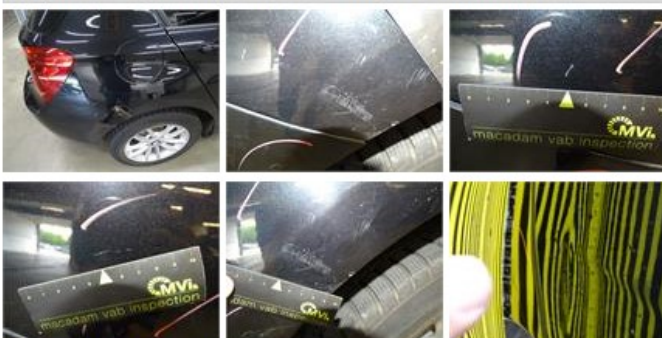
Wing R R, Dent(s) and scratch(es), LI - Repair and paint (complete) 308,20

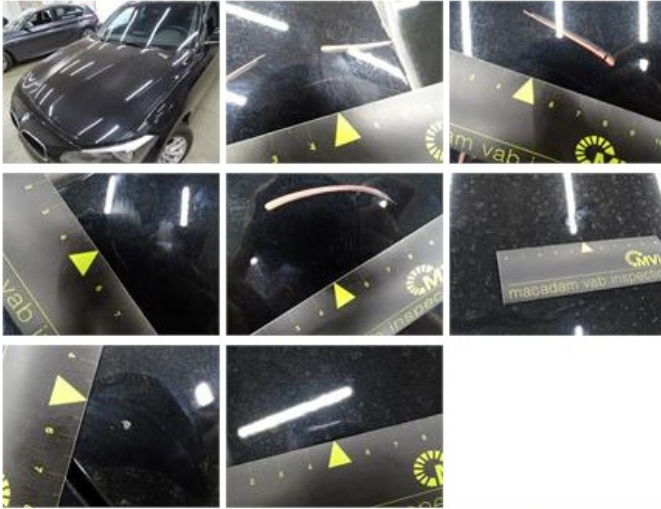
Bonnet, Scratch(es), LI - Repair and paint (complete) 290,08

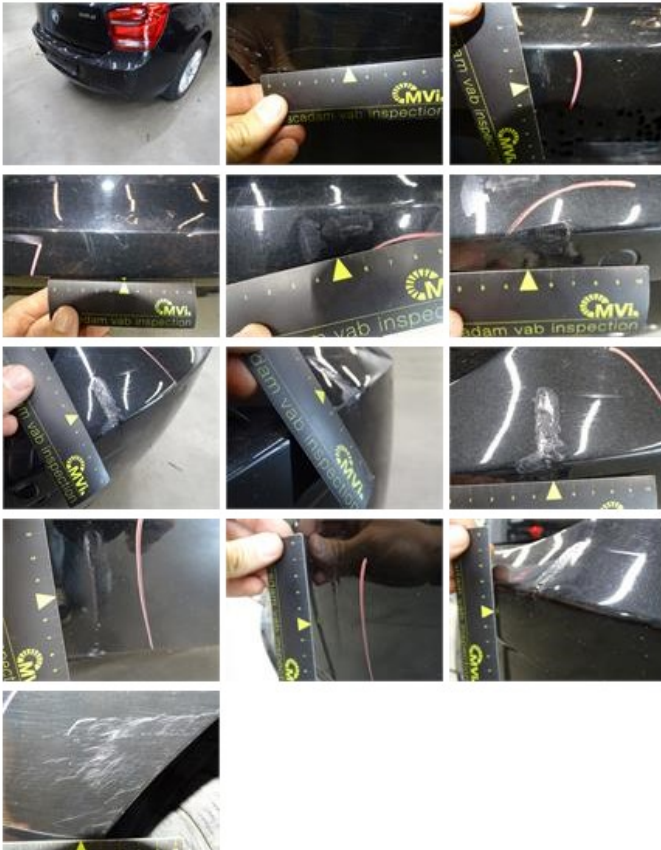
Bumper R, Dent(s) and scratch(es), LI - Repair and paint (complete) 211,80

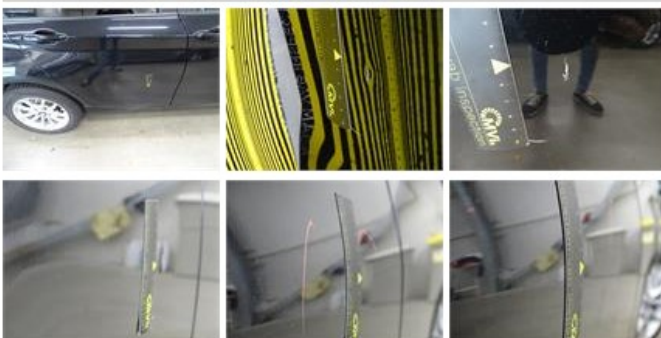
Door R R, Dent(s) and scratch(es), LI - Repair and paint (complete) 318,35
