MERCEDES B: 1JJG057

Limited Technical Inspection

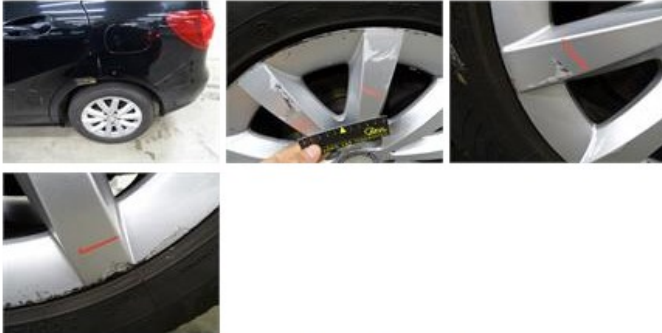
Alloy rim R L, Scratch(es), LI - Repair and paint (complete) 95,00

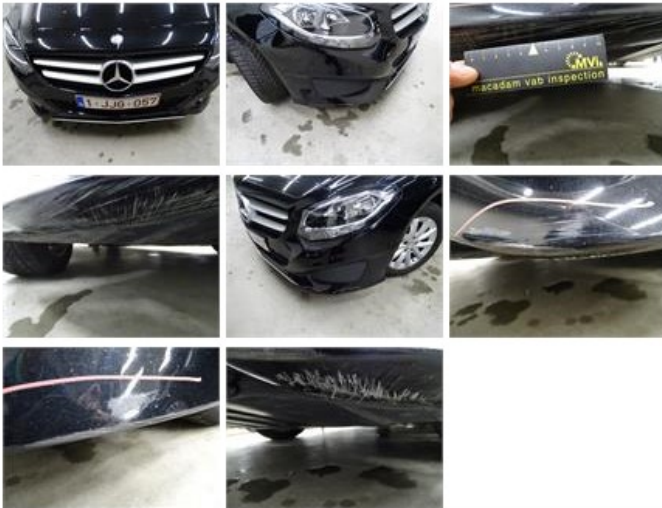
Bumper F, Scratch(es), LI - Repair and paint (complete) 211,80

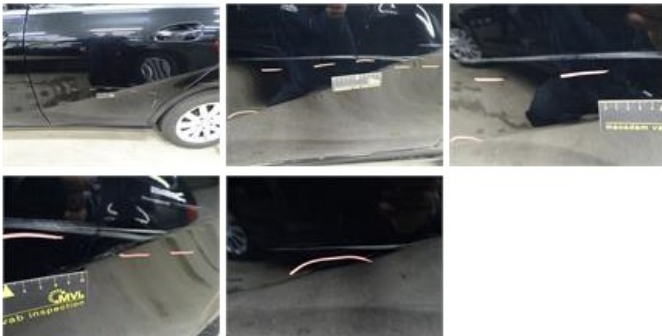
Door R L, Scratch(es), LI - Repair and paint (complete) 318,35

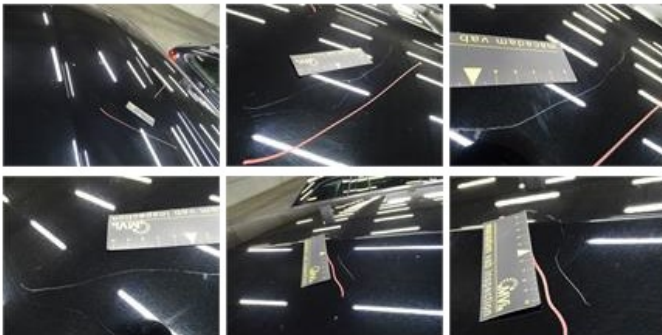
Roof, Scratch(es), LI - Repair and paint (complete) 481,50
