VOLKSWAGEN Golf: 1HHG458

Limited Technical Inspection

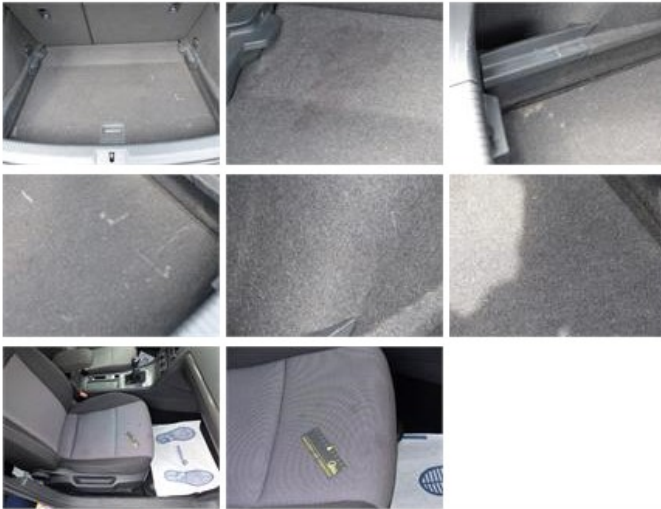
Interior, Dirty, Cleaning 25,00
