VOLKSWAGEN Sharan: 1GWN850

Limited Technical Inspection

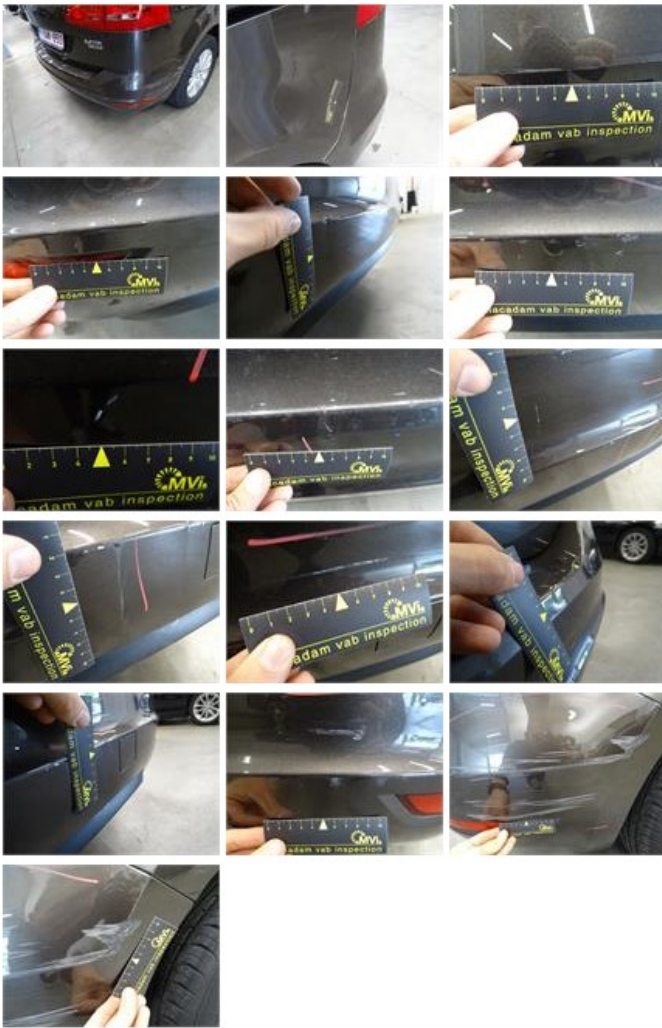
Bumper R, Dent(s) and scratch(es), LI - Repair and paint (complete)

254,16

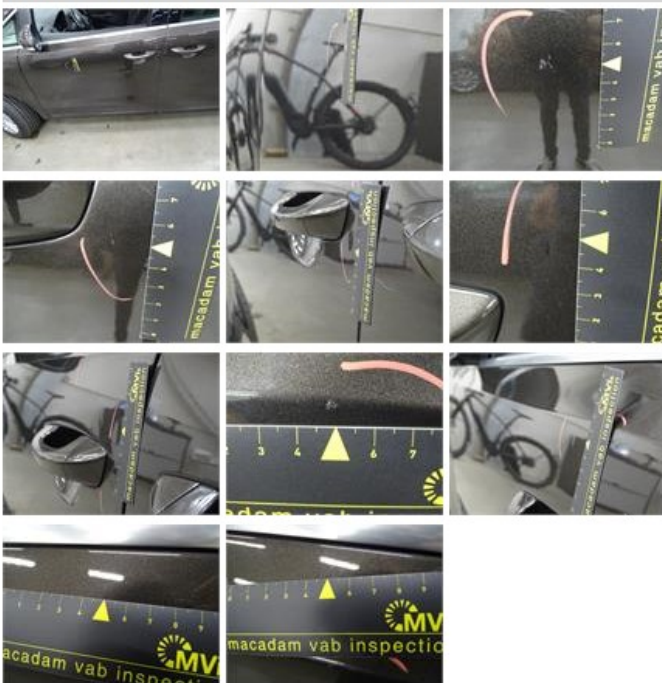
Door F L, Dent(s) and scratch(es), LI - Repair and paint (complete)

382,02

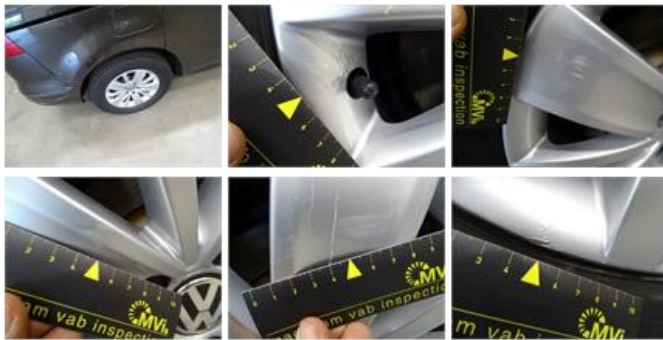
Alloy rim R R, Scratch(es), LI - Repair and paint (complete)

95,00

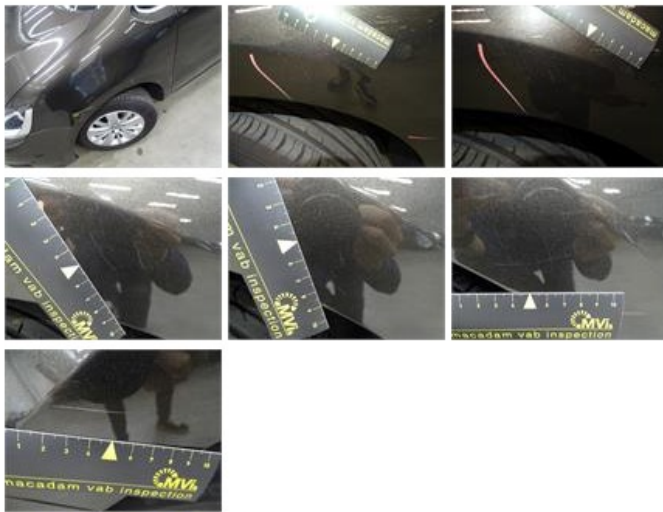
Wing F L, Scratch(es), LI - Repair and paint (complete)

264,21

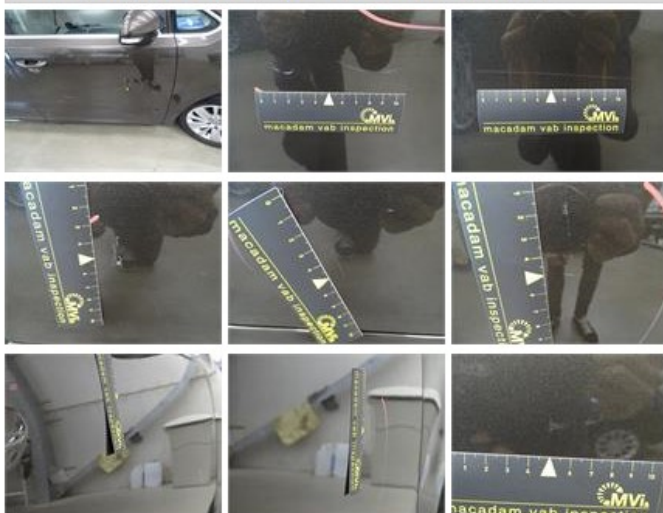
Door F R, Dent(s) and scratch(es), LI - Repair and paint (complete)

382,02

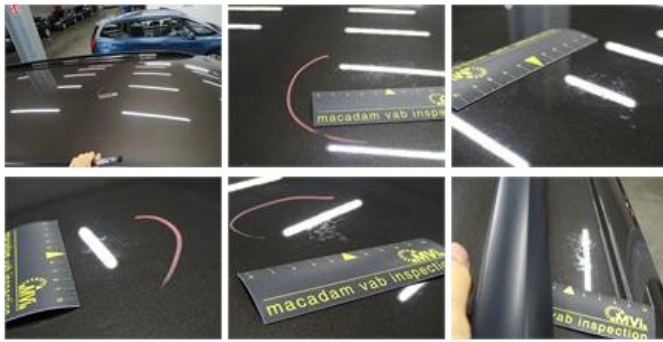
Roof, Chemical polution, LI - Repair and paint (complete) 577,80

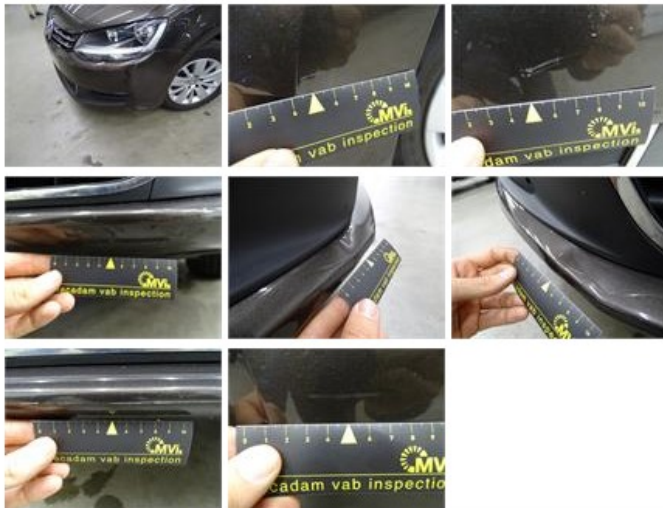
Bumper F, Dent(s) and scratch(es), LI - Repair and paint (complete) 254,16

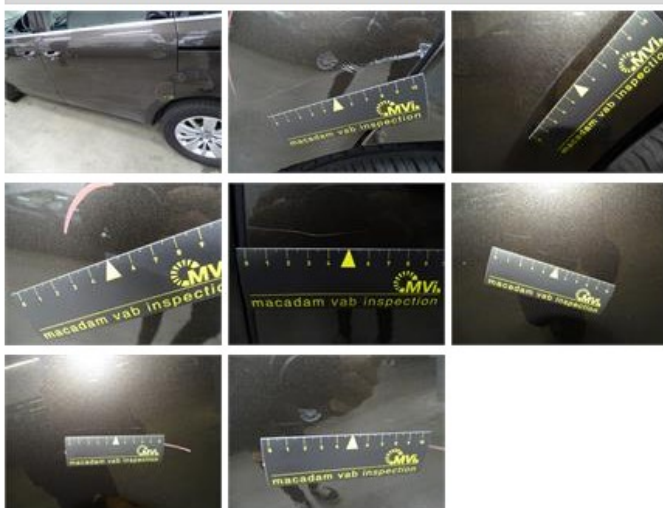
Door R L, Scratch(es), LI - Repair and paint (complete) 382,02

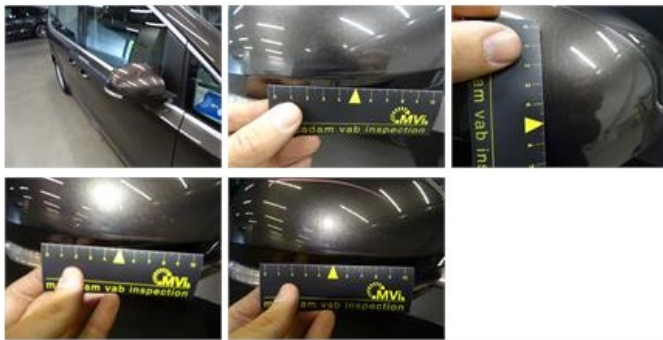
Rearview mirror housing R, Scratch(es), LI - Repair and paint (complete)

115,56

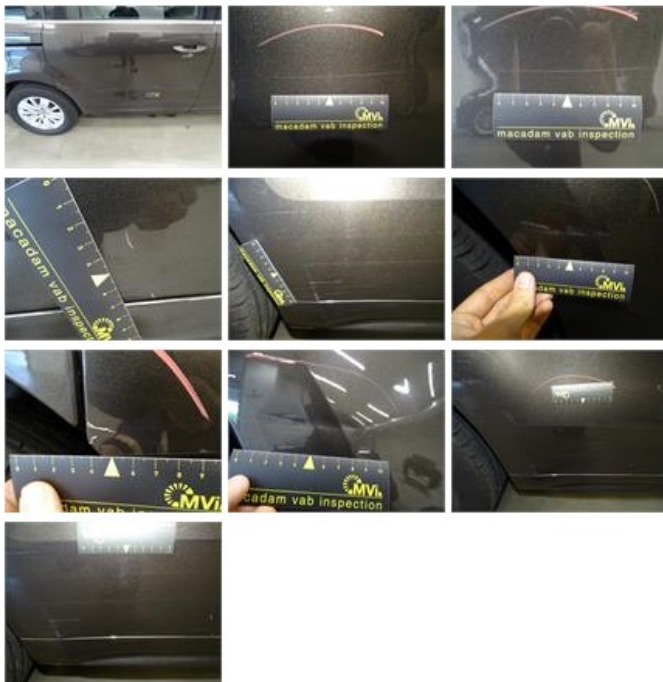
Door R R, Dent(s) and scratch(es), LI - Repair and paint (complete)

382,02

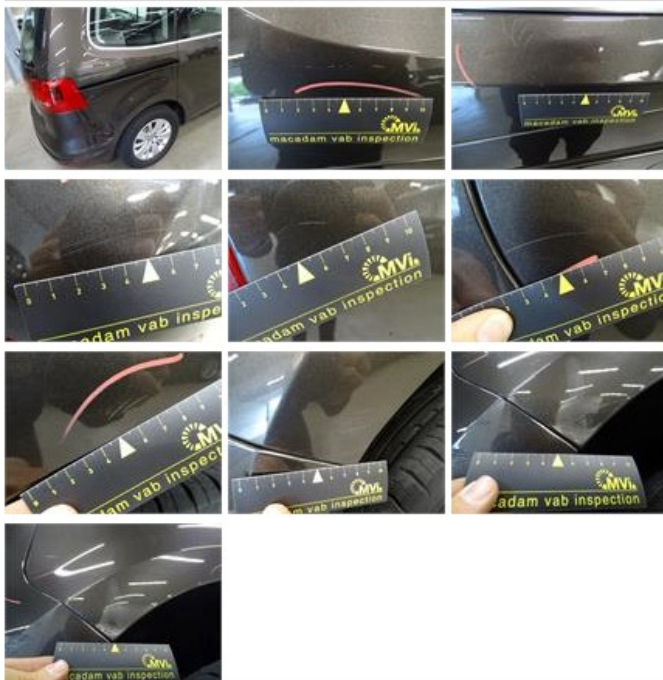
Wing R R, Dent(s) and scratch(es), LI - Repair and paint (complete)

369,84
