VOLKSWAGEN GOLF VII: HL8469

Limited Technical Inspection

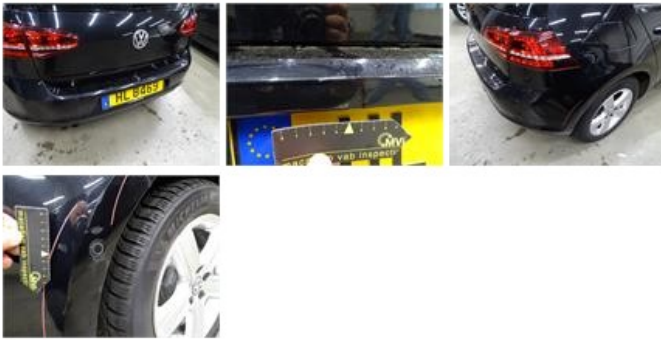
Bumper R, Scratch(es), LI - Repair and paint (complete) 211,80

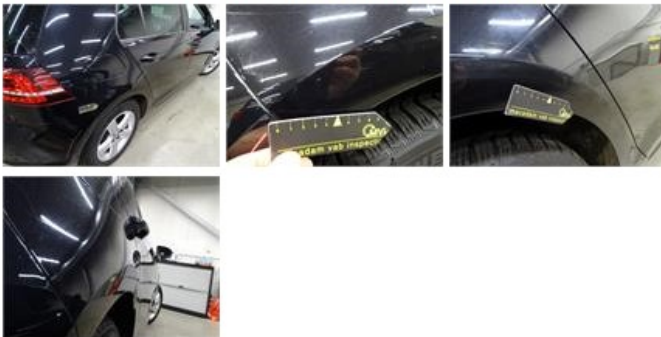
Wing R R, Dent(s) and scratch(es), LI - Repair and paint (complete) 308,20
