BMW 2 ACTIVE TOURER: HL8334

Limited Technical Inspection

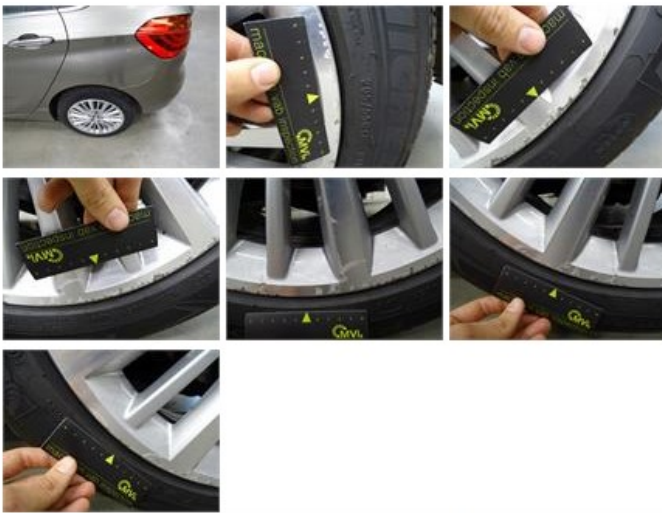
Total cost ex VAT	1690,11
Door R L, Dent(s), Acceptable	0,00
<i>No pictures to display</i>	
Alloy rim R L, Scratch(es), LI - Repair and paint (complete)	95,00

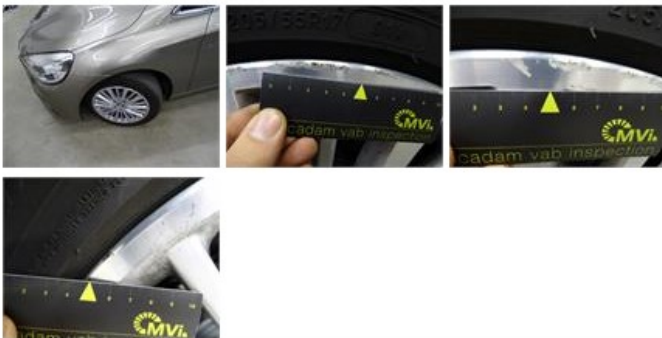
Alloy rim F L, Scratch(es), LI - Repair and paint (complete) 95,00

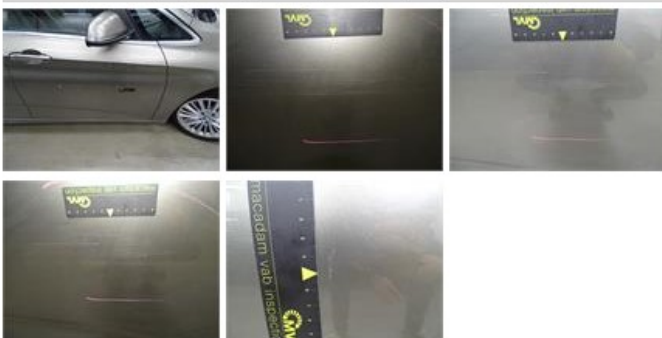
Door F R, Scratch(es), LI - Repair and paint (complete) 318,35

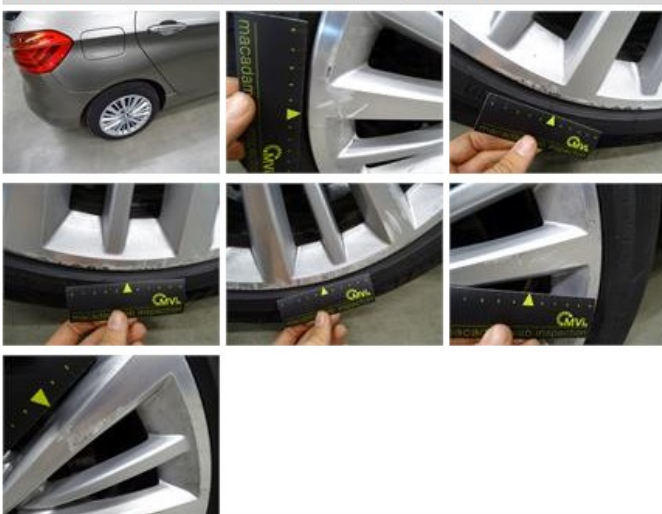
Alloy rim R R, Scratch(es), LI - Repair and paint (complete) 95,00
