| BMW 1 HATCH: KV0112 | | | |
| Vinnumber: | WBA1U510305D95363 | Versionname: | 2.0 118D XDRIVE (110KW) |

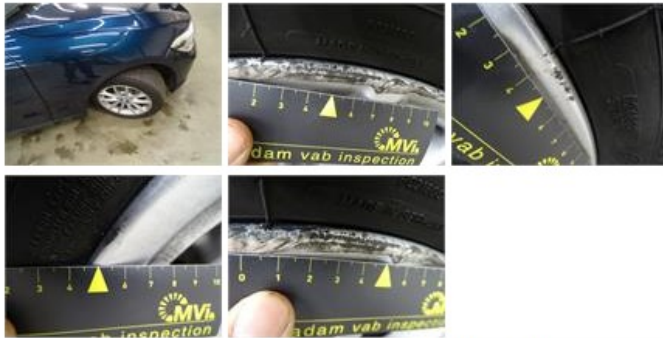
Alloy rim F R, Scratch(es), LI - Repair and paint (complete)

95,00

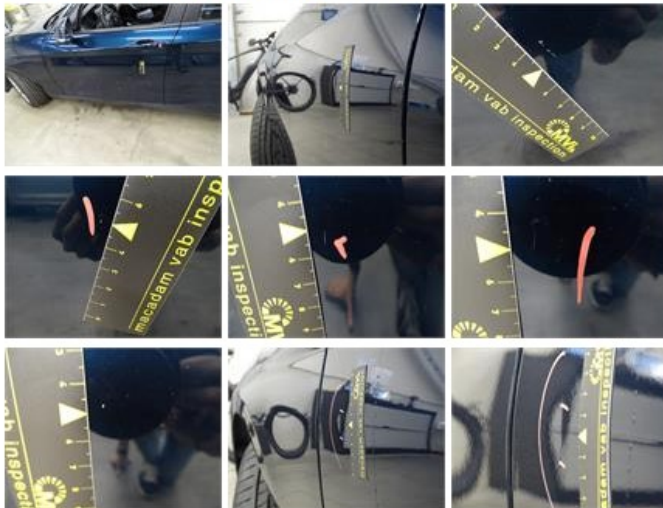
Door F L, Dent(s) and scratch(es), LI - Repair and paint (complete)

318,35
