AUDI A3: 1HLY892			
Vinnumber:	WAUZZZ8V7FA027861	Versionname:	A3 SB Ambiente 110PK
First Registrationdate:	25/08/2014	Fiscalpower:	
Expertise Mileage:	159985	Power Kw:	81
Bodytype:	Hatchback	Body color:	Black
Gearbox:	MAN 6 VIT	Paint type:	Metalic
Transmission:	Front	Rims summer:	Aluminium
Fueltype:	Diesel	Oil level:	OK
Battery functioning:	Yes	Parking lot:	2627
Number of doors:	5		
Number of seats:	5		
Number head rests:	5		
Rims summer:	Aluminium		
Category:	Passenger Car		
Oil level:	OK		
Registration Certificate Car (BE):	Yes

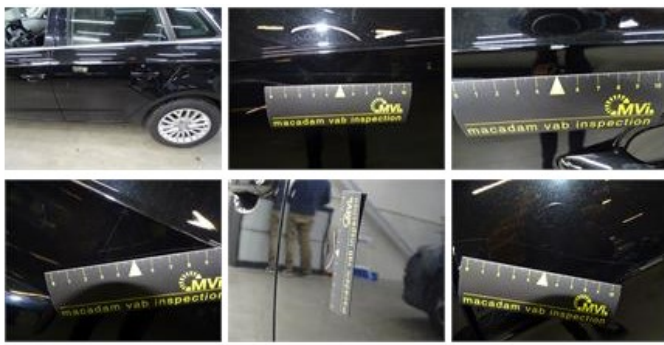
Total cost ex VAT		1758,65
Tailgate, Scratch(es), Acceptable		0,00
<i>No pictures to display</i>		
Door R L, Dent(s) and scratch(es), LI - Repair and paint (complete)		318,35

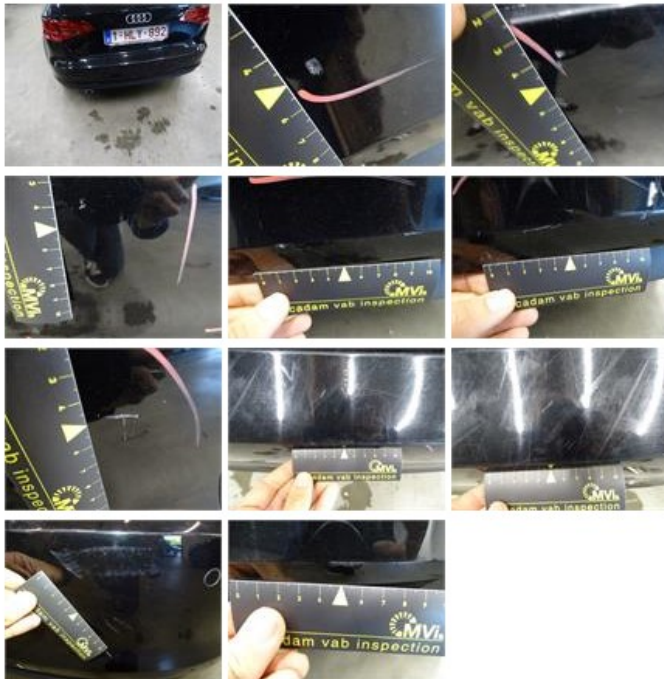
Bumper R, Scratch(es), LI - Repair and paint (complete) 211,80

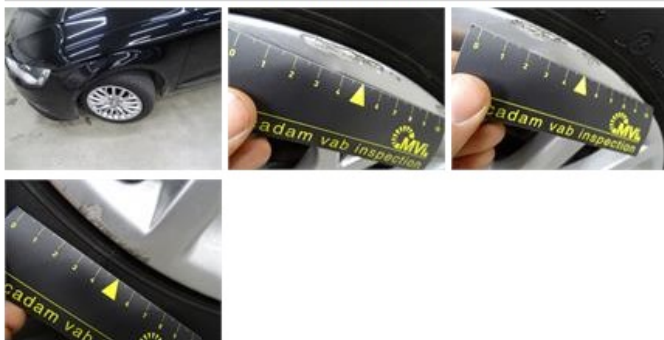
Alloy rim F L, Scratch(es), LI - Repair and paint (complete) 95,00

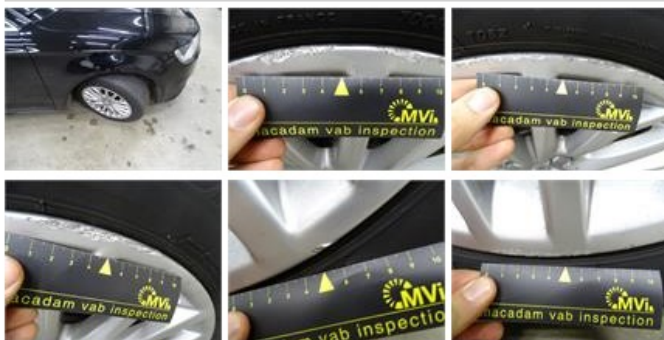
Alloy rim F R, Scratch(es), LI - Repair and paint (complete) 95,00

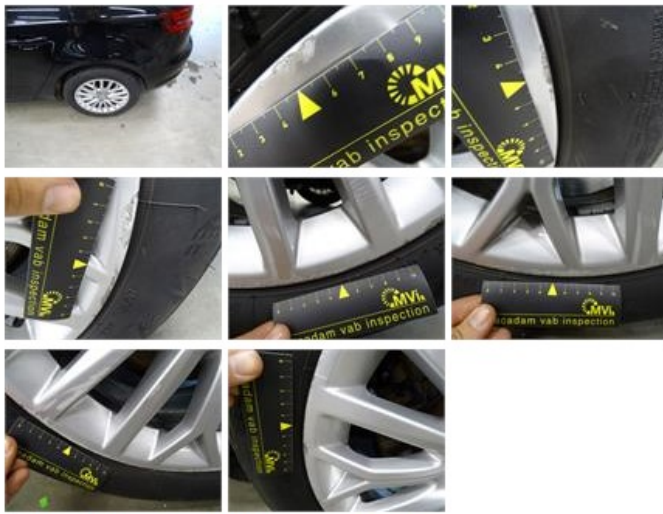
Alloy rim R L, Scratch(es), LI - Repair and paint (complete)

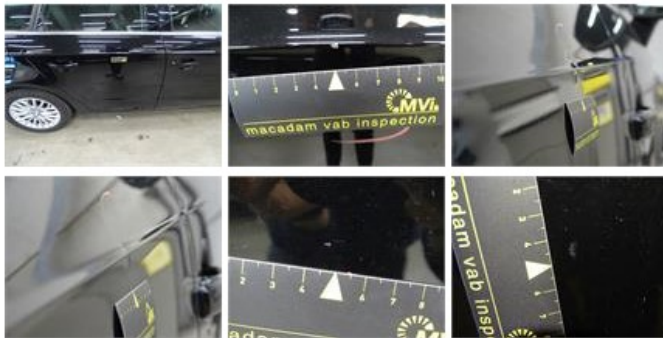
Door R R, Dent(s) and scratch(es), LI - Repair and paint (complete)

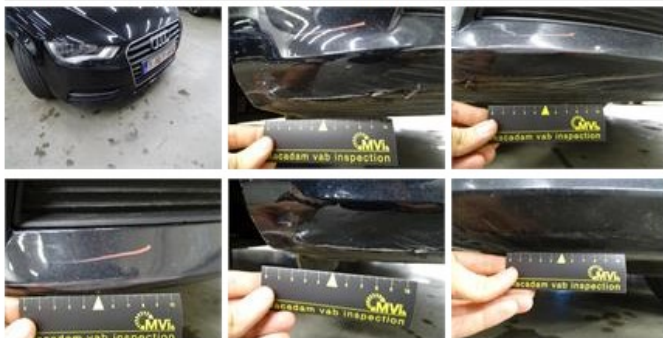
Bumper F, Scratch(es), LI - Repair and paint (complete)

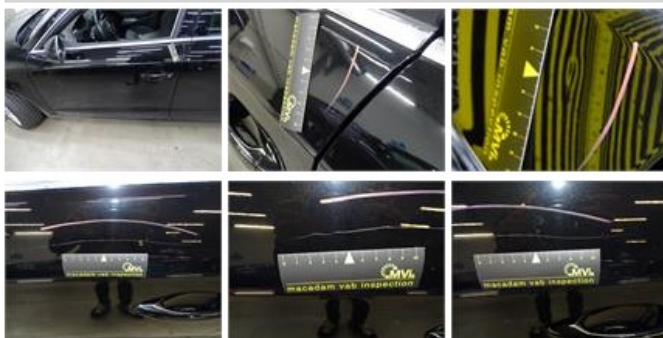
Door F L, Dent(s) and scratch(es), LI - Repair and paint (complete)
