**LU Mercedes c Berline: KL6401**

**Limited Technical Inspection**

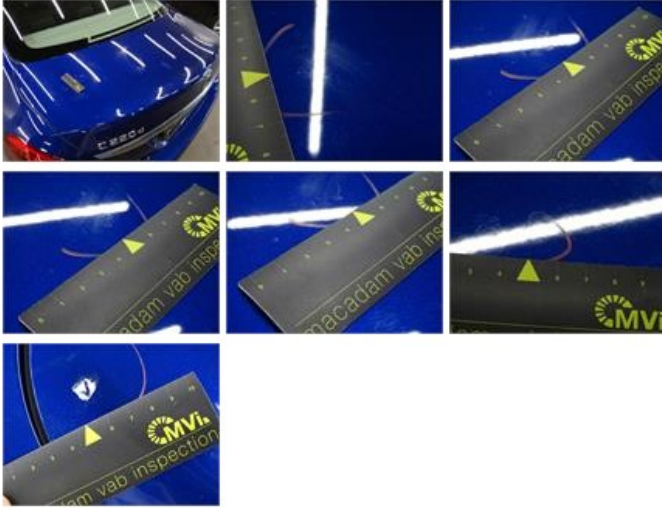
Tailgate, Chemical polution, LI - Repair and paint (complete) 301,68

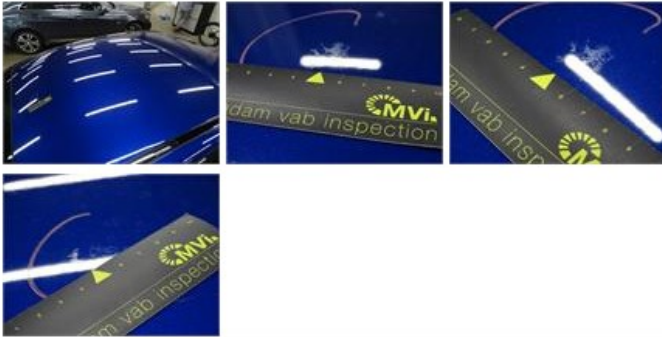
Roof, Chemical polution, LI - Repair and paint (complete) 481,50
