<b>LU Mercedes gla: ZX8857</b>			
Vinnumber:	<b>WDC1569081J346063</b>	Versionname:	<b>GLA 200 d Style</b>
First Registrationdate:	<b>20/01/2017</b>	Fiscalpower:	
Expertise Mileage:	<b>50542</b>	Power Kw:	<b>100</b>
Bodytype:	<b>SUV</b>	Body color:	<b>Grey</b>
Gearbox:	<b>MAN 6 VIT</b>	Paint type:	<b>Metallic</b>
Transmission:	<b>Front</b>	Rims summer:	<b>Aluminium</b>
Fueltype:	<b>Diesel</b>	Oil level:	<b>OK</b>
Battery functioning:	<b>Yes</b>	Parking lot:	<b>2428</b>
Number of doors:	<b>5</b>		
Number of seats:	<b>5</b>		
Number head rests:	<b>5</b>		
Rims summer:	<b>Aluminium</b>		
Category:	<b>Passenger Car</b>		
Oil level:	<b>OK</b>

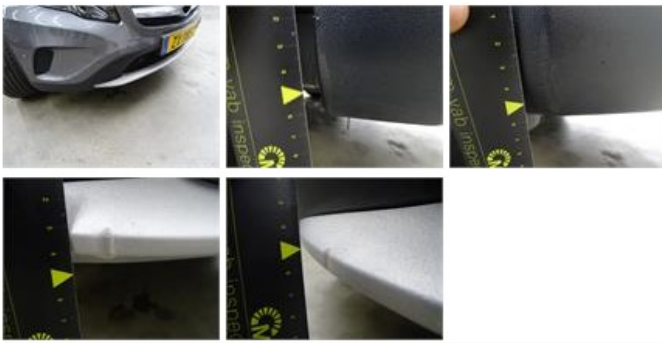
<b>Total cost ex VAT</b>	<b>840,24</b>
<b>Bumper F M, Dent(s) and scratch(es), Smart repair</b>	<b>110,64</b>

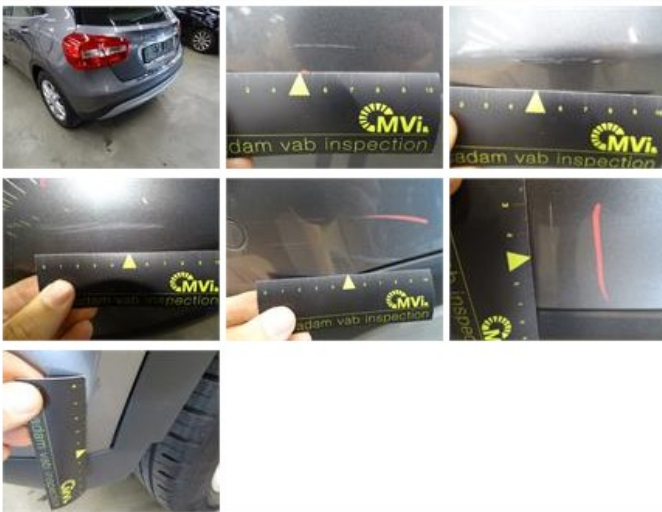
Bumper R, Dent(s) and scratch(es), LI - Repair and paint (complete) 254,16

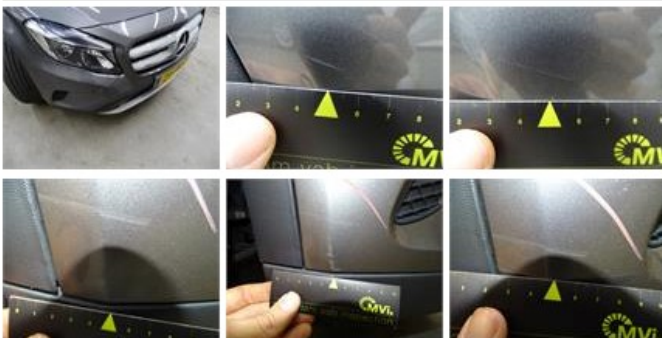
Bumper F, Scratch(es), LI - Repair and paint (complete) 254,16
